Visual Aid for Cartridge Inspection

This document is for use with D8148, D16199 and D12547. It provides a visual aid for defects found on completed cartridges.

This document pertains to visual inspection that occurs during Manufacturing and In-Process Testing.

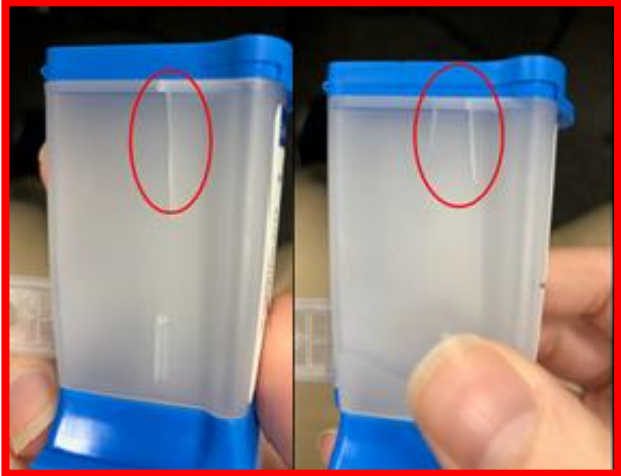
Unacceptable/Minor Visual	Acceptable
<p>Unacceptable Figure 1 – Cracked Damage on the cartridge body.</p>

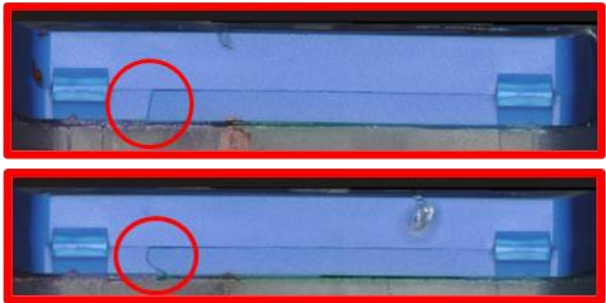
Unacceptable/Minor Visual	Acceptable
<p>Unacceptable Figure 2. Single crack at any part of the back lid, potential for lid to leak.</p>

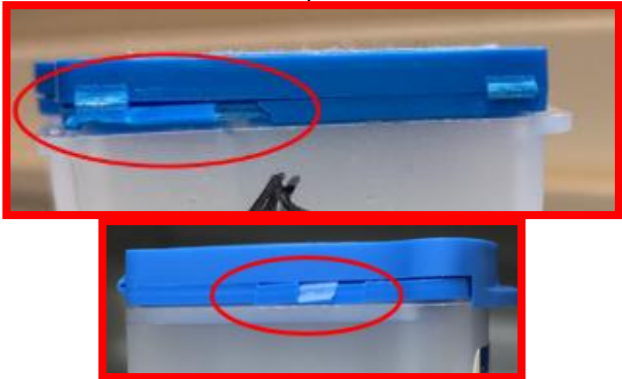
<p>Unacceptable Figure 3a - Multi-cracked lid at the back of the lid, lid particulate is breaking off from lid and multi-crack on the side of the lid, potential for lid particulate to break off and cause leaks. All multi-cracked lids at the back or sides of the lid are unacceptable</p>

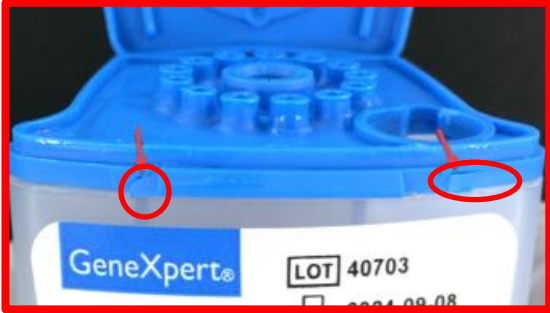
<p>Unacceptable Figure 4b - Multi-cracked lid at the front of the lid, lid particulate is breaking off from lid and potential for lid particulate to break off and cause leaks.</p>

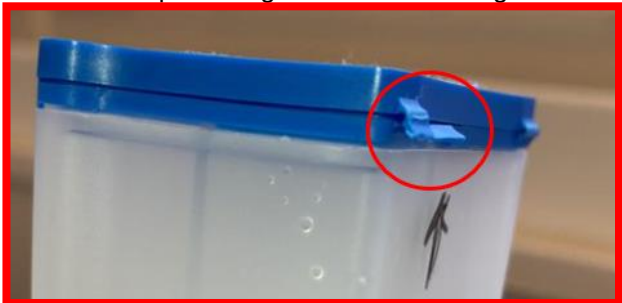
Unacceptable/Minor Visual	Acceptable
<p>Unacceptable Figure 5 – Broken hinge.</p>

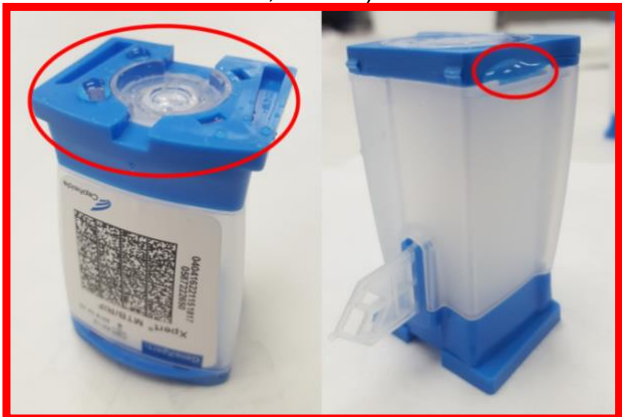
Unacceptable/Minor Visual	Acceptable
<p>Unacceptable Figure 6 – Evidence of leakage (foot leak, lid leak).</p>

<p><i>*(Information for IPT) In cases where cartridge(s) leaked onto the rest of the cartridges in the sample bag, locate, mark, and count the leaky cartridge(s) as a Minor Visual Failure(s) and replace the remaining cartridges in the time point.</i></p>	<p>Acceptable Figure 6 – No evidence of leakage (no leak from the foot or lid).</p>

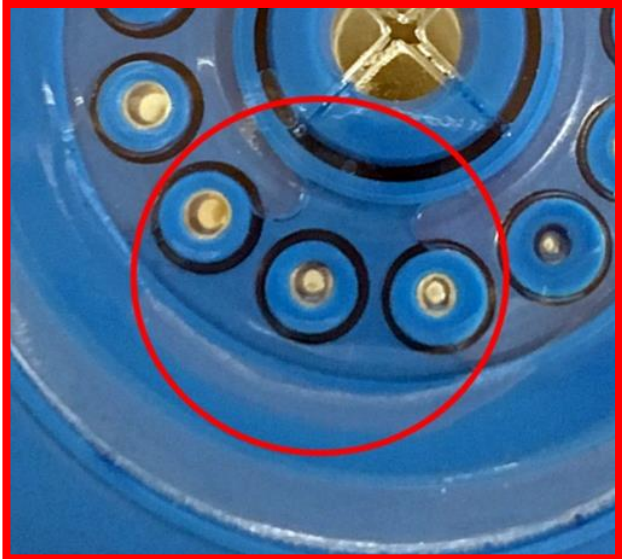
Unacceptable/Minor Visual	Acceptable
<p>Unacceptable Figure 7 – Liquid observed under the film seal.</p>

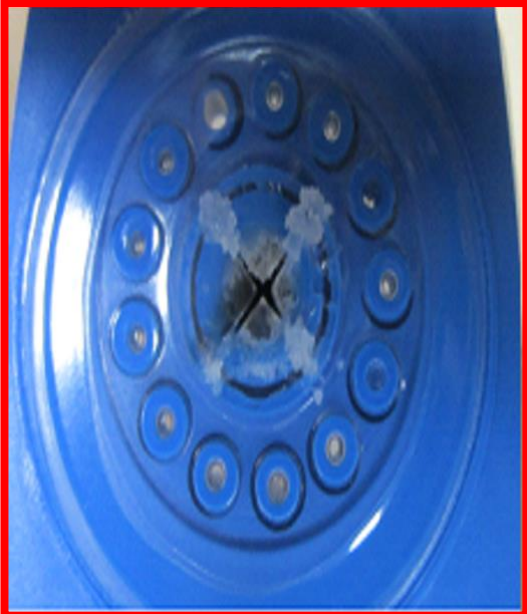
Unacceptable/Minor Visual	Acceptable
<p data-bbox="191 422 764 485">Unacceptable Figure 8 – Moderate crystallization observed.</p>

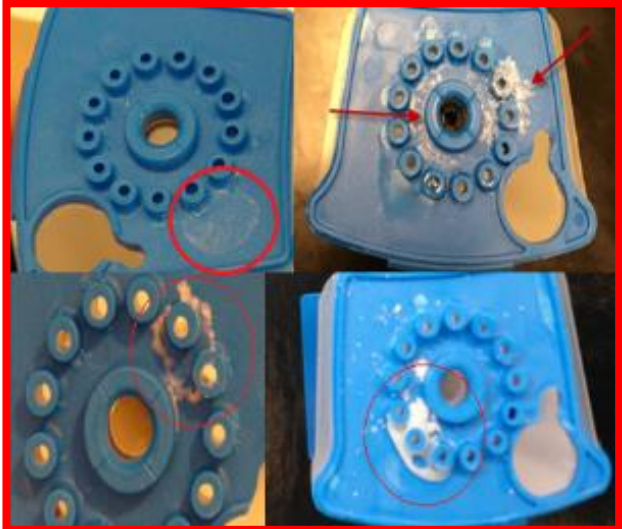
<p data-bbox="180 1100 802 1247">Unacceptable Figure 9 - Any presence of liquid on lid surface, any presence of crystallization or liquid on or touching the plunger hole, moderate crystallization on more than 1 chimney or crystallization on more than 5 % of lid surface.</p>

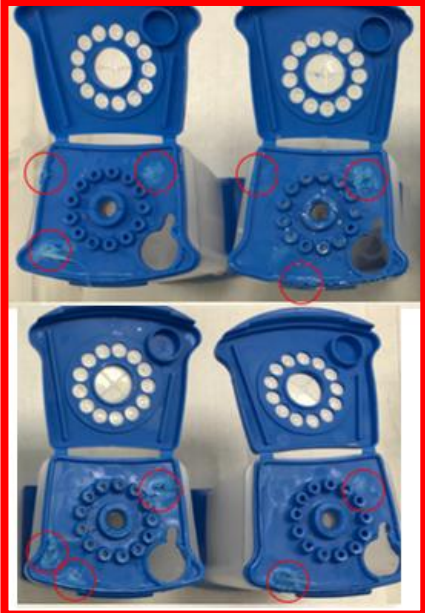
Unacceptable/Minor Visual	Acceptable
<p>Unacceptable Figure 11 – Lid Overwelding with Plastic Hair.</p>

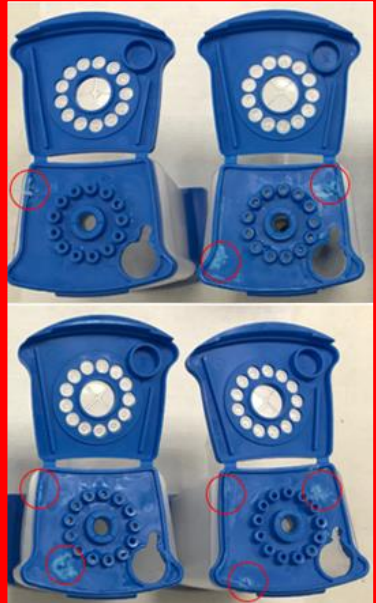
<p>Unacceptable Figure 12 - Lid Overwelding, Plastic Strings, Damage to Upper and Front Lid</p>

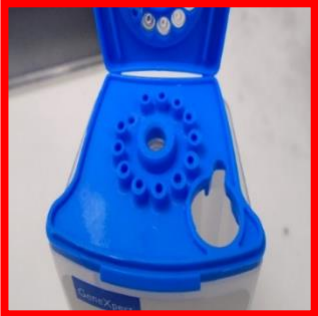
Unacceptable/Minor Visual	Acceptable
<p>Unacceptable Figure 13 – Cracked/Broken chimneys.</p>

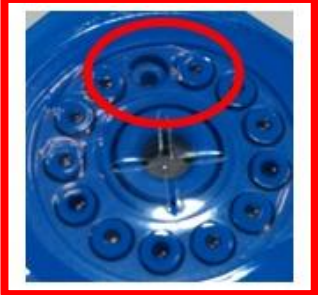
<p>Unacceptable Figure 14 - Missing Chimney</p>

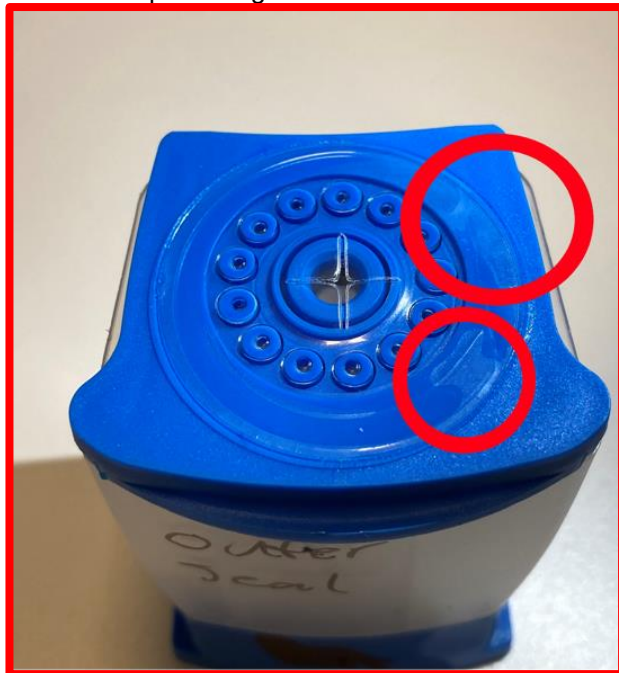
Unacceptable Figure 19 - Poor outer seal

NOTE: To differentiate lift/void from glare, view top-down then tilt 10–20°. Glare moves with angle; a true lift/void tends to remain.

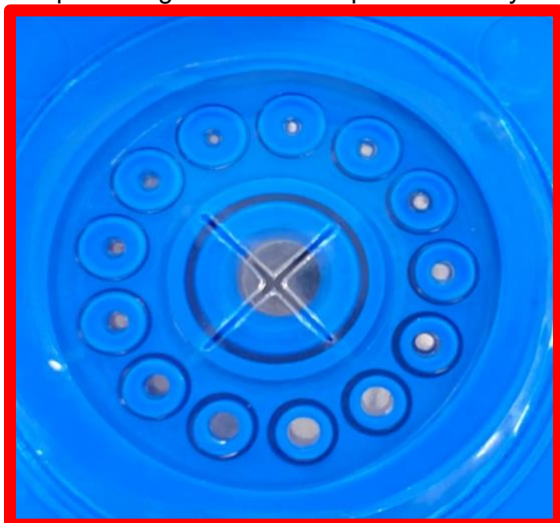
Unacceptable Figure 19 – Incomplete Chimney Melt

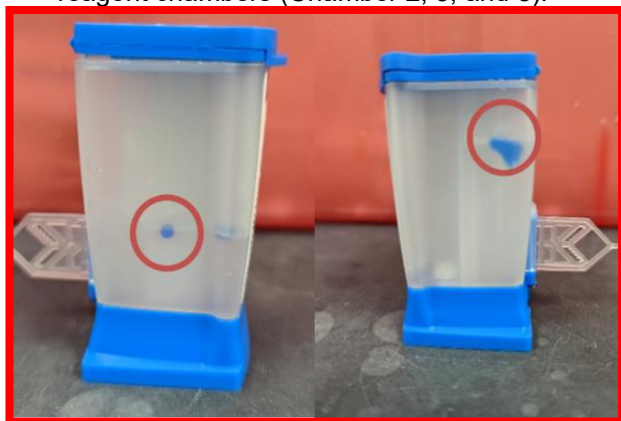
Unacceptable Figure 22 – Retain balls, beads, or debris in sample chamber (Chamber 3) or liquid reagent chambers (Chamber 2, 5, and 8).

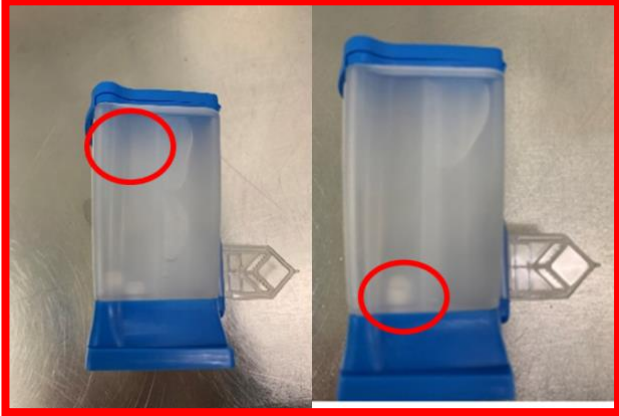
Unacceptable/Minor Visual	Acceptable
<p data-bbox="159 447 795 506">Unacceptable Figure 23 – Damaged Prefilter (e.g., out of place, cracked, loose).</p>

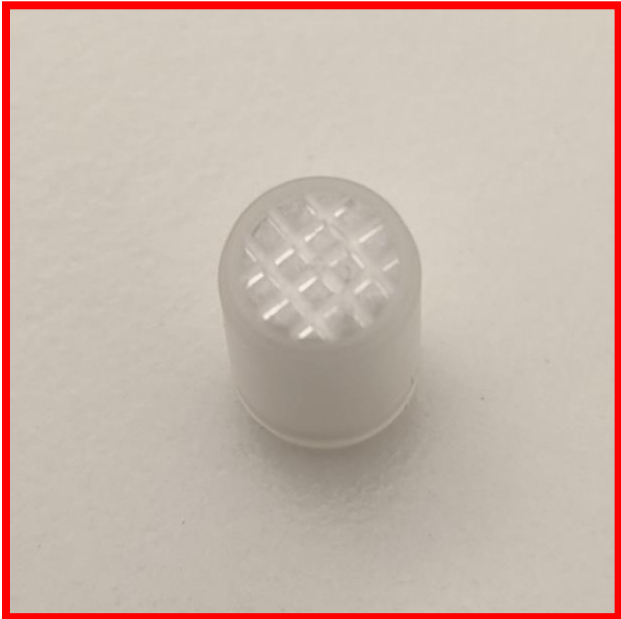
<p data-bbox="170 1037 784 1096">Unacceptable Figure 25 – Standalone filter in wrong orientation.</p>

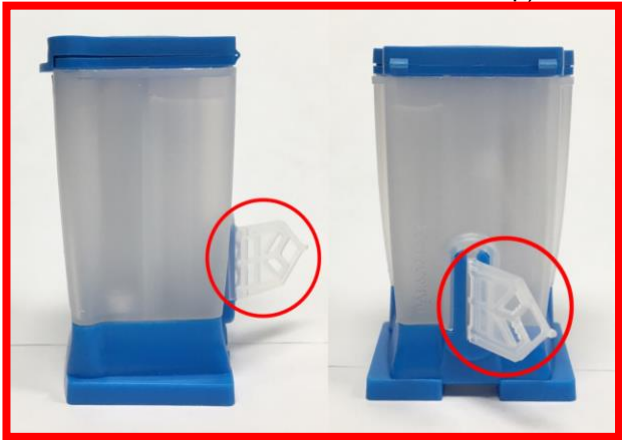
Unacceptable/Major Visual	Acceptable
<p>Unacceptable Figure 26 - Damage (e.g., bent, broken reaction tube or broken reaction tube tip).</p>

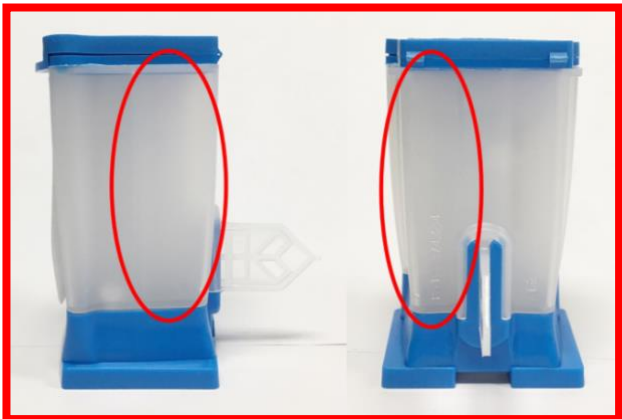
Unacceptable/Major Visual	Acceptable
<p>Unacceptable Figure 27 - Absence of liquids on board reagents, if applicable (e.g., Chamber 2, 5 and 8).</p>

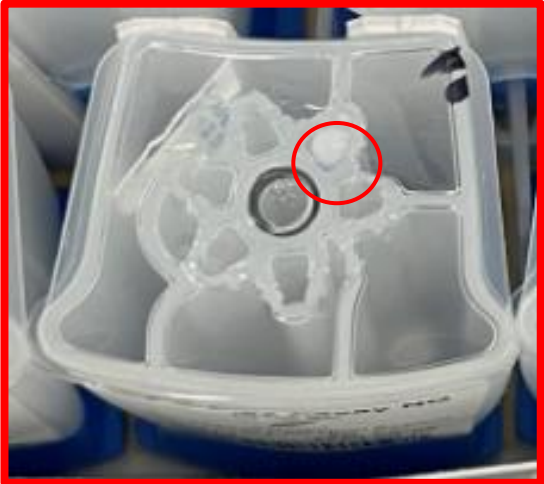
Unacceptable/Major Visual	Acceptable
<p data-bbox="180 422 776 483">Unacceptable Figure 28 – Loose Large Retain Ball visible at film seal</p>

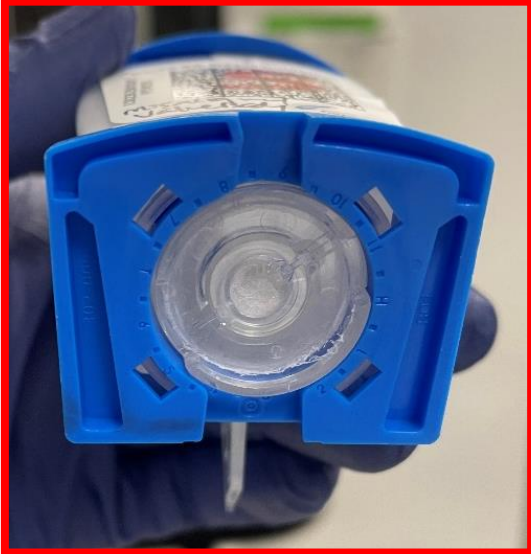
Unacceptable/Major Visual	Acceptable
<p data-bbox="168 489 779 552">Unacceptable Figure 29 – Valve body is misaligned. (This is a more easily determined failing example).</p>

***Note:** The arrow needs to be pointing within the H. The arrow pointing at the line, or the line edge of the H is acceptable.

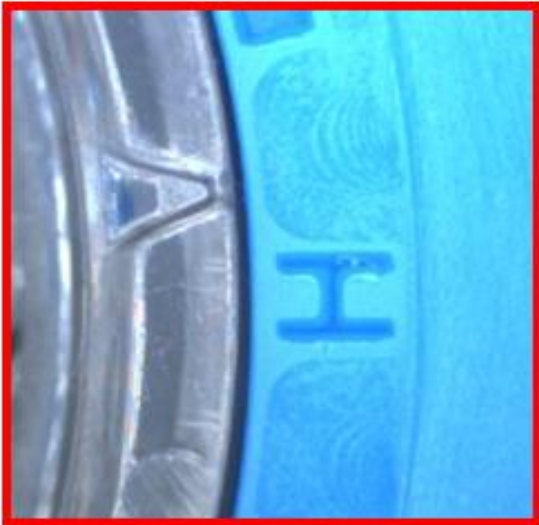
<p data-bbox="191 1129 779 1192">Unacceptable Figure 29a – Arrow pointing outside the H.</p>

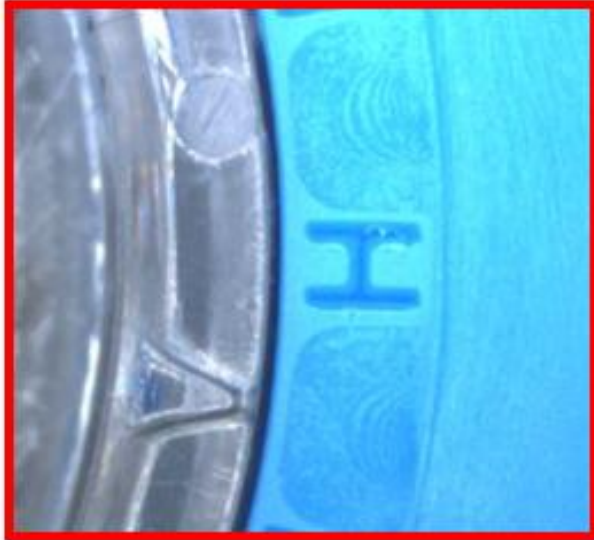
Unacceptable Figure 29b – Arrow pointing outside the H.

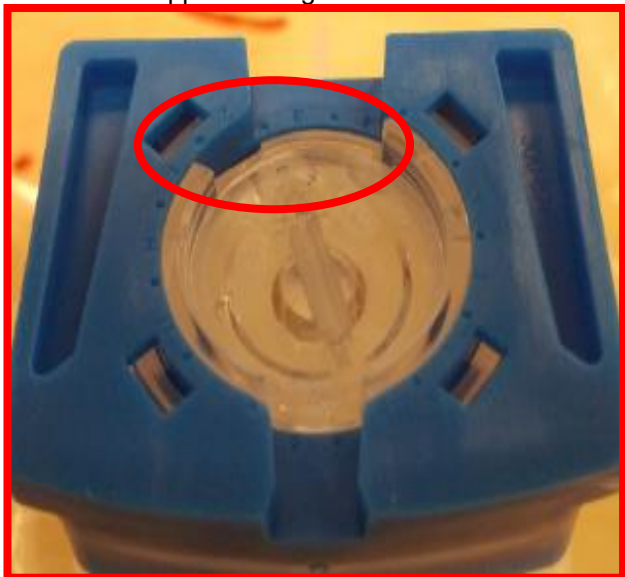
Unacceptable/Major Visual	Acceptable
<p data-bbox="245 422 711 485">Unacceptable Figure 30 - Valve body is chipped/damaged/deformed.</p>

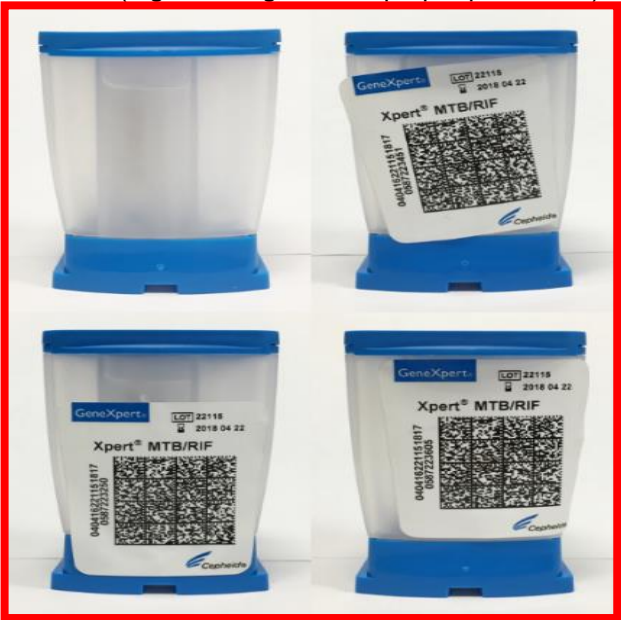
Unacceptable/Major Visual (non-NFC cartridge)	Acceptable (non-NFC cartridge)
<p>Unacceptable Figure 31 – Unacceptable cartridge label placement (e.g., missing label, improper placement).</p>

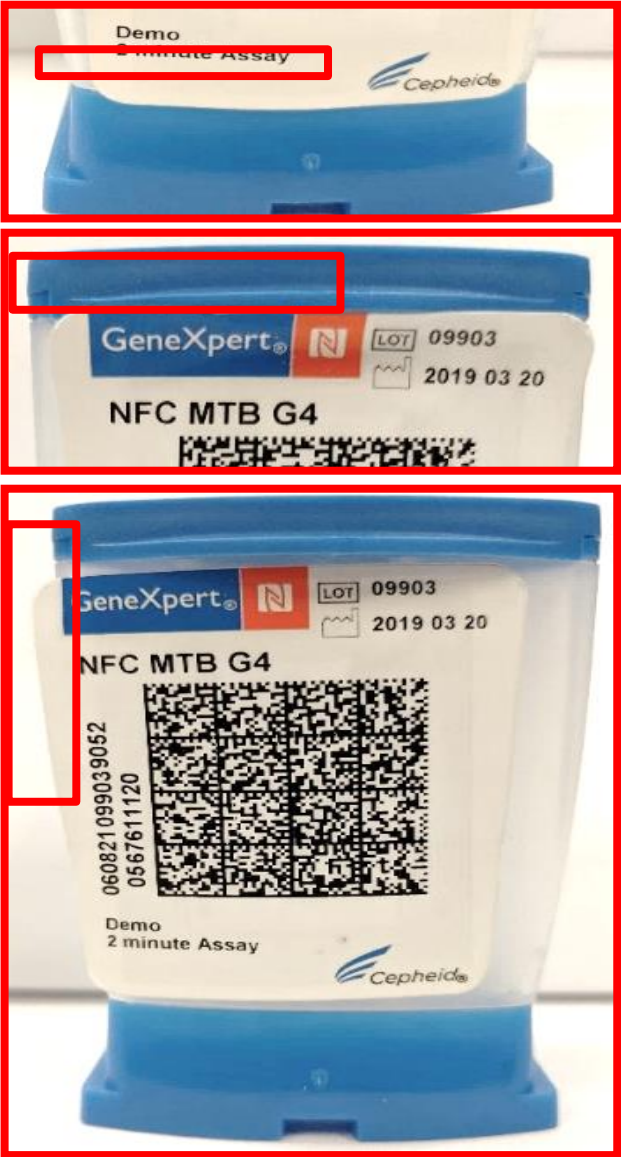
Unacceptable/Major Visual (NFC cartridge)	Acceptable (NFC cartridge)
<p data-bbox="131 390 776 449">Unacceptable Figure 32 - Touching blue lid/foot and/or hanging off to the side.</p>

<p data-bbox="139 1619 768 1675">Not a failure at IPT (see section 5.6.5.2 in D12547 for more information)</p>	<p data-bbox="878 405 1482 434">Acceptable Figure 27 - Label present and centered.</p>

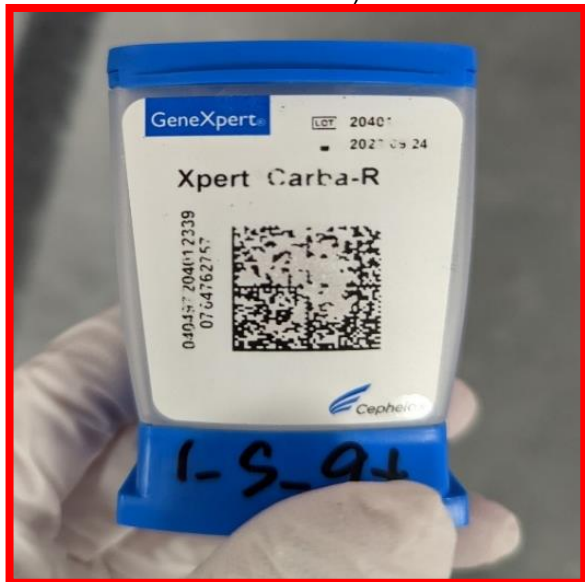
Unacceptable/Major Visual	Acceptable
<p>Unacceptable Figure 33 - Cartridge info incorrect, faded, or barcode cannot be scanned (e.g., illegible, unscannable).</p>

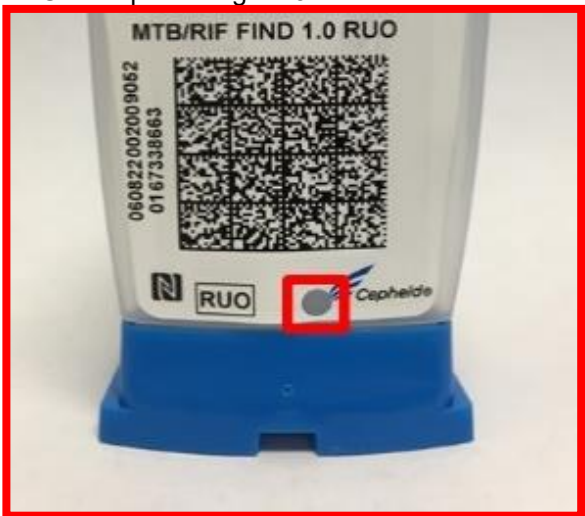
Unacceptable/Major Visual (NFC cartridge)	Acceptable (NFC cartridge)
<p>Unacceptable Figure 34 - Punch in label.</p>

<p>Classified as a barcode failure at IPT (see section 5.6.5.2 in D12547 for more information)</p>	<p>Acceptable Figure 29 - No Punch.</p>

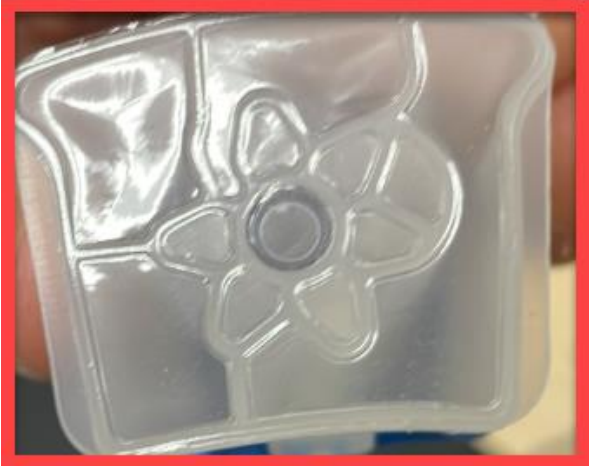
Unacceptable/Major Visual	Acceptable
<p data-bbox="167 457 787 514">Unacceptable Figure 35 – Missing Center perforation on top film seal</p>

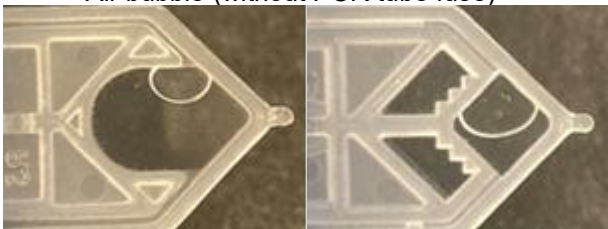
NOT qualifying for PCR tube film fuse	Qualifying for PCR tube film fuse
<p>Figure 36 – Visual findings that do NOT indicate a PCR tube film fuses:</p> <ul style="list-style-type: none"> PCR tube not liquid filled (observed best by comparing the light refraction of the tube to a non-run PCR tube empty cartridge and a post-run passing cartridge) Air bubble (without PCR tube fuse)

6.3.1.4.1. Importantly, a PCR tube film fuse will not move while air bubbles or precipitates could move upon e.g., turning or gently tapping the cartridge, or gently touching of the PCR tube (which should be generally avoided and if, should be done under utmost care not to damage the PCR tube). Air bubbles may be observed additionally to PCR tube film fuses.

6.3.1.4.2. White/milky shadows may sometimes be observed on PCR films post-run. These are not considered PCR tube film fuses if no actual fuse is observed and there is still liquid between the two film pieces.

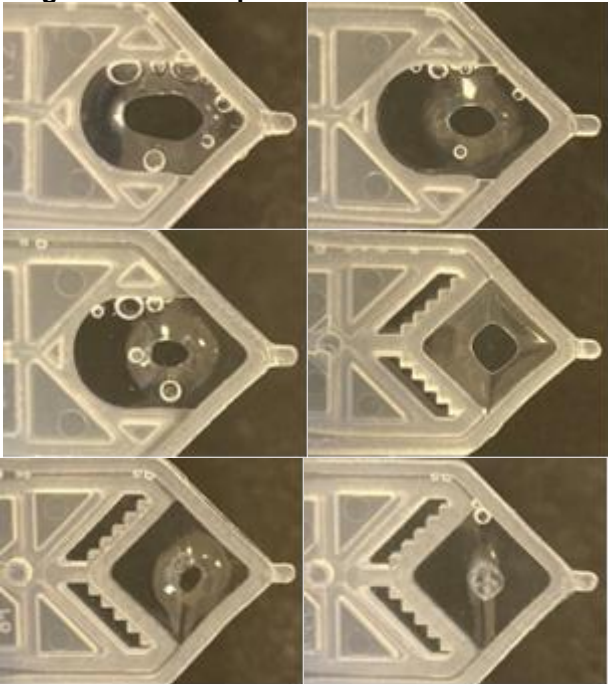
<p>Figure 31 – Examples of PCR tube film fuses:</p>

<ul style="list-style-type: none"> Fused area must be at least 1mm in size (1 dimension) PCR tube film fuse post-run may be combined with air bubbles (often multiple smaller ones)

6.3.1.2.3. PCR tube film fuse is not considered a visual failure but only used to motivate meeting criteria for re-test per D12547.
