WP 3: Reliability of Urban Flood Defences

D3.1 Guidance on improved performance of urban flood defences

Report Number: WP3-01-12-11

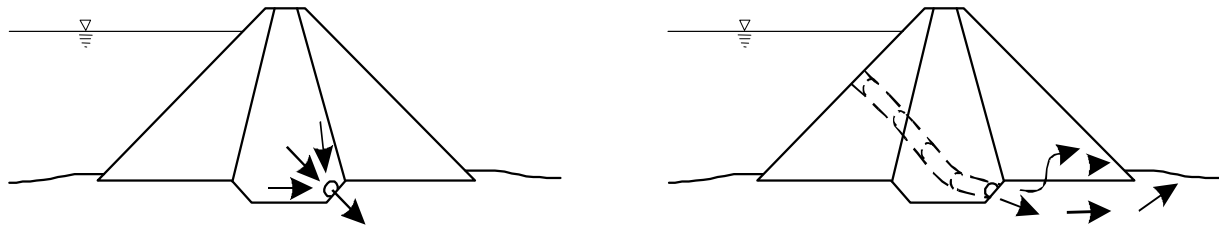
- Backward erosion in a cohesive soil. In this configuration, erosion is initiated by a leakage at the exit of a cohesive core to the foundation. The formation of a hole in the core increases erosion rate and hence leads to progressive backward extension of a pipe.

Figure 2.3 Typical example of backward erosion in a cohesive soil (clay core) (Fell & Fry, 2007).

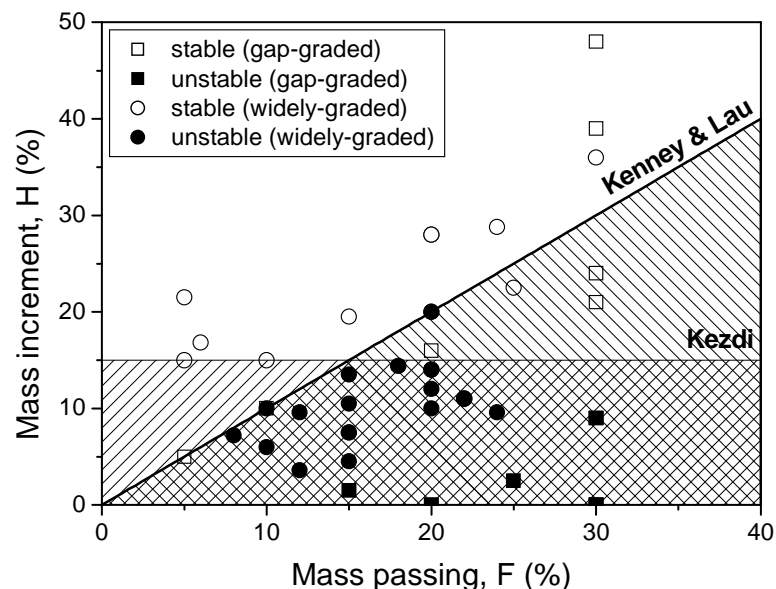
Using some new experiments and many previous ones found in the literature, Li and Fannin have recently proposed to use Kezdi criterion for gap-graded size distribution whereas Kenney and Lau criterion is suited for widely-graded soils.

Figure 2.7 Comparison of Kezdi and Kenney & Lau criteria, adapted after Li & al. (2008)

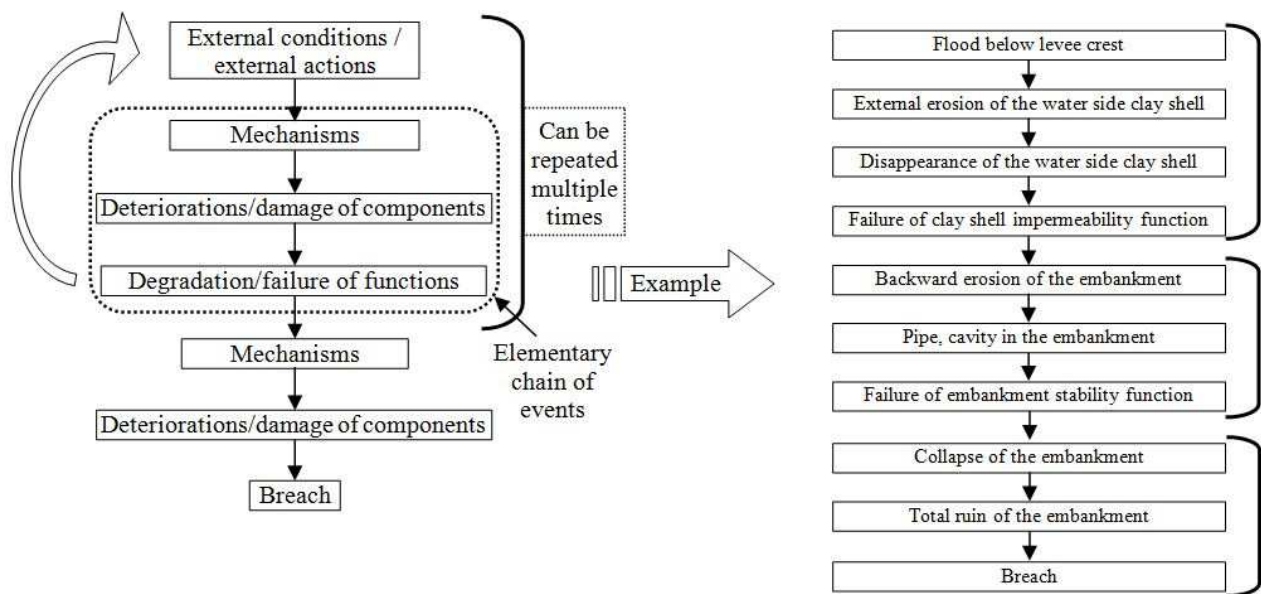
Figure 3.1 Breach scenarios (ILH, 2013)

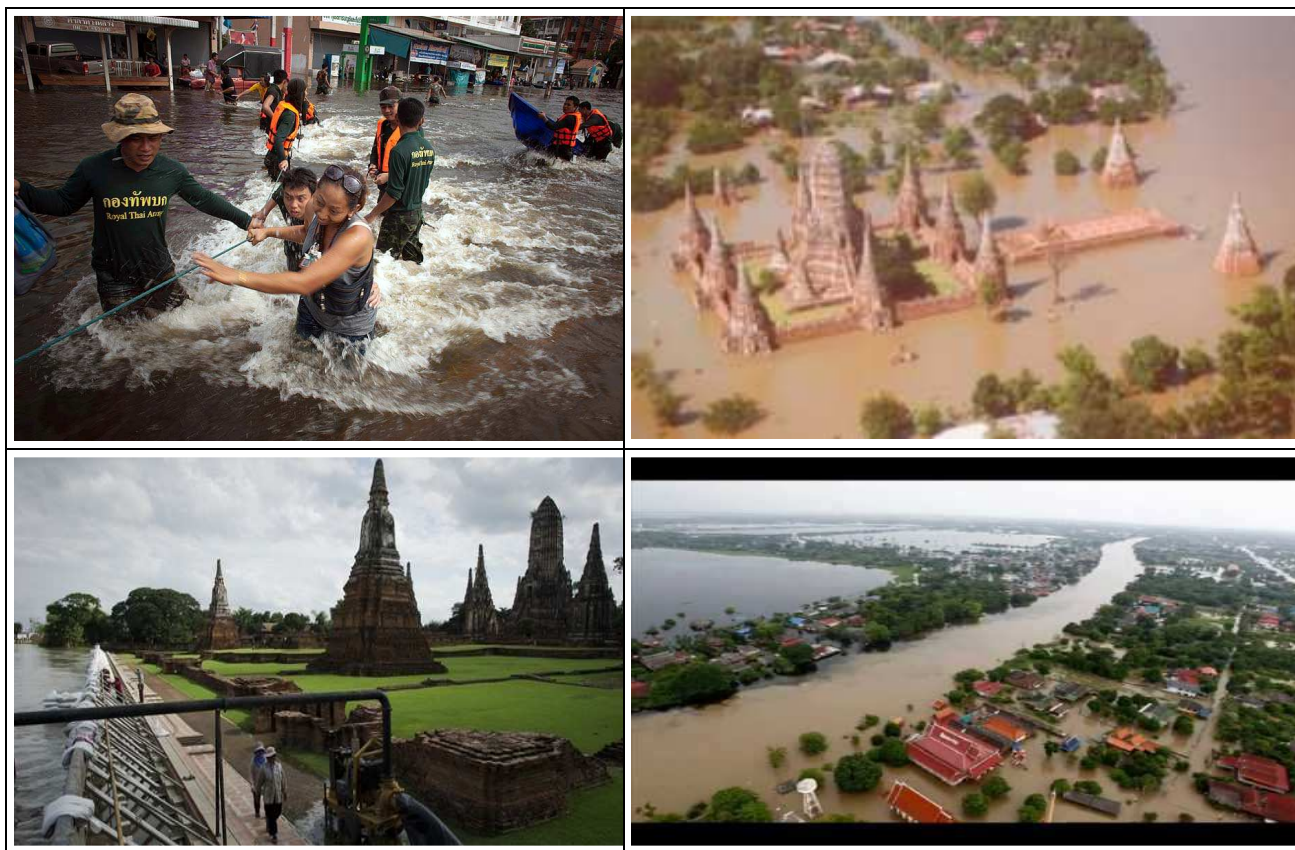
Figure 3.8 (i) Flood evacuation; (ii) Historical sites flooded; (iii) Temporary flood defences; (iv) Widespread flooding

The Lower Chao Phraya river basin is a complex network of rivers, canals and streams (Figure 3.7). The maximum discharge capacity in the lower part of the basin ranges from 2750 m³/s to 3500 m³/s. During the 2011 floods Thailand was struck by one of the most devastating natural disasters in Thailand's modern history. Sixty five out of seventy seven Thai provinces were subject to flooding along the Mekong and the Chao Phraya river basins. The flooding persisted in some areas for months and resulted in more than 800 deaths and 13.6 million people being directly affected (Figure 3.8).

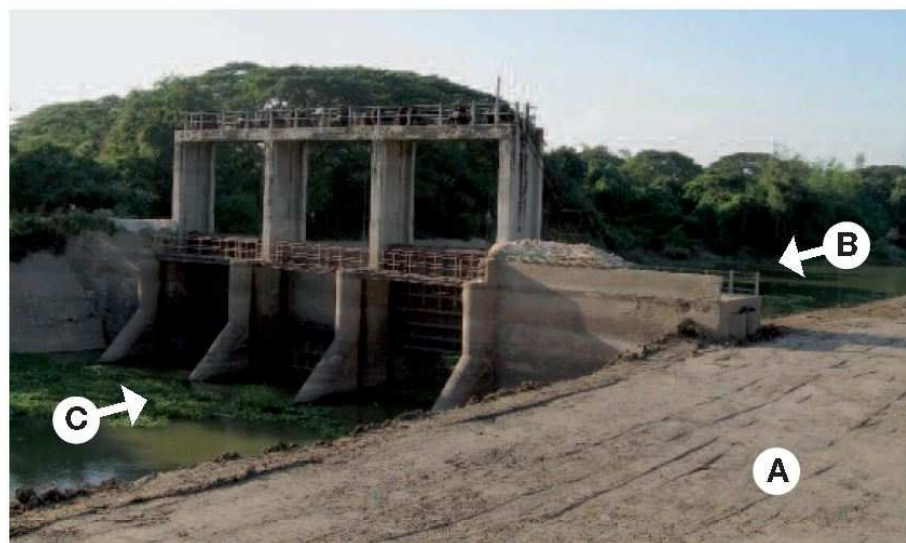
**Pra Ngam floodgate**

- A** sand fill at the original breach
- B** regular flow
- C** flow during flooding

**Figure 3.10 Failure of the Pra Ngam floodgate**

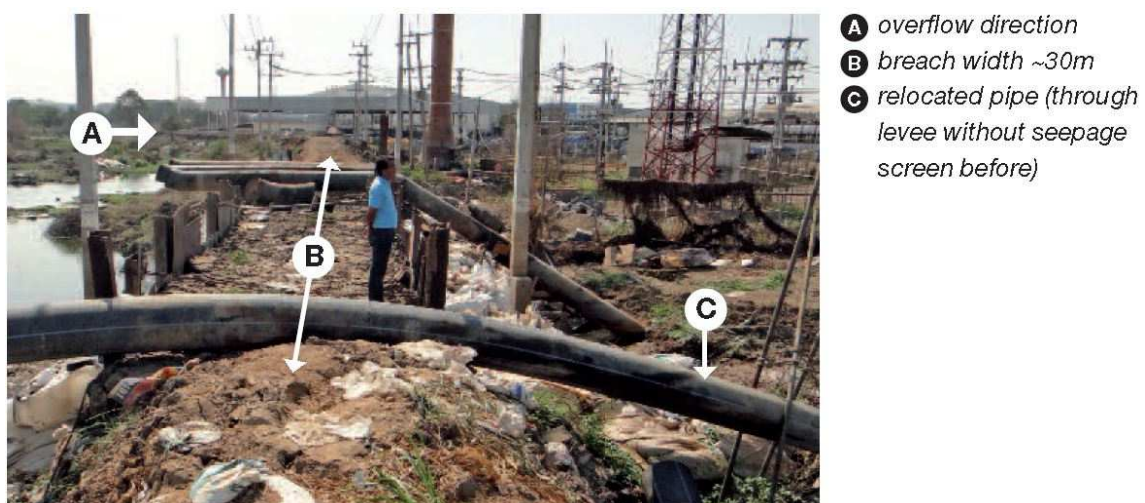
The second breach that was visited occurred at a pipe in the dyke, which was not protected by seepage screens. At this location the failure started with seepage along a pipe through the levee (no seepage screen) and failure progression accelerated when it was also overtopped. According to eye witnesses it took about 2 hours to form the 30 wide breach. The levee was rather new and built after floods in 1999. (See Figure 3.12).

Figure 3.12 Breach through seepage initiated along a pipe passing through the dyke

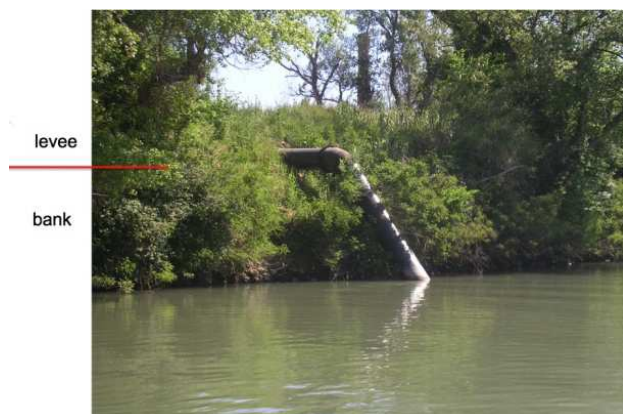
Figure 3.15 A pipe crossing through and across the water side of a levee (Rhône River)

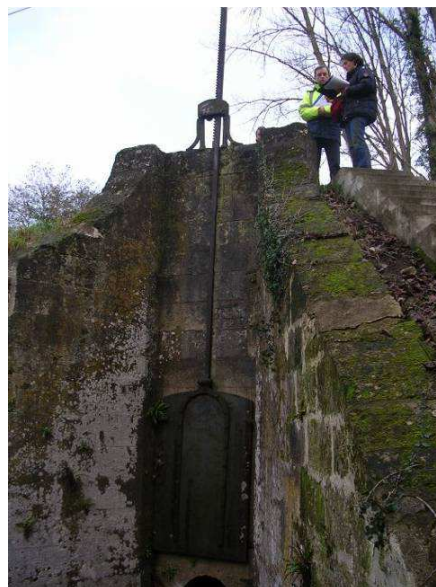
Figure 3.16 A gate control at the end of a culvert passing through a levee (River Loire)

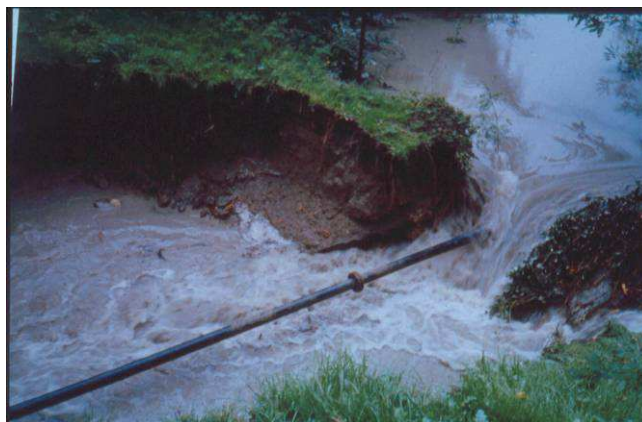
The following picture was taken during the 1993-94 floods of the Rhône River in Camargue.

Figure 3.17 Levee breach initiated along a pipe crossing (Rhône River). Photo SNRS.

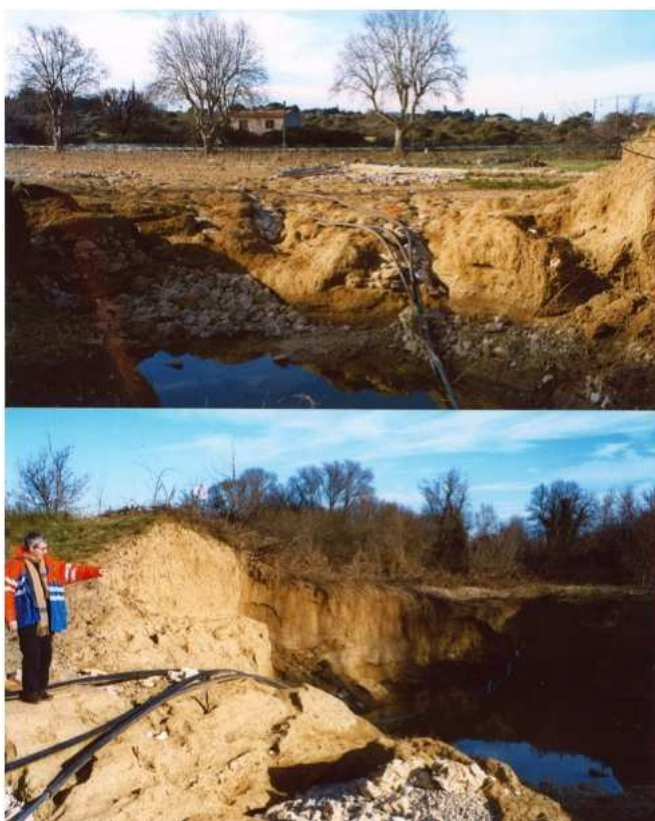
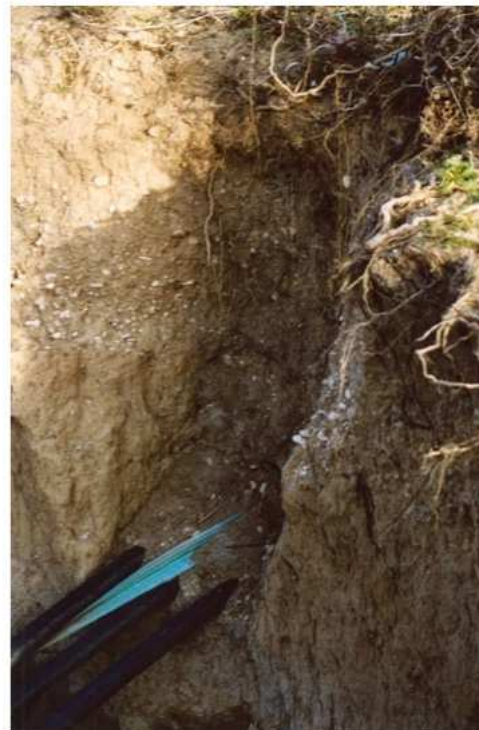
The following set of pictures shows a breach which was probably caused by erosion around some telecommunication cables: in the picture on the right, it can be seen that the cables were put in a trench filled with coarse and non cohesive material which would act as a preferential seepage path. The trench can also be seen on the upper left picture, on the left of the set of cables (just under the house).

Figure set 3.18 Breach initiated along crossing cables (Mosson River).

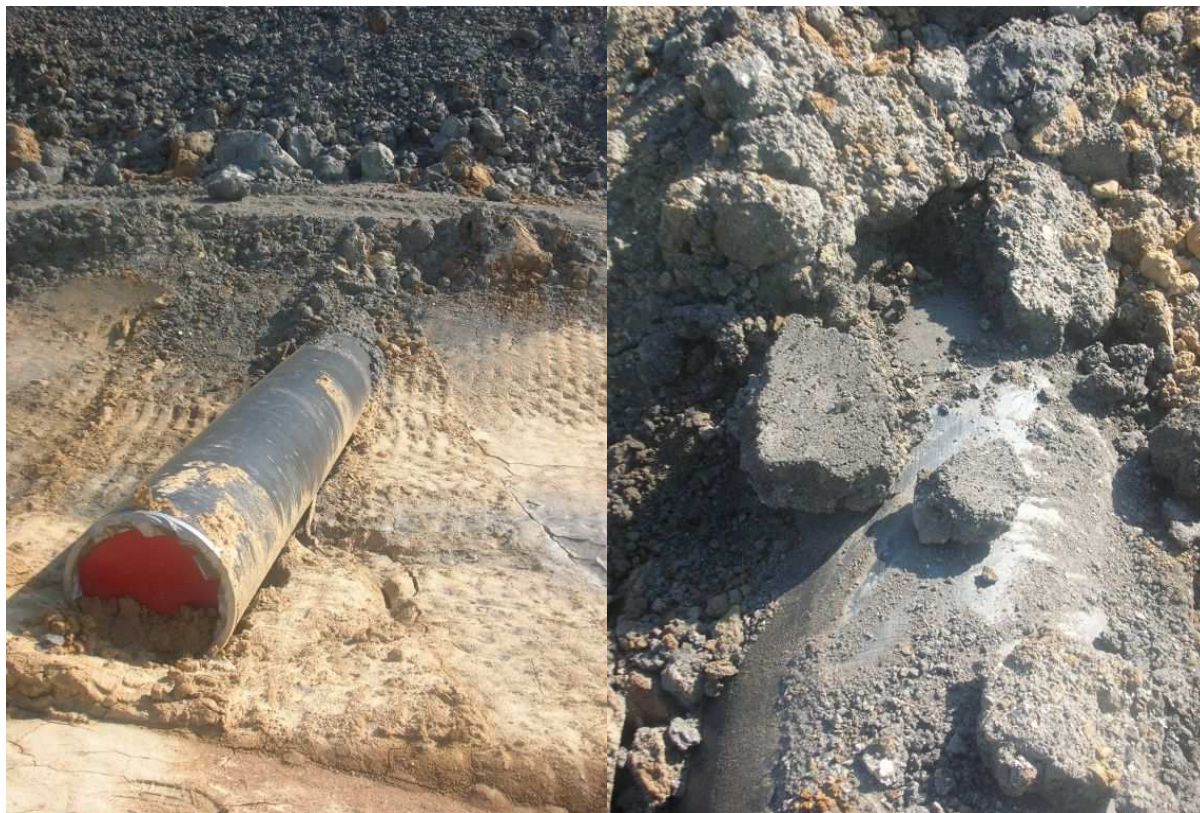
The following set of pictures shows a pipe which is crossing under the base of a levee with no specific treatment of the contact surface visible, and hence the strong possibility of contact erosion

Figure set 3.19 A pipe crossing at the base of a levee (Dresden)

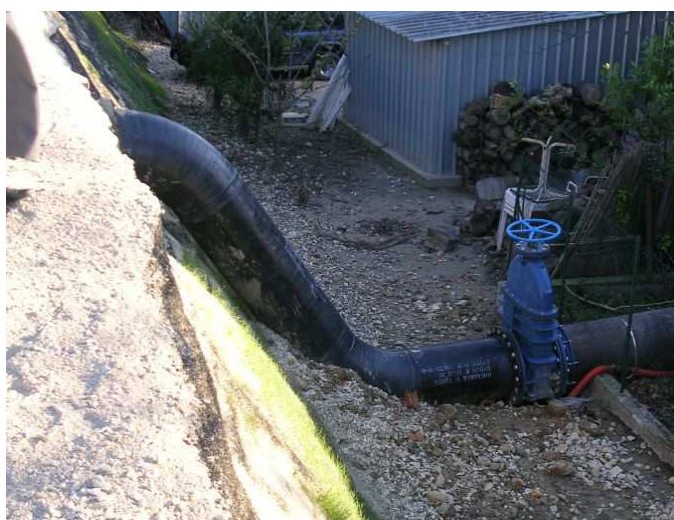
The next picture presents a solution (adopted as general design by SYMADREM, Rhone River levee management organisation, for retrofitting older pressure pipes), as it lengthens the contact area, and removes most of it at the point of highest gradient.

Figure 3.20 A crossing pipe with " siphon shape" (Rhone River), to minimize the risk of internal erosion along the pipe. Picture of the land side of the levee.

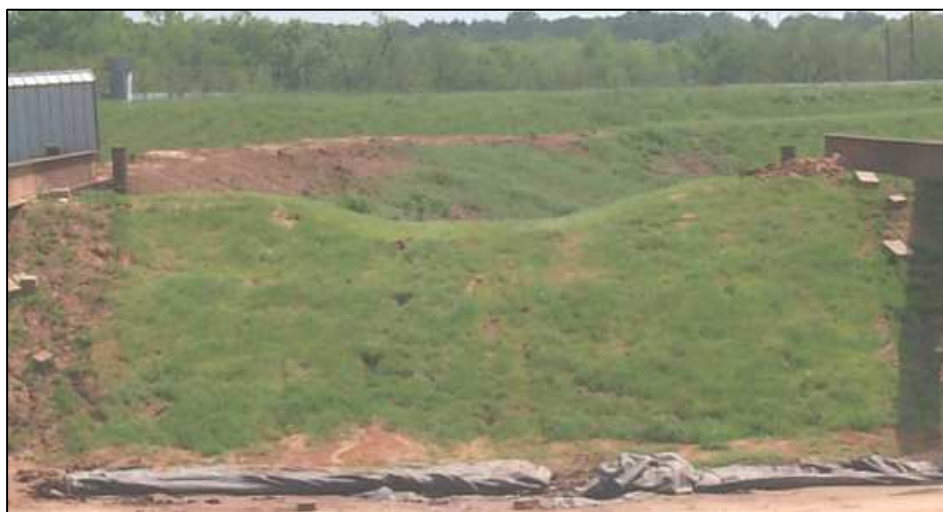
Figure 4.7 Test case 1 embankment

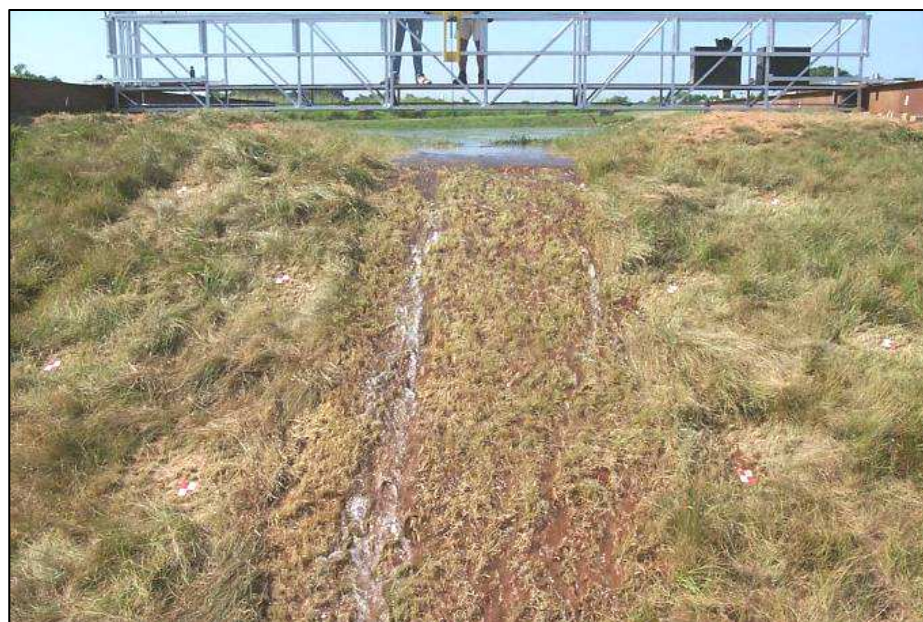
Figure 4.9 Test Case 2 embankment
