Spatial video data collection in a post-disaster landscape: The Tuscaloosa Tornado of April 27th 2011

A B S T R A C T

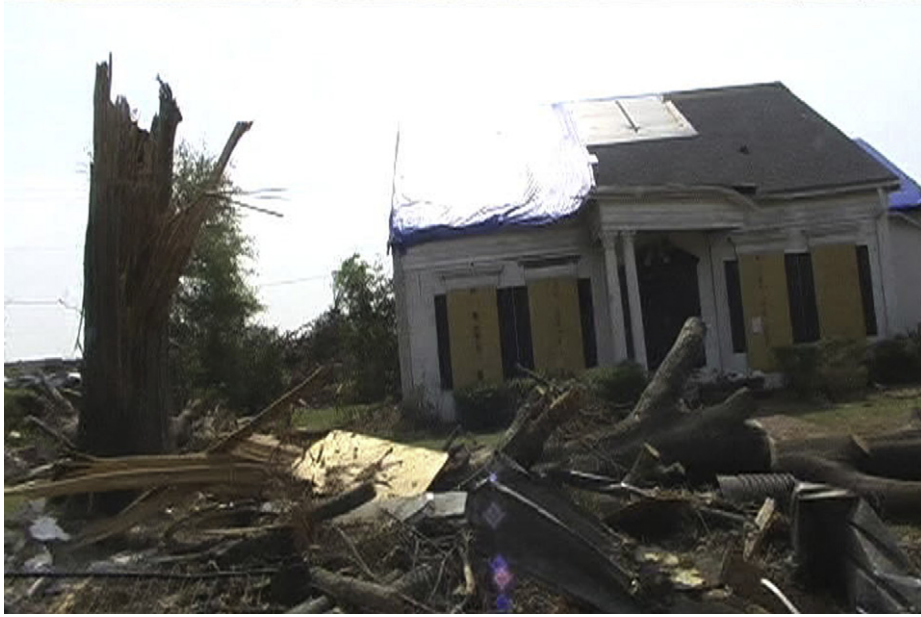
Sample Area 1. This middle income neighborhood of large detached homes bordered the path of severe damage. There is variation in damage along the street with some homes having extensive areas covered with blue tarps while others appear largely untouched. Although this video collection was twenty three days after the tornado, the city was still in a response/post-response phase as evidenced by the American Red Cross disaster relief van. Continuing around the crescent, the damage to trees increases, and there are large piles of debris at the curb side. Although the majority of homes suffered some damage, this video surveillance suggests that this was superficial to moderate with mostly roof damage. It is unlikely any home was damaged to the point of having to be rebuilt, which given the income level of this community suggests that recovery will occur quickly and “normalcy” should reflect the pre-disaster environment (Fig. 2).

Fig. 2. A damaged home from Sample Area 1, the windows have been blown out, the roof damaged (and covered with a blue tarp), and the tree in front broken in two. (For interpretation of the colour reference in this figure caption, kindly refer to the online version of this article.)

If we refer to Table 1 then the highest degree of damage scores “4” for a single or double family residence, suggesting a tornado of EF 1 to 2 though it should be remembered this section was not directly on the scoured path as seen in Fig. 1.

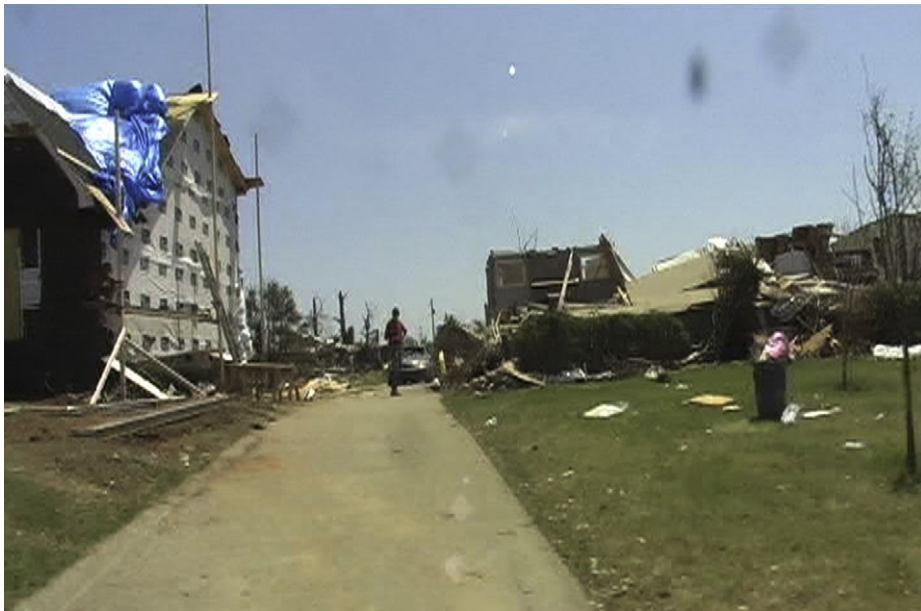
Sample Area 2 is further along the tornado’s path and cuts directly across the center of the worst damage. The neighborhood is again middle income with moderately sized detached homes. At the beginning of the sample are a cluster of disaster support facilities which provide food, water, comfort and even insurance information for returnees. Next to these facilities are extensive piles of debris showing that this neighborhood was hit far harder than Sample Area 1 and that at its height the tornado caused complete building destruction. Interestingly, one home is already being rebuilt (Fig. 3). The rest of the homes show decreasing amounts of damage, mainly roof related, until the last home appears untouched. In this street, the level of damage runs from complete destruction to apparent habitability.

Fig. 3. Rebuilding in Sample Area 2 next to a completely destroyed home.

Using Google Street View as a pre-disaster reference, the single-family homes in the section with the greatest damage have been

completely destroyed and leveled to the ground. If we refer to Table 1, the degree of destruction ranges between 9 and 10, suggesting a tornado of size EF4 or EF5.

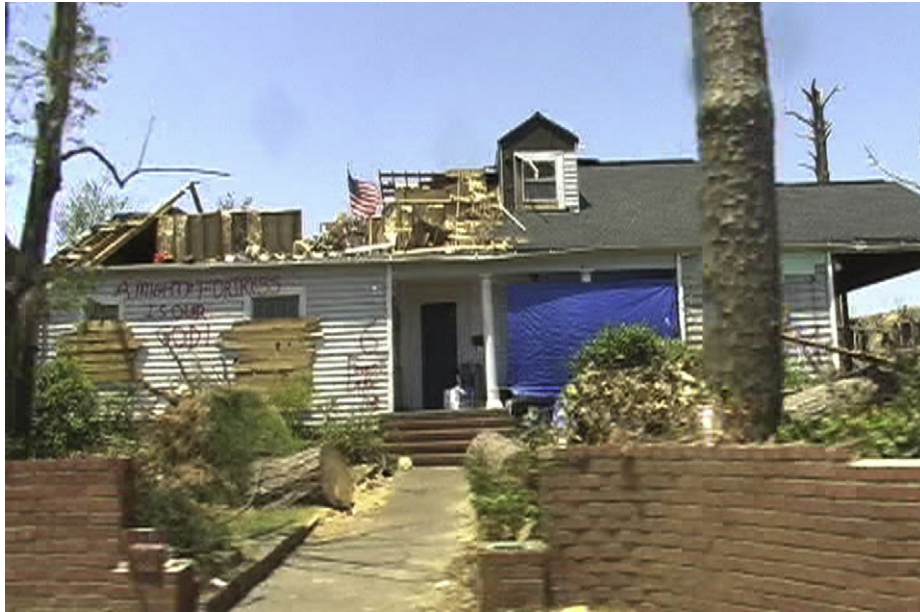
Sample Area 3. The next transect of the tornado’s path captures a wider swath of destruction. Although the area was characterized by single family homes, they are smaller and indicate a lower income status than the two previous neighborhoods. The first home has been cut in two by a fallen tree. The next few homes are either completely destroyed or display catastrophic structural failure with only a few walls remaining. It is also interesting to note how the trees have been sheared off. The last home also displays one of the telltale signs of wind damage; the roof has been completely lifted from the house though the walls remain untouched. The wind enters through broken windows and doors and causes failures along the weakest structural surfaces, which in this case is from below the roof pushing upwards (Fig. 4).

Fig. 4. A home from Sample Area 3 showing severe upper deck damage, with a flag waving from within the roof, and a message from the owner spray painted on the building side.

Again using Google Street View as a pre-disaster reference, the degree of damage scores a 9 suggesting wind speeds in the range of 170–198 mph, and an EF4 tornado.

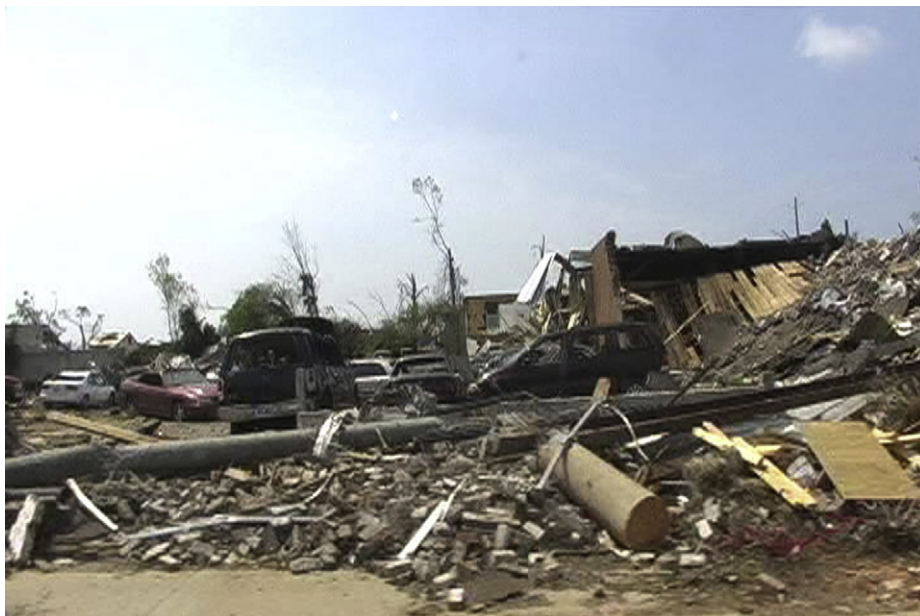
The degree of damage is variable, from buildings which appear to have suffered mainly glass breakages to those that have been totally destroyed. It is also possible to see along some of the side streets to the homes beyond which also display considerable damage. The majority of structures along this segment has been completely destroyed and will have to be cleared before being rebuilt (Fig. 5).

Fig. 5. A light commercial building from Sample Area 4 leveled to the ground.

This section also benefits from reference to pre-disaster imagery found in Google Street View. Most of the buildings were single story simple construction commercial units typical of strip malls. The hardest hit section, toward the beginning of this sample, was completely destroyed and reduced to rubble. There are several building types along this segment that could be used to suggest the EF. For “small professional building” then “total destruction of the entire building” would place wind speeds at between 157 and 200 mph. For “strip mall” then “complete destruction” would again place wind speeds at between 171 and 198 mph. In other words, for commercial sections such as this, it is hard to suggest a tornado of EF5 as an EF4 would cause complete destruction of typical small commercial buildings.

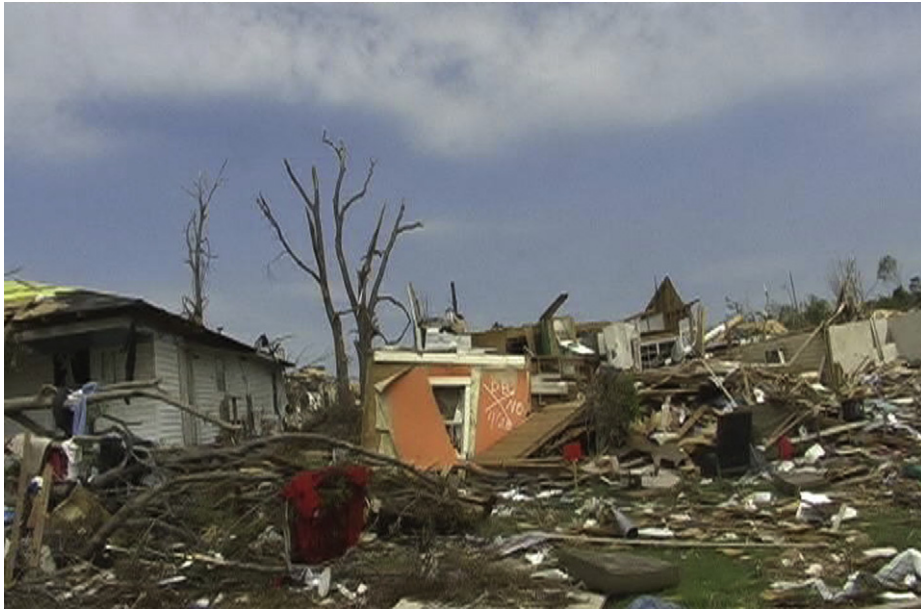
Sample Area 5 is the first of the two horseshoe collection routes which show the condition of an entire block. At this point the tornado had intensified and the path becoming wider. The destruction of this block is total with all structures needing to be rebuilt. The relatively small homes have all been reduced to either piles of debris or massively compromised structures. It is worth watching this video segment to appreciate the destructive capability of the tornado. There are several images to look for: a) the “home” which is now just a concrete slab with debris on top and a house number painted on a board in the front; b) the cars which lie upside down and inside where a house had previously stood; c) the corner home where both outside walls have been blown out but the front remains intact; d) the classic search and rescue “X” (the search and rescue team is to the top, the date to the right, and any mortalities below); e) and the uprooted trees and other trunks that have been splintered. Comments from a resident who accompanied us during data collection were telling (Fig. 6)

Fig. 6. Complete destruction in Sample Area 5 with a search and rescue “X” visible on the wall that remains standing.

Just as with Sample Area 2, the degree of destruction is between 9 and 10 suggesting a tornado of EF4 or EF5. However, there are differences between these neighborhoods, as the quality of construction is less robust in Sample Area 5 with fewer larger brick buildings.

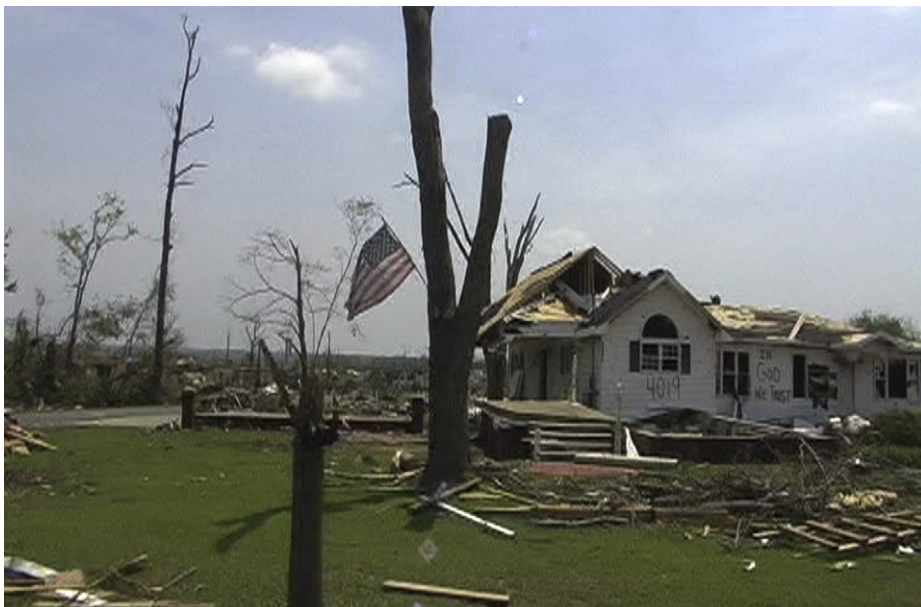
Sample Area 6 captures data from where the tornado path widens further, and the extent of severe damage covers large tracts of homes. This neighborhood is on the outskirts of the city and could almost be classed as rural in nature. Just as with Sample Area 5, a horseshoe route captures a block where none of the buildings appear salvageable (Fig. 7).

Fig. 7. The home has been shifted off its foundation and there is considerable roof damage.

Although there is some variation in the degree of damage for this video segment, the highest score is 10, suggesting a tornado of EF4 or EF5.
