AUTOMATIC POWDER FILLING MACHINE

Sep - nov 2025

This project was completed under the guidance of **HOD Ms. Pooja Bhardwaj** and **Dr. Rahul Raj Choudhrey**, with mentorship from **Parveen Jangir**. The project was carried out by **Chandan Markanda** and **Raghav Sharma**.

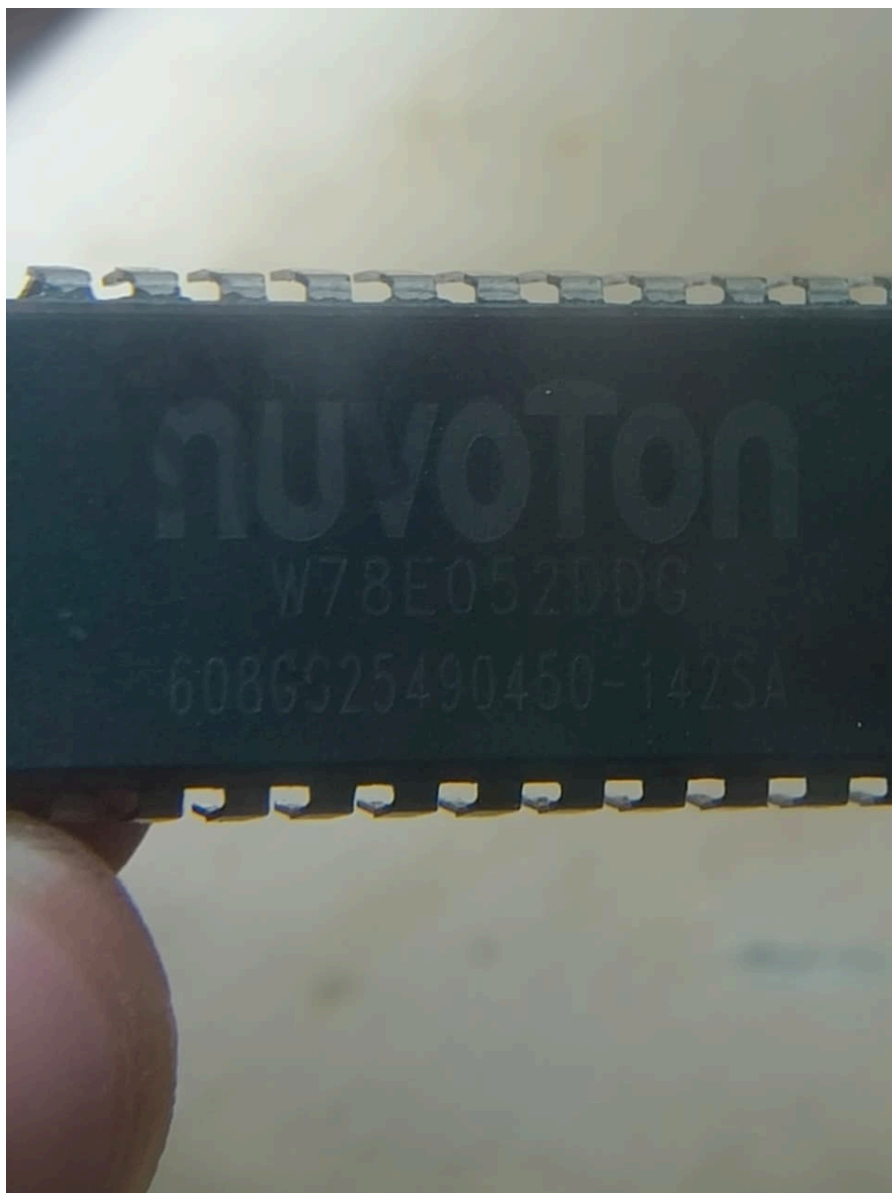
However, detailed inspection of the weighing machine revealed that it was built around a **Nuvoton W78E02DDG microcontroller**, a legacy **8051-based chip** that is programmed only once and lacks modern data-output capabilities. The device's architecture offered no accessible communication port that could provide real-time weight readings. Attempting to modify or extract firmware information from this microcontroller was not feasible, as the chip supports an outdated one-time-programmable method and its documentation does not provide any mechanism for reading calibrated data externally.

Despite spending nearly ten days attempting to extract data paths, probe internal communication lines, and evaluate potential firmware access, it became clear that the machine could not be interfaced with in any reliable or reproducible way. No viable channel existed to obtain weight information digitally, and the embedded firmware could not be reprogrammed. This critical realization forced the team to abandon the initial approach entirely. It was concluded that a custom weighing system, using a load cell, an **HX711 amplifier**, and a programmable microcontroller, would need to be developed from the ground up to meet project requirements.

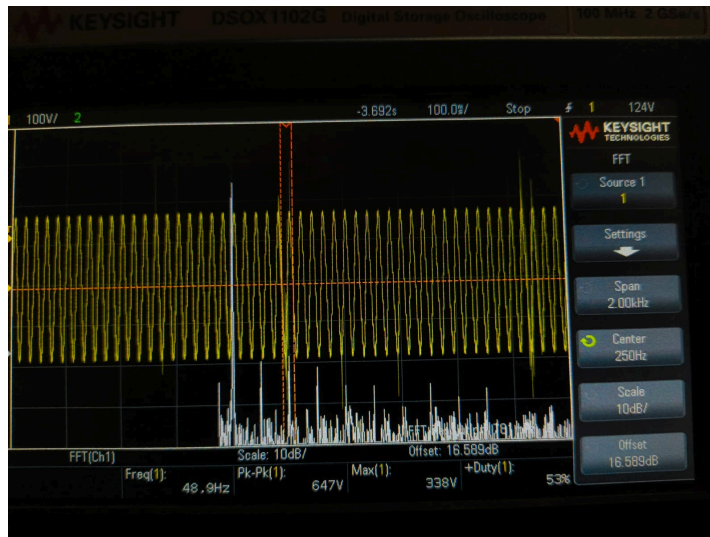
To properly quantify the issue, the team conducted a series of electrical measurements to capture the transient disturbances produced during motor switching. It was found that voltage spikes approaching nearly 20 volts were appearing on the low-voltage side of the

system. These surges were more than sufficient to induce microcontroller resets, distort signals on the LCD data bus, and interfere with the precise analog measurements performed by the HX711.
