Assessing the influence of third body damage to articulating surfaces with bone void fillers

Sean Aiken

July 2019

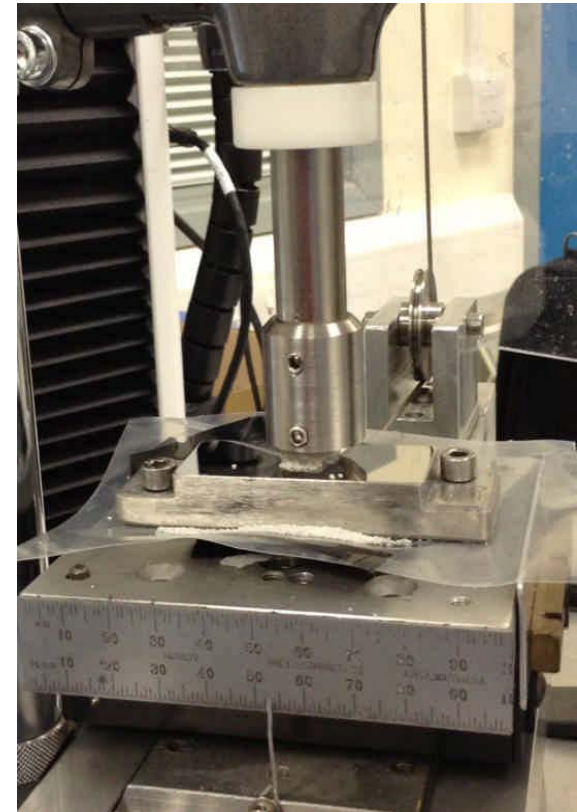
Simulating damage to CoCr plate

Method – Phase 1

To simulate damage to a cobalt chrome (CoCr) plate by third body using pin on disk multi-axial reciprocating rigs*.

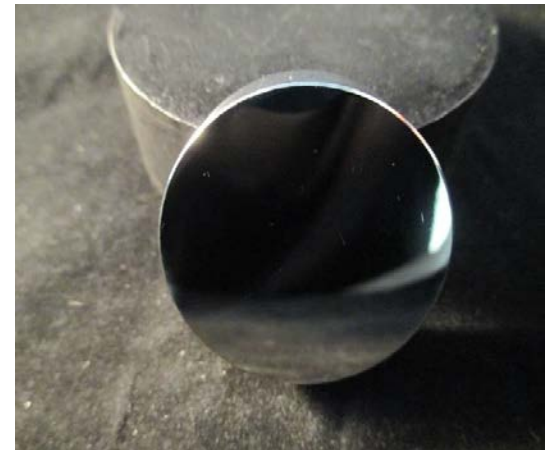
- CoCr disks first polished to mirror finish
- Pins moved over the surface of the CoCr disks in the presence of bovine serum containing 1.5g of particles of crushed third body material
- Pin moved for up to 480,000 cycles (4 cycles of 120,000)

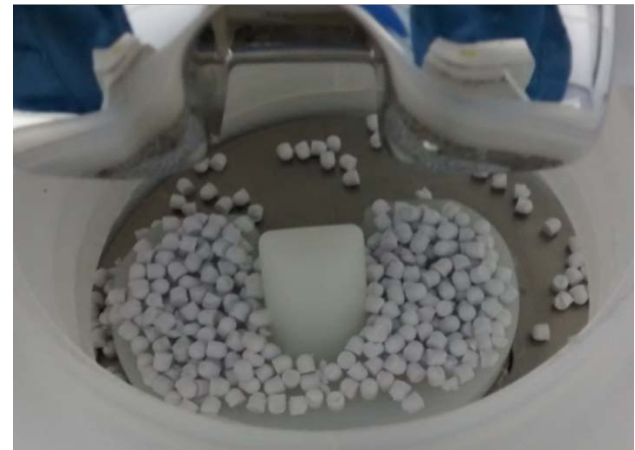
Place 5cc of STIMULAN beads between counterfaces - then attempt to damage surfaces by running dry in knee simulator for 60 cycles

5cc of beads (3mm diameter)
