Inspection Report

Inspection location: **Wuxi City, Jiangsu Province, China**

Date of inspection: **Jun.22, 2022**

SGS order No.:	IN-TJ-5301-22154				
Coordinator:	Lucy Lu		Telephone:	022-59995333	
Description of commodity (Name ,Model ,Quantity ...) As PO declared					
SEAMLESS SQUARE PIPE ASTM A312M TP 316L / 18pcs					
Buyer (Name, Address...)					
Seller (Name, Address...)					
ADVANCED METALS CO., LTD Tongda International Building Hi-tech Development Zone, Xi'an, Shaanxi. 710065, China					
PI	/				
PL	/				
CI	AMC-ST-22101 MAY 26, 2022				
Nature of inspection:	Item	Satisfactory		Non conforming	
	Quantity check (not include weight check)	●			
	Item	Satisfactory	Non conforming	Rejected	Subject to buyer's evaluation
	Visual check				●
	Marking check				●
	Dimension check				●
	Witness PMI	●			
	Document review				●

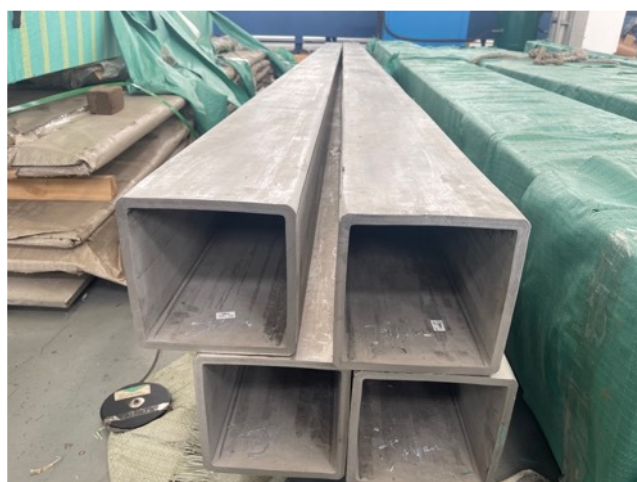
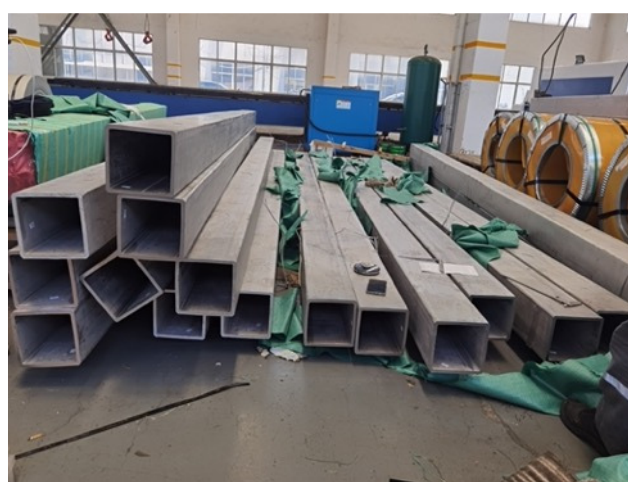
No.	Description	REQ. quantity	ACT. quantity
1	200 x 200 x 12 x 5.8 mtr lengths SMLS	18	18

3.3. Remark: The result of quantity check was in line with CI and acceptable.

Fig. 1 Quantity check

Fig. 2 Quantity check

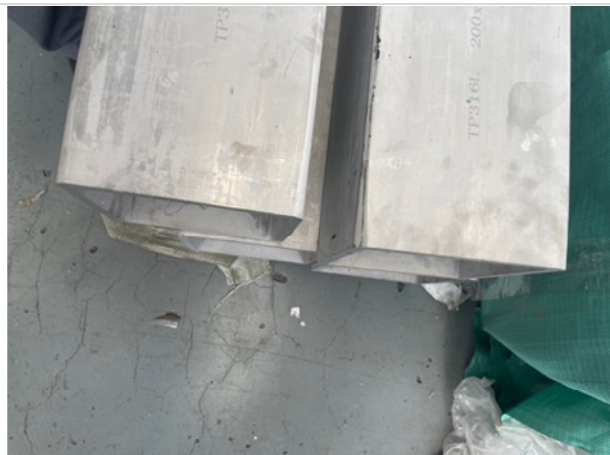
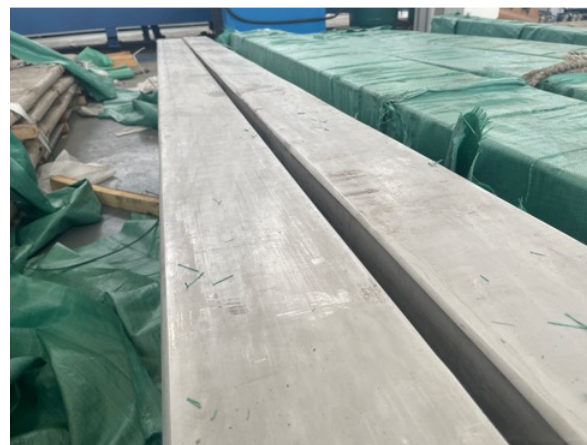
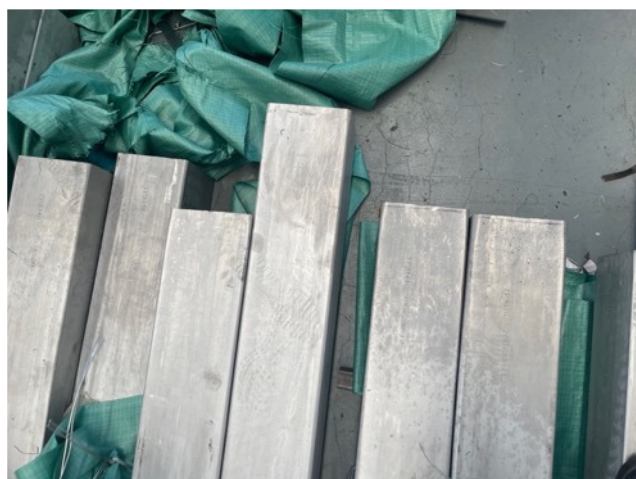
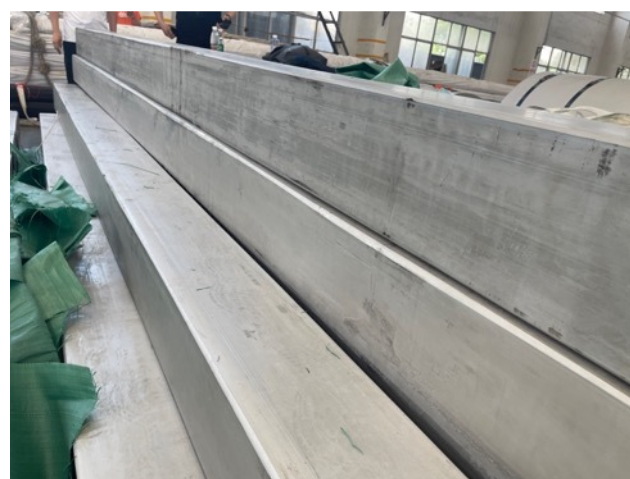
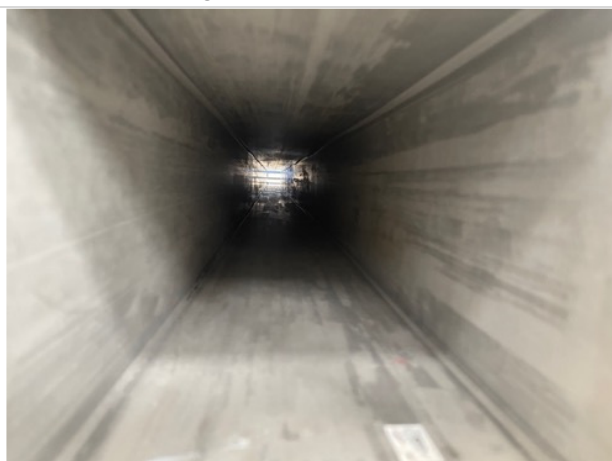
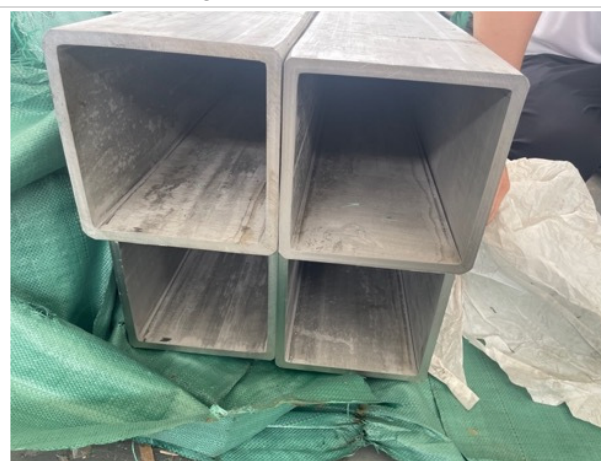
Except above mentioned, no other defects such as cracks, deformation were found.

Fig. 3 Visual check

Fig. 4 Visual check

Fig. 5 Visual check

Fig. 6 Visual check

Fig. 7 Visual check

Fig. 8 Visual check

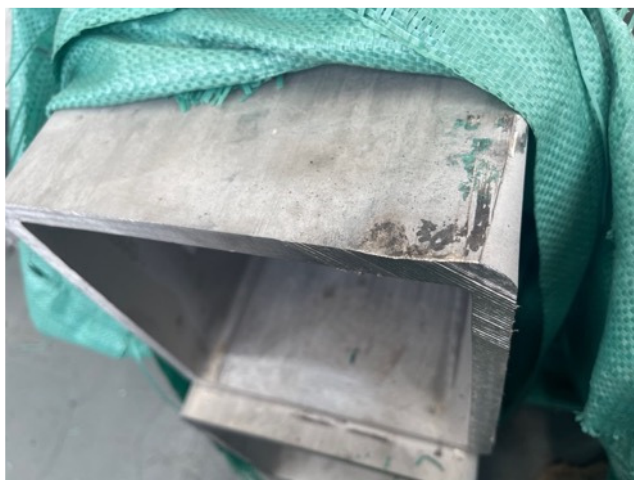
- Both internal and external surface of cargoes was smooth.
- Both ends edges without burrs.
- No oil stain was found on surface.
- Pipe with SGS number 7#: little scratch was found on external surface at one end. (Please refer to picture No. 9)
- Pipe with SGS number 8#: 2 scratches were found on external surface at one end. (Please refer to picture No. 10)
- Pipe with SGS number 11#: little pit was found on internal surface at one end. (Please refer to picture No. 11)

Fig. 9 Visual check – little scratch 7#

4.3. Remark: The result of visual quality check should be subjected to client's evaluation.

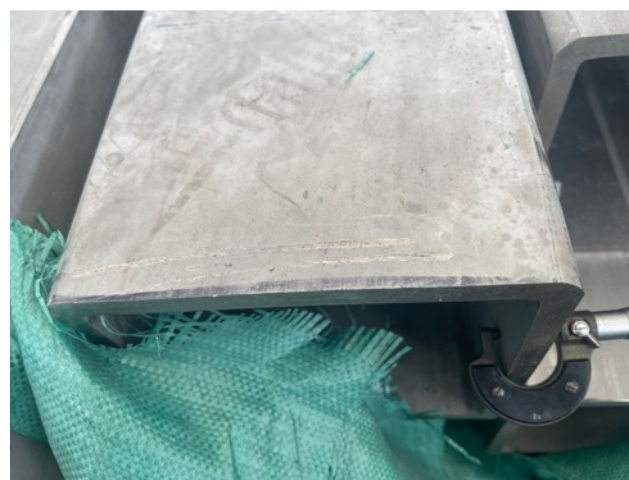
Fig. 10 Visual check – 2 scratches 8#

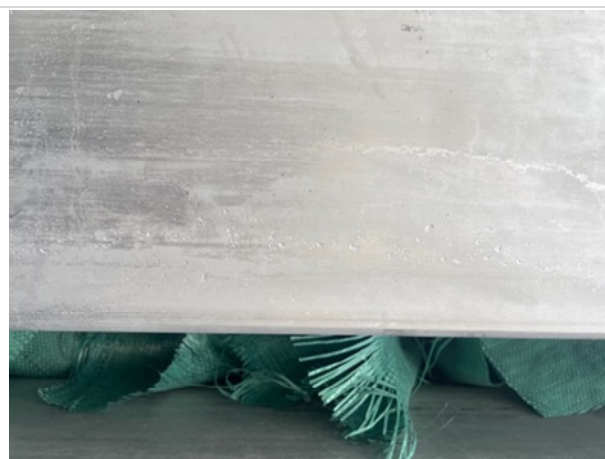
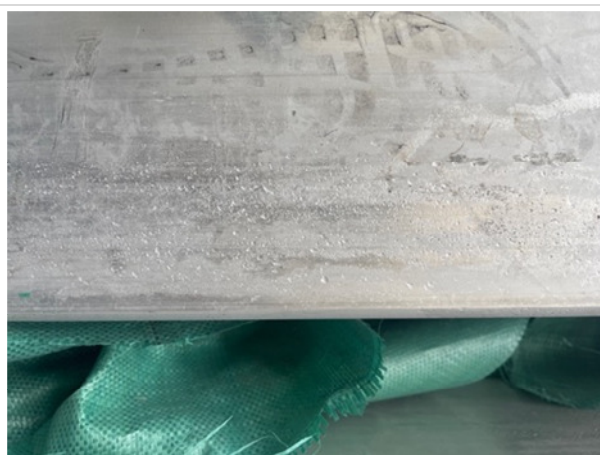
- Pipe with SGS number 14#: pits were found on external surface at the middle of the pipe. (Please refer to picture No. 12 & 13)

Fig. 12 Visual check – pits 14#

Fig. 13 Visual check – pits 14#

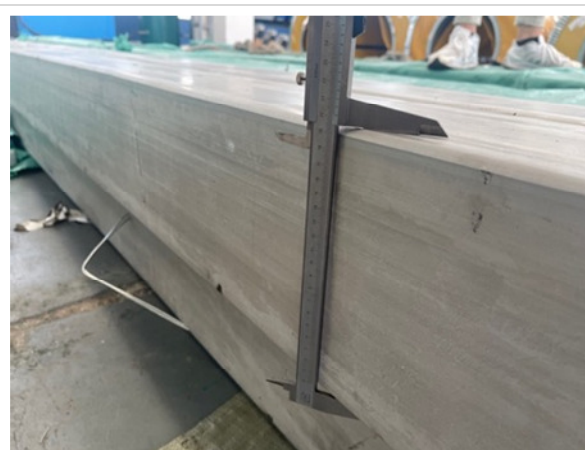
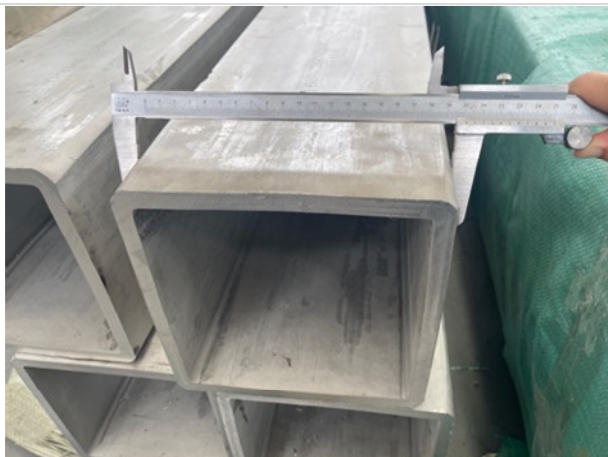
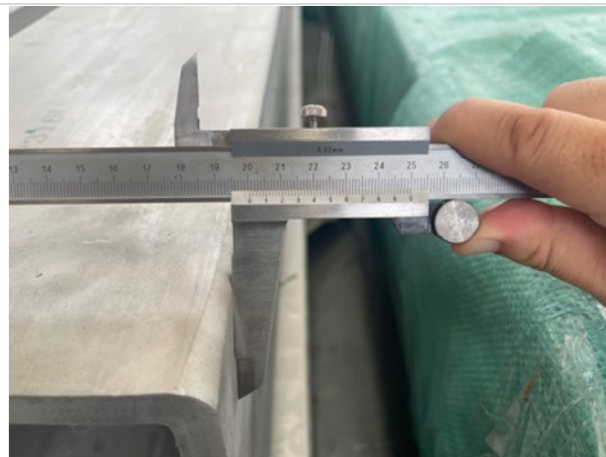
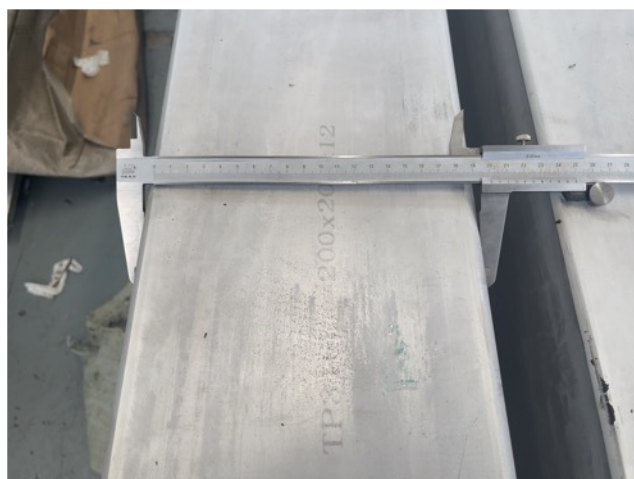
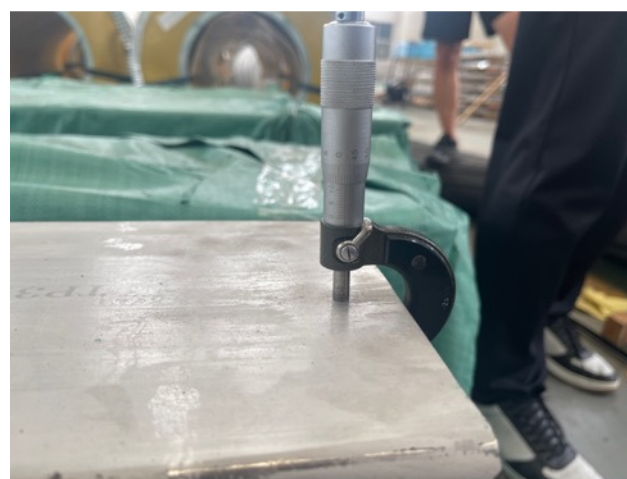
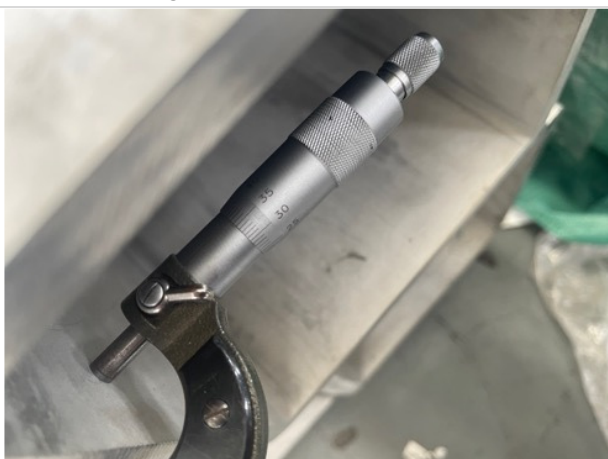
Size	Side length A (mm)	Side length B (mm)	WT (mm)	Length (mm)	Straightness (mm)	Perpendicularity (mm)
200x200x12x5800	199.82- 201.00	199.90- 201.50	11.43- 12.97	5813- 6112	1-4	0.5-1

Note: 1. The tolerance of wall thickness was $\pm 10\%$ provided by the client on site. The actual value of WT was acceptable.

Fig. 14 Dimension check

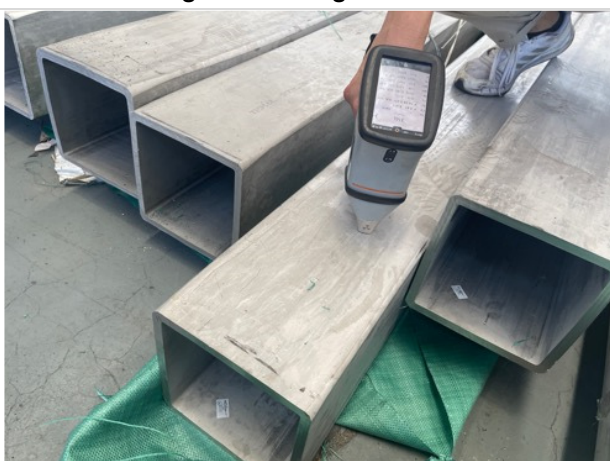
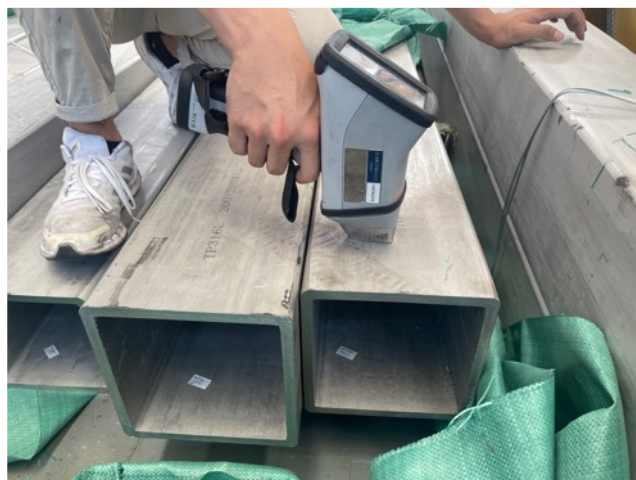
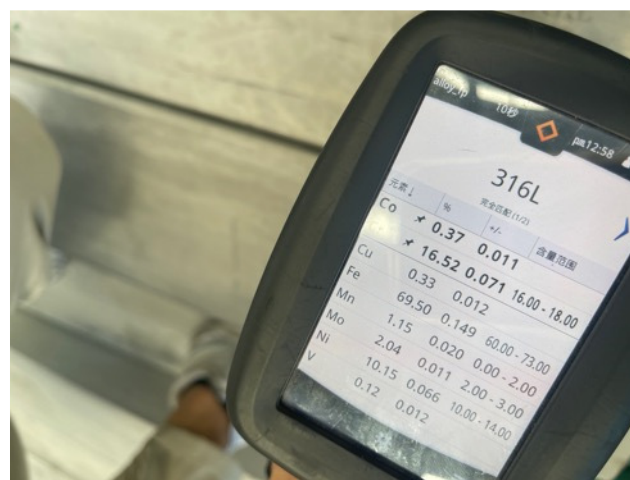
During the inspection, SGS inspector witnessed PMI test on site. The spectrometer shows chemical elements composition and shows the material result.

7.3. Remark: The result of witness PMI was acceptable.

Fig. 31 Witness PMI

Fig. 32 Witness PMI

Fig. 33 Witness PMI

Fig. 34 Witness PMI
