Chemical Analysis of MoS2 Nanoparticles formed by Ultrasonic Exfoliation

Erik Cheng, Dr. Tim Kidd, Eric Clausen
University of Northern Iowa

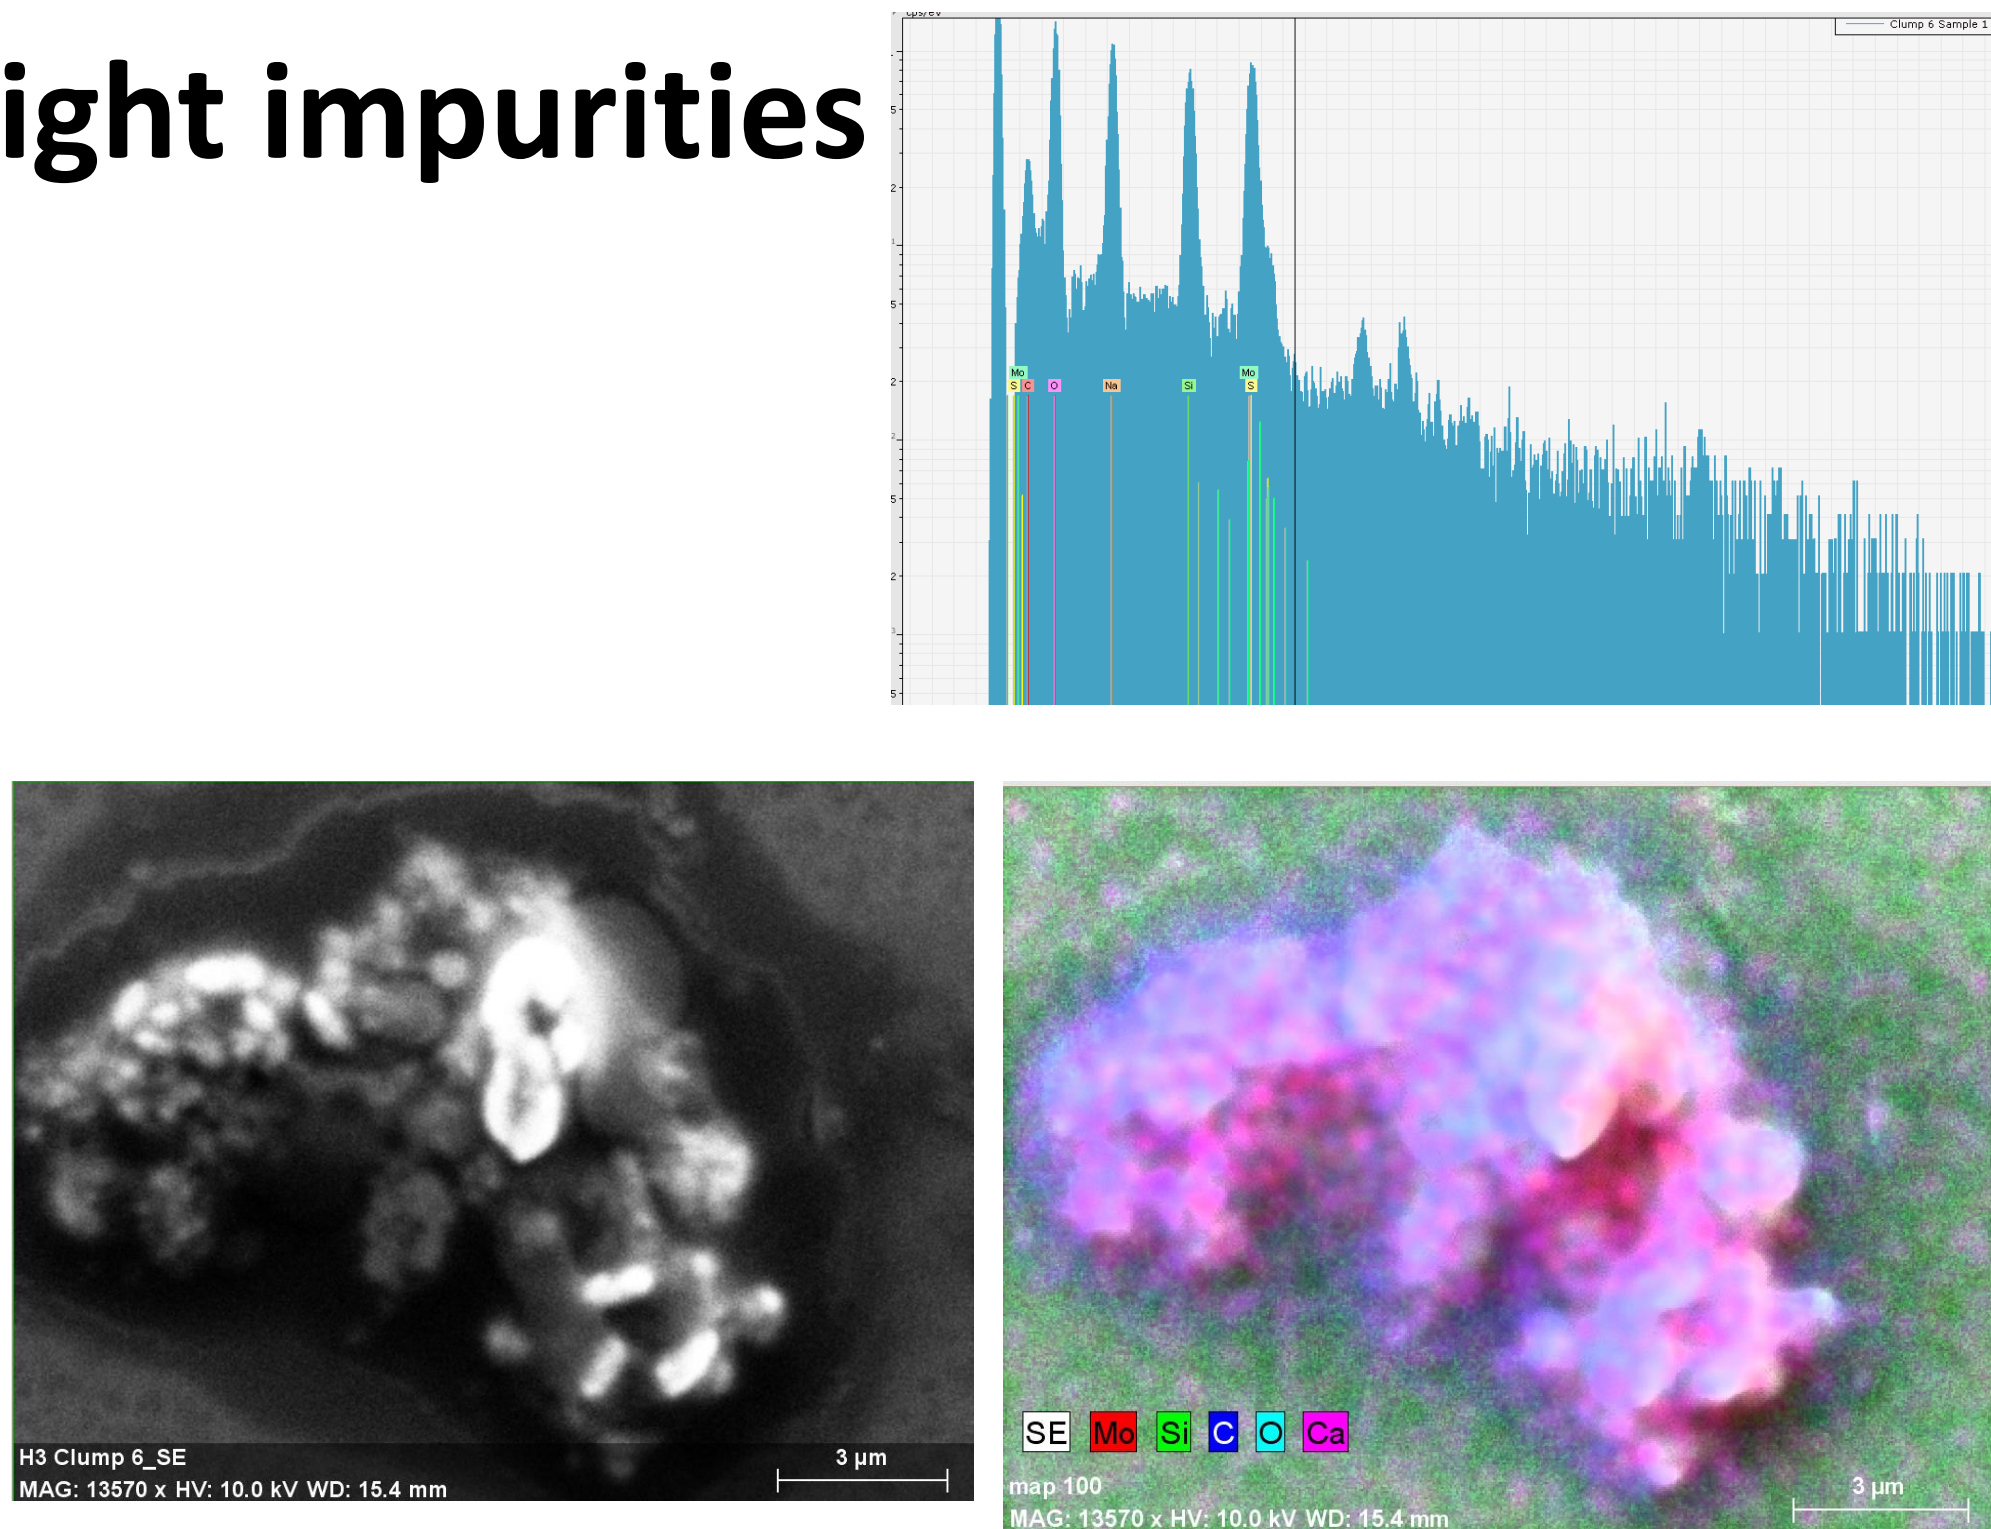
Typical Sample- MoS2 clump, slight impurities

This sample is a good representative of how most of the MoS2 sample came out. We see a high concentration of the MoS2 in this clump to the right, as expected. However, there is also the impurity of carbon that is found everywhere throughout the batch of MoS2. The silicon shown in the scan is the surface onto which the sample was placed. The peaks seen above the scans , from left to right, are O, Na, Si, and Mo/S (their peaks overlap). Therefore, we can see that even though this object is mainly MoS2, impurities are also somewhat prominent in the sample, as they are throughout.

Mo Si C O Ca

The grayscale image is the SEM image. The colored image is the result of an EDX function called mapping, where certain elements are being scanned for specifically, as to give an idea of exactly where each specific element can be found. Here, we scanned for Mo, Si, C, O, and Ca.
