Study of fatigue damage in wind turbine blades

Article in *Engineering Failure Analysis* · March 2009

J.C. Marín *, A. Barroso, F. París, J. Cañas

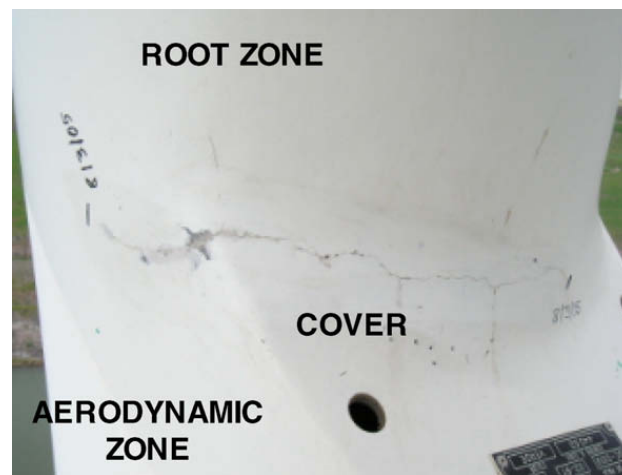
A picture of the typical damage found in a blade, in the form of cracks on the external surface, is presented in Fig. 1. The crack is located in the transition zone between the root of the blade and the zone of aerofoil profile. The cross-sectional section of the blade in the aerodynamic zone is a thin-walled section that reproduces the aerofoil profile and presents a vertical partition (denominated spline) that divides the section into two cells: leading edge and trailing edge (Fig. 2). The cross section in the root zone is practically cylindrical.

Fig. 1. Location of the cracks on the surface of a blade.

Although the evolution of damage is difficult to establish, the crack observed in the inspection (see Fig. 1) is formed by several well differentiated parts: (a) the part that runs through the cover (slices 8 and 9), which affects the whole thickness of a laminate without resistant function, (b) the continuation of this part on slice 7 which only affects the external layers of the laminate, with breaking of unidirectional fibres and multiple delaminations (as can be observed in Fig. 3c), (c) the part corresponding to slices 5 and 6 in which the whole

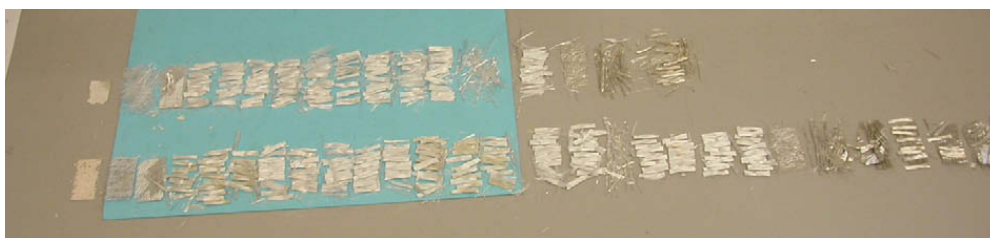
Calcinations of laminate samples from slice 5 were carried out in a muffle oven at 600 °C for 90 min to obtain the real stacking sequence on both sides of the crack. After the calcination of the resin, the layers defining the laminate are shown in Fig. 4.

Fig. 4. Stacking sequence of the laminate.

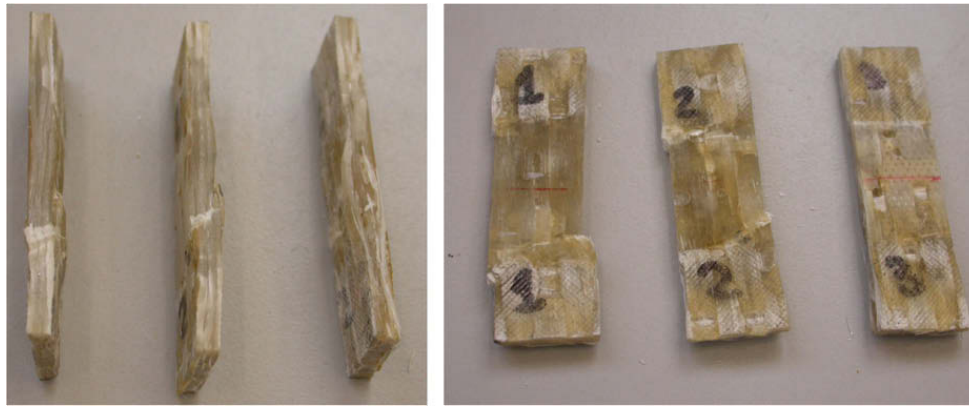
A series of compression tests on unidirectional (NUFF) specimens, which is the component that predominantly characterizes the resistant behaviour of the laminates of the blade, were carried out. The specimens were made of a laminate of glass fibre vinylester resin with three layers of NUFF 1450, the total thickness being 3.99 mm. The tests were carried out in an INSTRON 8801 (100 KN). The tested specimens are shown in Fig. 8, the experienced failure type being associated to a phenomenon of micro-buckling of the fibres, which is favoured by the longitudinal waving of the tows of the fibres present in these materials.

The measured average value of the compression strength is 250.9 MPa, presenting a typical deviation of 23.7 and a coefficient of variation of 9.45%. Starting from these values, and applying the statistical treatment that recommends the GL standard, the characteristic value of the compression strength of the NUFF layers would be 189.4 MPa. Therefore, the relationship between the characteristic values of the tensile and compressive strength of the unidirectional (NUFF) layers is 2.65.

Fig. 8. Compression tests of unidirectional laminates.
