FDOT Aviation Office Experience with the TransTech Joint Maker™

by J. David Scherling, PE, State Airport Pavement Engineer

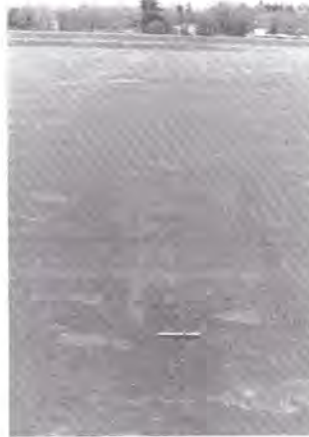
Albany (NY) County Airport Paved 1991

**With Joint Maker
(Photo 1994)**

It remains to be seen what the effects of time, traffic, and weather will be. When the equipment was first introduced, about four years ago, Bruce Loev, P.E., of PBS&J, was project engineer on a test project on the Albany County Airport in New York. He reports that the results were not only readily apparent from the density tests, but that after four years cracks have appeared along the joints paved without the TransTech Joint Maker™. No cracks have occurred where the joint maker was used.

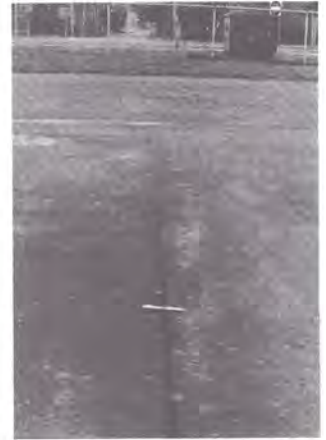
**Without Joint Maker
(Photo 1994)**
