Solvage of Car Lifter Breakage on Chrysler Line

An inner liner within a car lifting mechanism broke at a *Chrysler* assembly plant. *Valiant Machine and Tool* (the designer, programmer, and maker of the assembly line) requested WIDL's assistance to resolve the issue, remotely, without interfering with production.

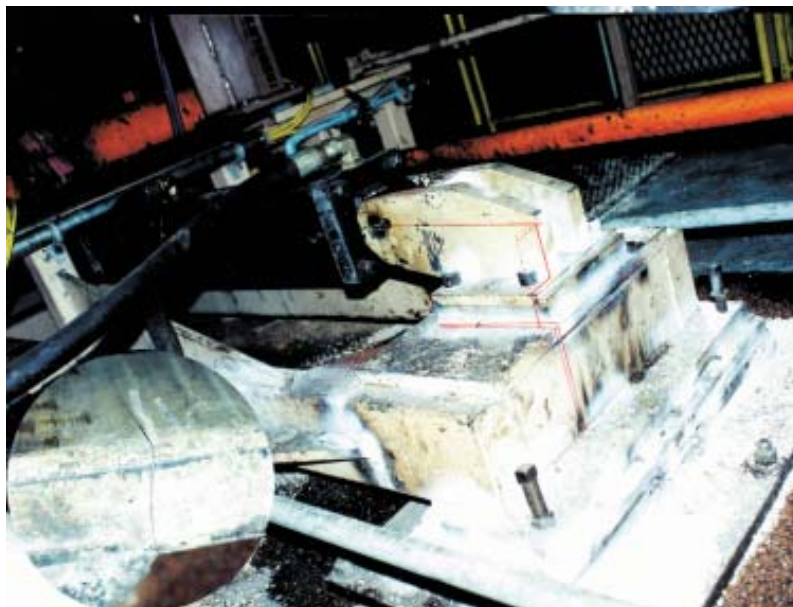
Failing Line at Chrysler; Zoom on Crack

Following the localization of cracking, and translating numerical predictions to the assembly plant, several optimization analyses were completed at WIDL. The goal was to weld reinforcing plates and gussets at strategic locations, and attenuate inertial forces. In the end, FEA and the regulation of movement of the lifter increased strength, under both static and dynamic loads.

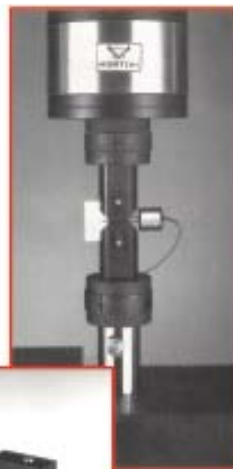
Initial calculations in MARC™ were static. Plates and gussets were made of steel SAE 1008 (elasticity modulus of 199 GPa and Poisson's ratio of 0.3). Stress levels were used to test pre-cracked Compact Tension (CT) samples, and monitor the Crack Opening Displacement (COD) with cyclic loads, as per ASTM standards (Designations E399, E813 and E647). To ensure both central location, and correct engagement in the specimen, the gauge had knife edges for a special jig. A servo-hydraulic unit by *INSTRON* (cf: <http://www.instron.com>) was used at WIDL, to condition the signal output locating the knife edges, as any crack would potentially advance. Post-processing “load versus crack propagation”, resulted in K_{IC} (or fracture toughness of the liner' steel).

COD Gauging at WIDL
