Gas Detection Report

Client Name	Holiday Inn Express Dublin City Centre	Job No	206
Client Site	Austinbrook Ltd 28-32 O'Connell Street Dublin 1 D01 T2X2		
Client Contact	Darren Murray		
Date	24/03/2023	PPM Visit	1 of 2

Asset No	018	Asset Location	Plant Room
Make	Medem	Model	AGDS-MC
Year	N/A	Fuel Type	Natural Gas

Maintenance Report

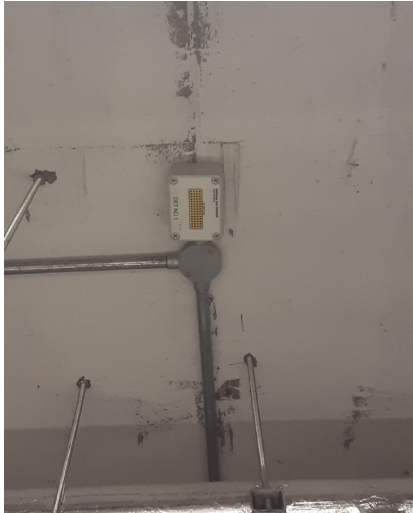
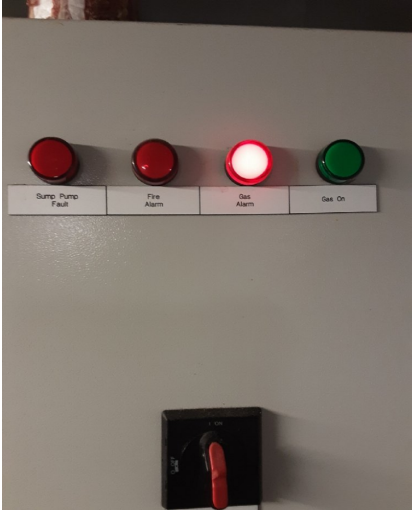
21. Alarm Signal verified	Yes	25. Connected to BMS	Yes
22. Fault signal verified	Yes	26. Mains Supply Voltage	Yes
23. Emergency Stop	Yes	27. Batteries Installed	No
24. Connected to fire alarm	Yes		
Engineer Comments	Methane sensor head no.1 tested and found to be fully operational.

Repair Required	No		
Engineers Name	Iain Egan	Engineers Signature

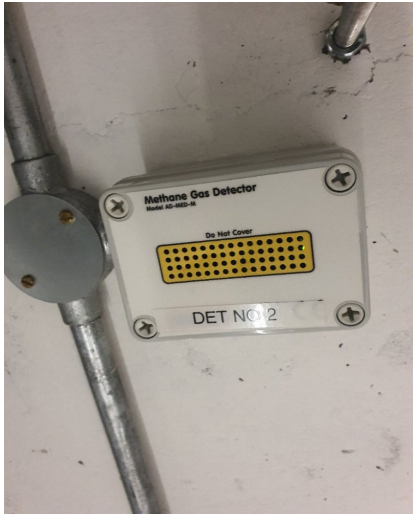
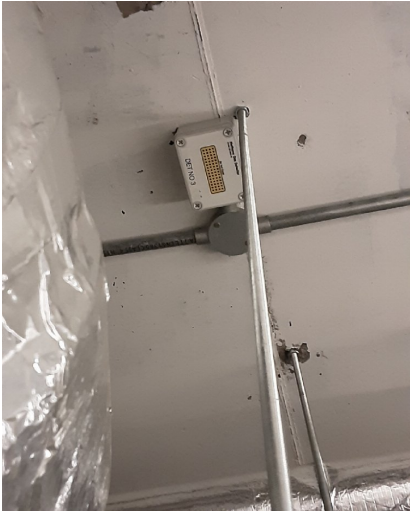
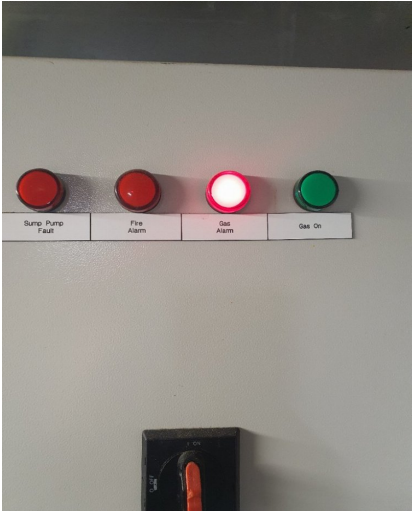
Engineer Comments	
Methane sensor head no.2 tested and found to be fully operational.

Repair Required	No		
Engineers Name	Iain Egan	Engineers Signature

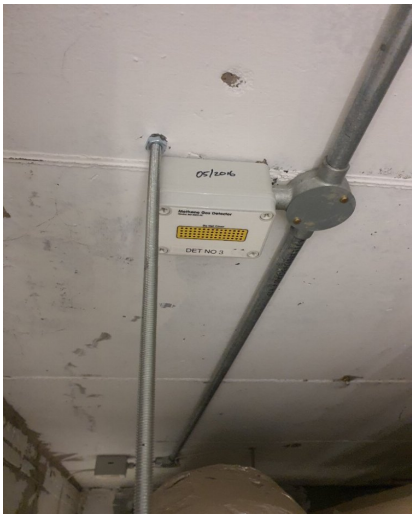
Engineer Comments	
Methane sensor head no.3 tested and found to be fully operational.

Repair Required	No		
Engineers Name	Iain Egan	Engineers Signature

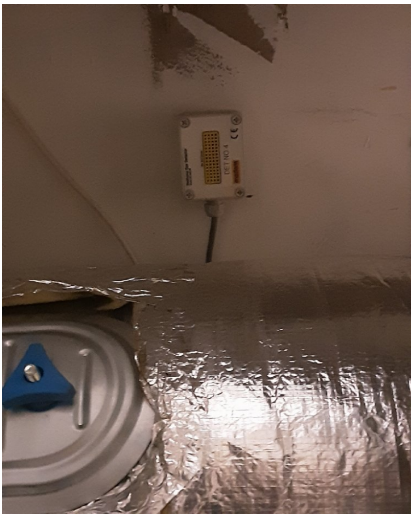
Engineer Comments	
Methane sensor head no.4 tested and found to be fully operational.

Repair Required	No		
Engineers Name	Iain Egan	Engineers Signature

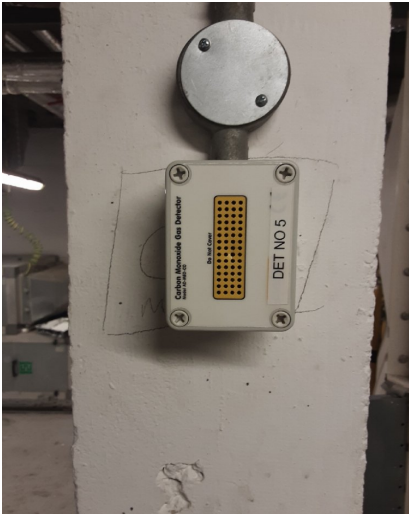
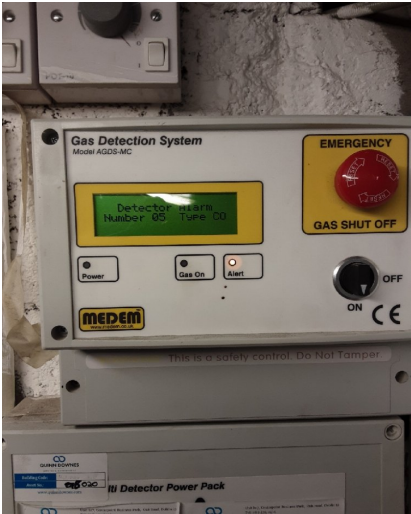
Engineer Comments	
Carbon Monoxide sensor head no.5 tested and found to be fully operational.

Repair Required	No		
Engineers Name	Iain Egan	Engineers Signature
