# **FAILURE ANALYSIS OF SLEWING GEAR BOX AND BELT DRIVE DRUM ASSEMBLY OF SPREADER 116 AT NLCIL**

**ALAGAPPA CHETTIAR GOVERNMENT COLLEGE OF ENGINEERING AND TECHNOLOGY,  
KARAIKUDI 630003.**

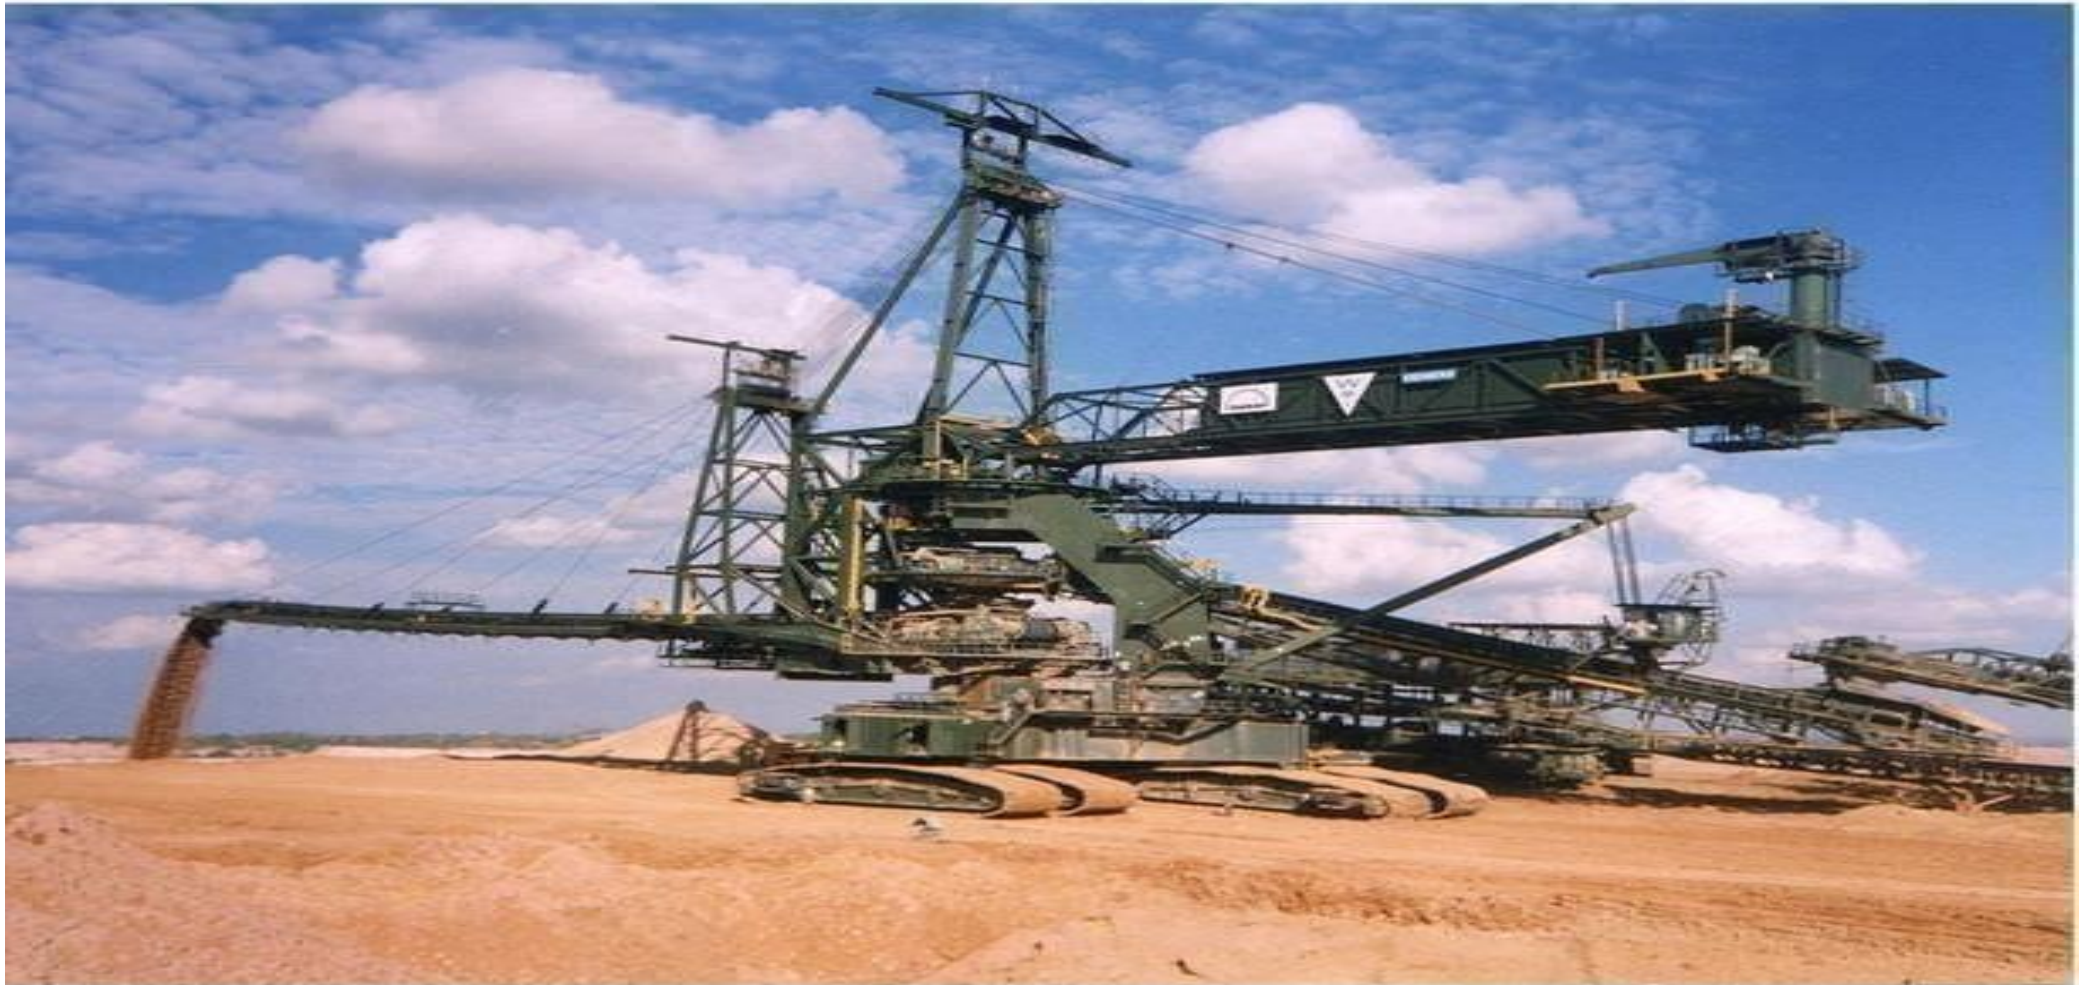
# VIEW OF SPREDER

- Spreaders (specialized mining equipment) used in surface mining and mechanical engineering/civil engineering.
- The primary function of a spreader is to act as a continuous spreading machine in large-scale open pit mining operations.
- Bucket-wheel excavators, BWEs, are used for continuous overburden removal in surface mining applications.
- The overburden is then delivered to the discharge boom, which transfers the cut earth to another machine for transfer it to the central collection area where the material will be sorted. Then the remains of the overburden will be transported to the spreader which then scatters the overburden at the dumping ground.

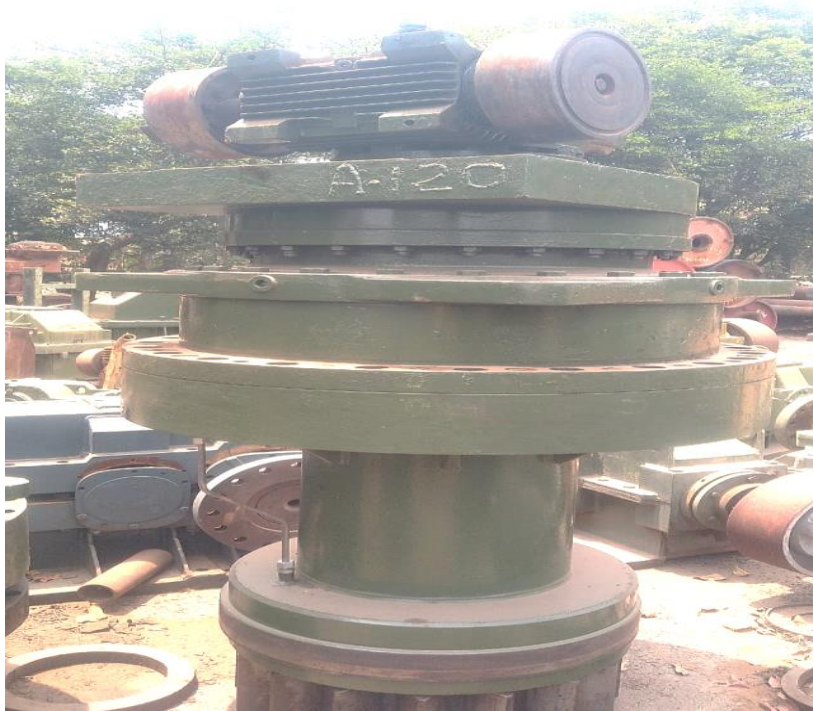
**SLEWING GEAR BOX**

- Slewing gearbox is used to slew the discharge boom of the spreader.
- It rotates up to 180 degrees.
- The slew gearbox having sun pinion and planetary gears arrangement to reduce the initial input speed.
- The slew gearbox is powered by using electrical motor.

- The torque is transmitted to the bolts which causes shear.
- The shear results in loosening of bolts, which causes opening of bolts resulting in oil leak.

- Torque arresting/transmitting ring plates (2 nos) with key be introduced to the in between mounting mother plate and the gearbox fixing joint.
- The joint between ring plates (900 mm diameter) and its preceding joint to be drilled for additional fixing holes and dowel holes.

Additional fixing holes 6 nos × M20 size

Additional dowel holes 6 nos - Ø20 & dowel pins

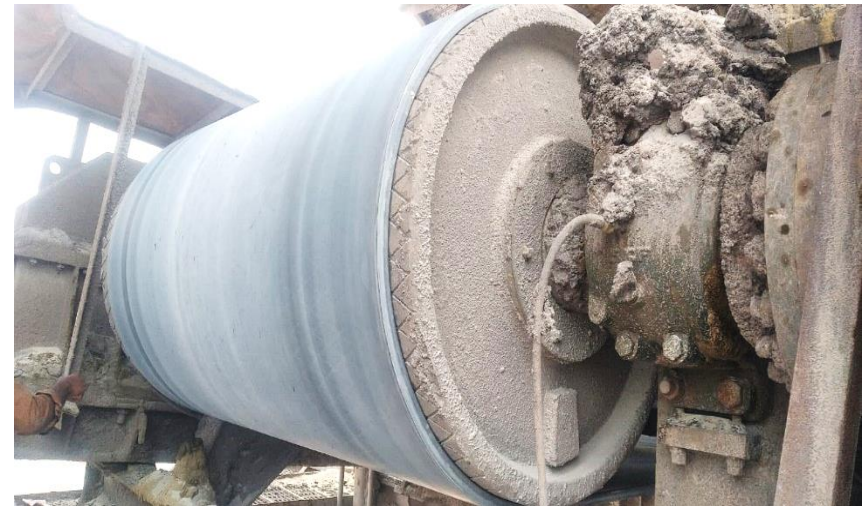
**BELT DRIVE DRUM ASSEMBLY**

- The belt drum assembly is used to move the conveyor belt in the spreader.
- There are two types of drum in spreader.
  - A) Driver
  - B) Driven
- From the belt drive gearbox the power is transmitted to the drum by shaft. The rotating drum results in the linear motion of the conveyor belt which help the sand to fill the area.

- Shaft got cut near coupling.
- Shaft got cut in-between shaft taper step bearing assembly.
- Shaft got cut at bearing seating.

- The bearing withstands the load and no bearing failure reported and the dynamic load of bearing found matching.
- Shaft re modification work with the given load was undertaken.
- Shaft size for existing mode is found to be 180 mm.
- Taking into consideration the shaft failure increase in the factor of safety was suggested.
- When the factor of safety increased the shaft size got increased to 200 mm.
- Without changing the 260 diameter step increase the diameter of 180mm diameter to 200 mm diameter.

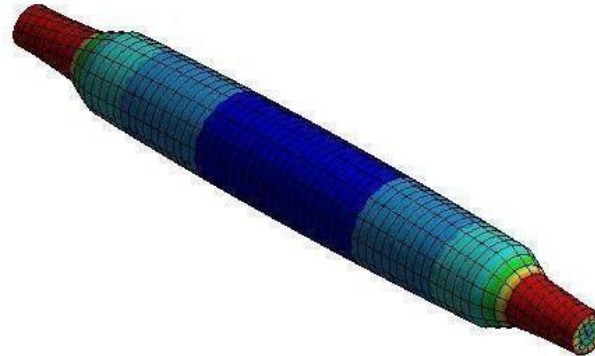
# STRESS IN EXISTING MODEL OF SHAFT

**B: Static Structural**

Equivalent Stress

Type: Equivalent (von-Mises) Stress

DESCRIPTION	EXISTING MODEL	MODIFIED MODEL	PERCENTAGE DECREASE
Stress(N/m <sup>2</sup> )	1.43e <sup>9</sup>	1.08e <sup>9</sup>	24.5%
Deformation(m)	0.0077	0.0057	25.97%

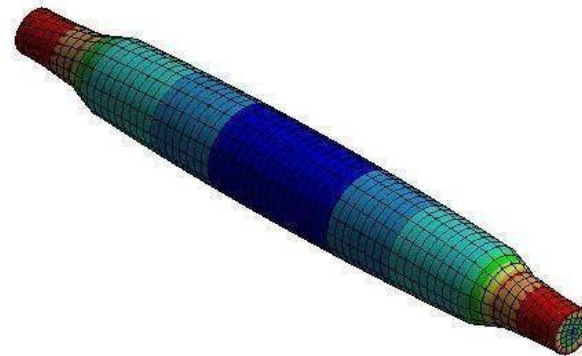
# STRESS IN MODIFIED MODEL OF SHAFT

**A: 200 shaft**

Equivalent Stress

Type: Equivalent (von-Mises) Stress

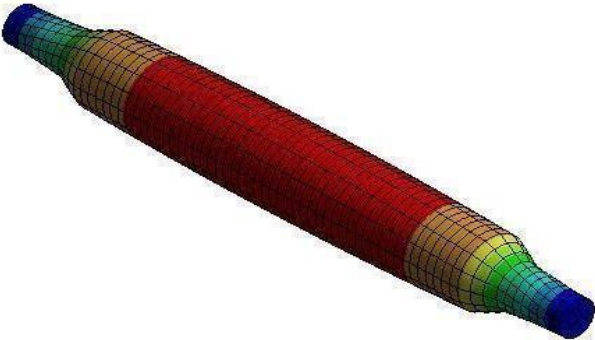
# DEFORMATION IN EXISTING MODEL

B: Static Structural  
Total Deformation  
Type: Total Deformation  
Unit: m  
Time: 1  
08-Apr-22 2:50 PM

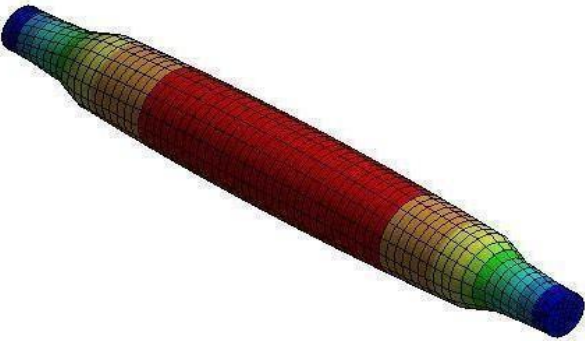
# DEFORMATION IN MODIFIED MODEL

A: Static Structural  
Total Deformation  
Type: Total Deformation  
Unit: m  
Time: 1  
08-Apr-22 2:51 PM

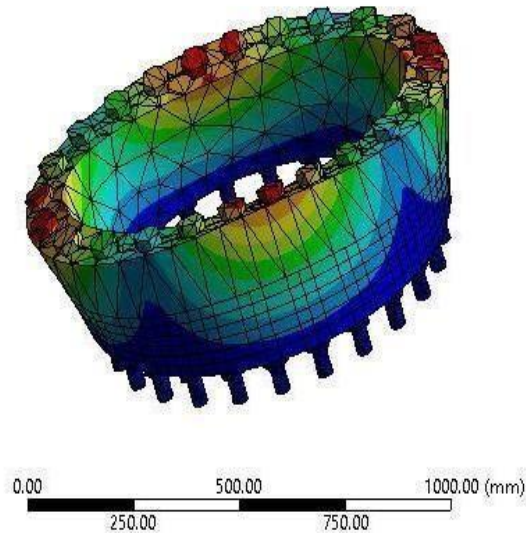
# MODAL ANALYSIS OF EXISTING MODEL

Total Deformation  
Type: Total Deformation  
Frequency: 1520.4 Hz  
Unit: mm  
06-May-22 3:29 PM

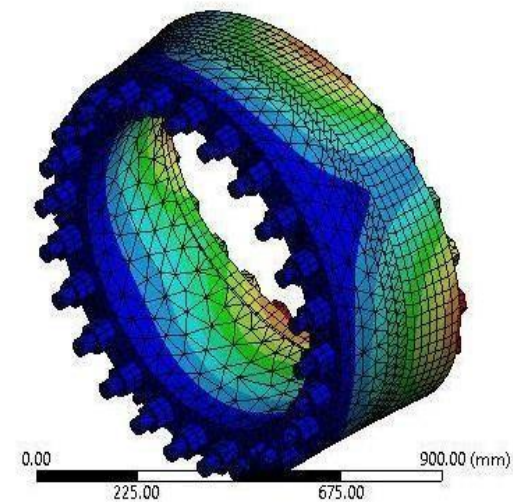
# MODAL ANALYSIS OF MODIFIED MODEL

Total Deformation  
Type: Total Deformation  
Frequency: 1296.9 Hz  
Unit: mm  
06-May-22 1:17 PM

The operating frequency is found to be 16 Hz which is very much smaller than the modified frequency which has a frequency of 1296 Hz

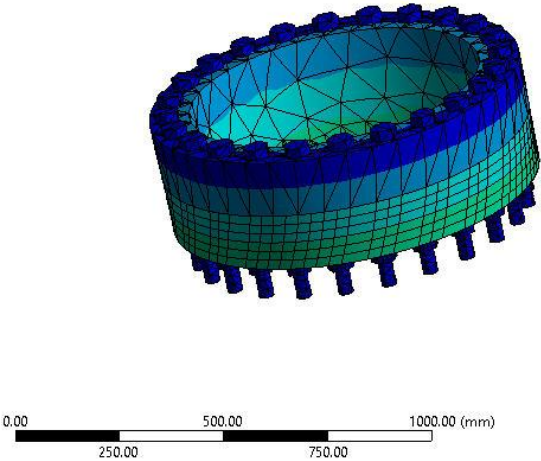
# STRESS IN EXISTING MODEL

A: Static Structural  
Equivalent Stress  
Type: Equivalent (von-Mises) Stress  
Unit: MPa  
Time: 1  
12-May-22 4:11 PM

DESCRIPTION	EXISTING MODEL	MODIFIED MODEL	PERCENTAGE DECREASE
Stress(MPa)	4.34e <sup>-6</sup>	3.45e <sup>-6</sup>	20.5%
Strain	2.19e <sup>-8</sup>	1.52e <sup>-8</sup>	30.5%

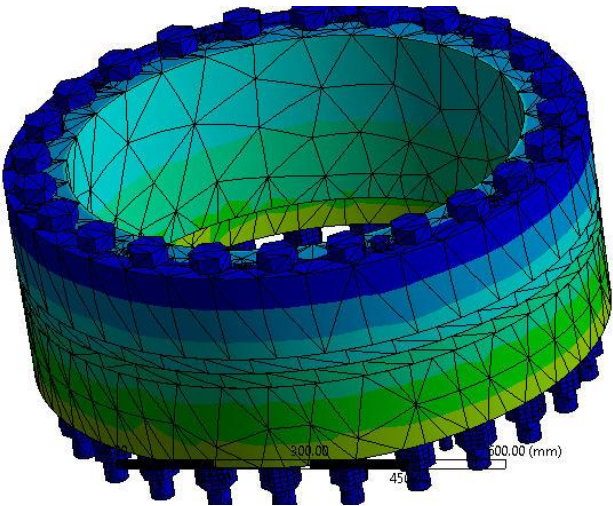
# STRESS IN MODIFIED MODEL

A: Static Structural  
Equivalent Stress  
Type: Equivalent (von-Mises) Stress  
Unit: MPa  
Time: 1  
12-May-22 12:19 PM
