# The diode non-conformity in Sector 2-3

EDMS [2593310](#)

*Mateusz Bednarek on behalf of MP3  
and ELQA teams*

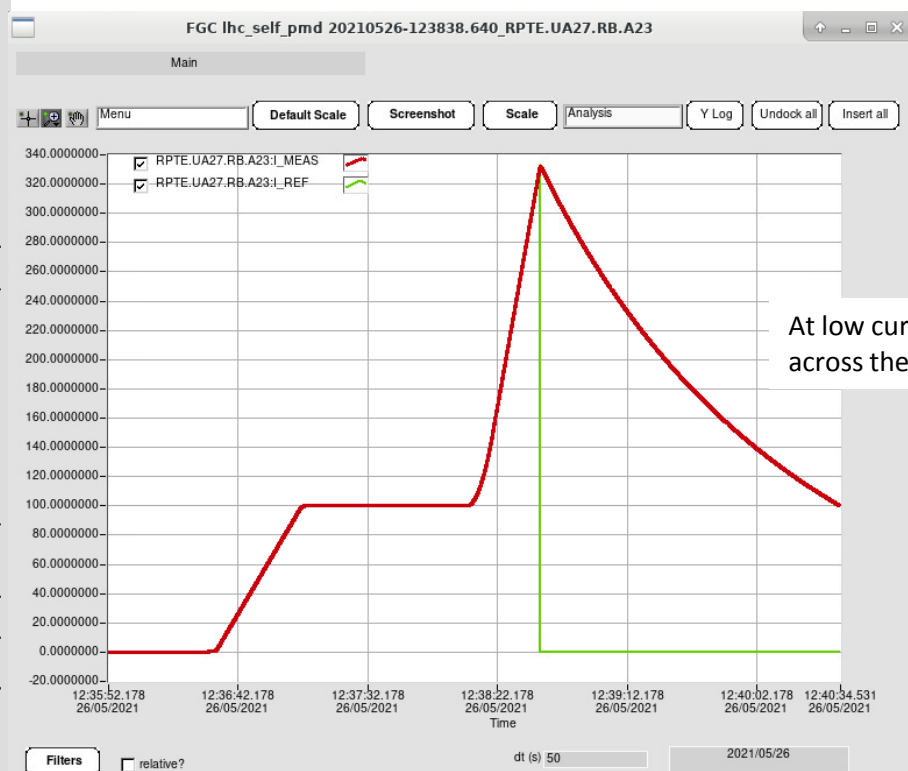
- 26/05/2021 12:38:38 - Trip of RB.A23 at 330 A
- The origin of the trip is nQPS at magnet A23R2
  - *nQPS is the protection system that monitors the bus-bars*
- The current does not flow through the magnet but through the diode
- Visible residual resistance of the diode and the resistance of diode leads

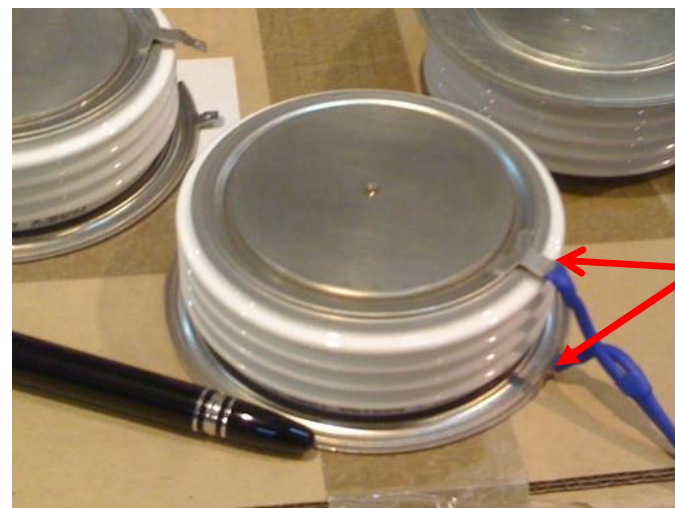
Voltage  
taps on  
the diode  
press-pack

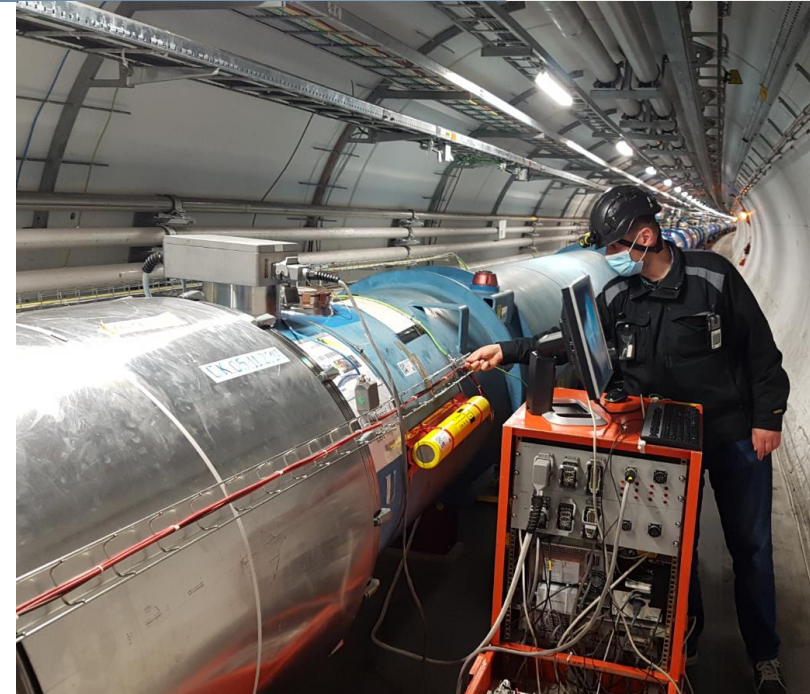
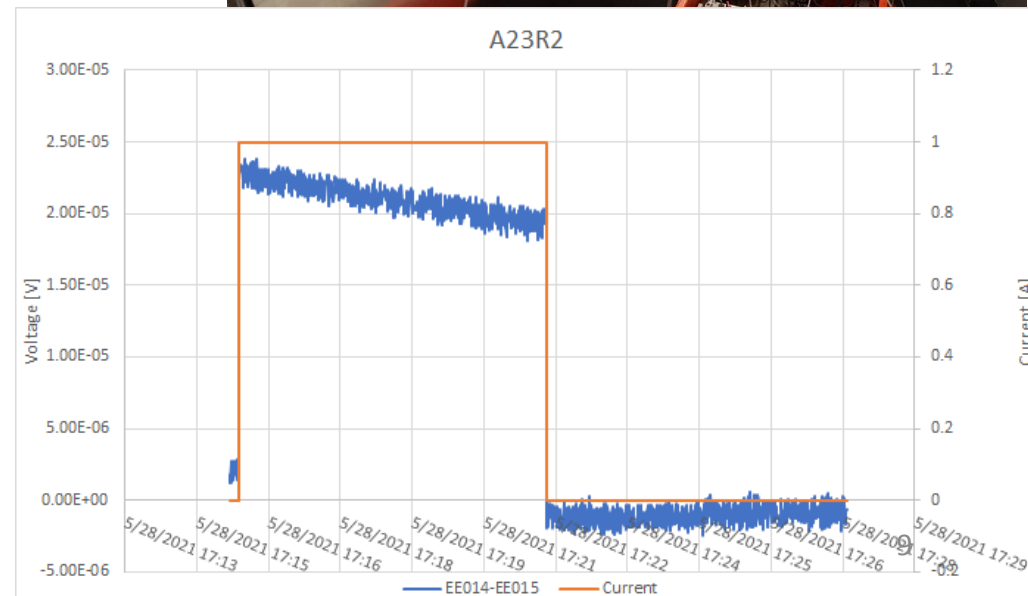
- Multiple special measurements performed
- The coils and instrumentation are sound
- Diode is in short-circuit:
  - The first such case in the LHC
  - $R_{\text{short}} = 20 \mu\Omega$
- No other apparent collateral damage

MB with left polarity: In sectors 2-3, 3-4, 4-5, 8-1

- Diode of A23R2 is in short-circuit
- The failure occurred during a GHe propagation quench at 8 kA
- This is the first such fault in the LHC
- There is no other damaged component in this magnet
- **The diode assembly needs to be replaced**
- Warm-up of the sector has started
- No precursors were identified
- Inspection of the shorted diode, once disassembled, will be performed in order to try to understand the causes of the failure
