Quality Assurance Management, Inc.
1620 Valwood Pkwy, Ste. 128
Carrollton, TX 75006
972-331-5800
QAM.com

Oxygen Test Report

Moisture Test Report

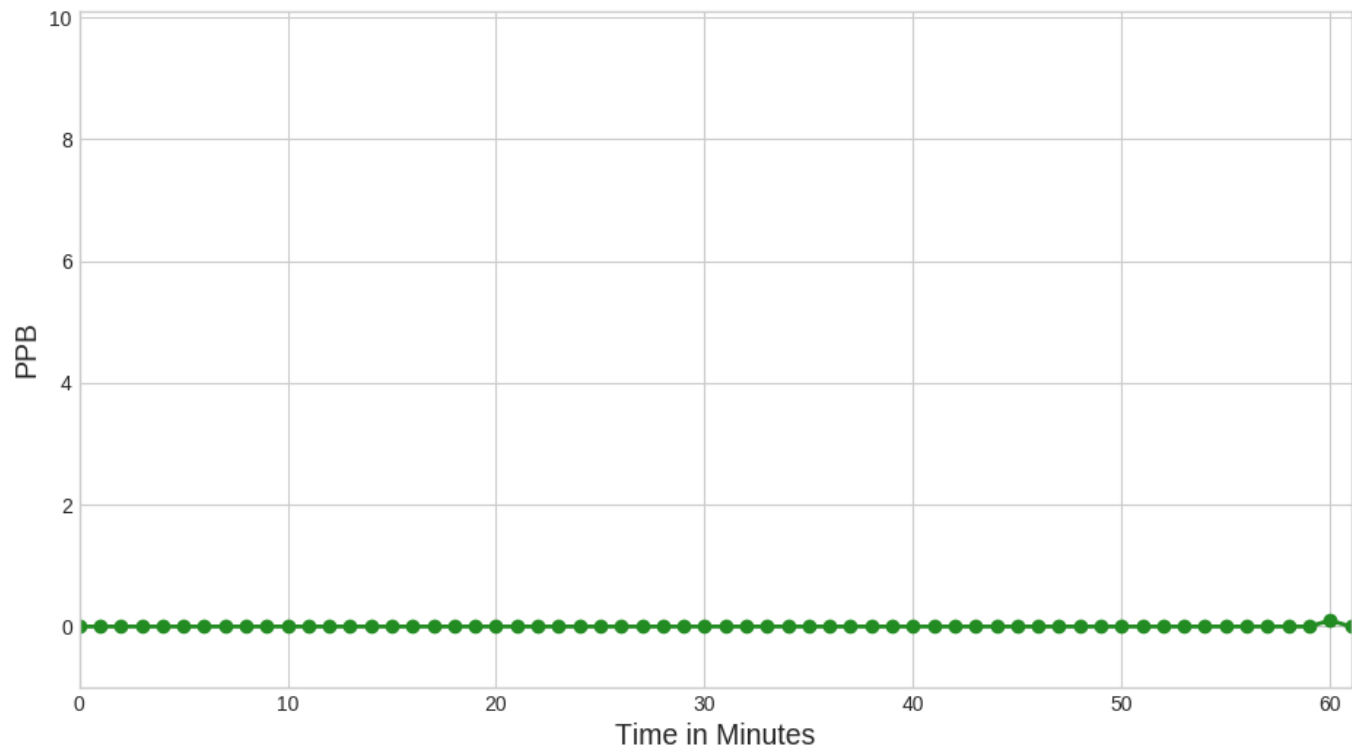
Client:	TEST CLIENT	Analyzer:	Delta F
Facility:	QAM HQ	Serial Number:	PT-18690-V6
Tool / Equipment ID:	TEST123	Calibration Due:	7/2021
System:	PN2	Instrument Flow:	2.0 SCFH
Source ID:	TST-SRC-ID	Start Time/Date:	10:39 03/01/21
Test Point ID:	PN2 POC	Stop Time/Date:	11:40 03/01/21
Test Gas:	Nitrogen	Test Duration:	1 hours 0 minutes 50 seconds
Test Flow:	4.3 SCFH	Average:	0.0 PPB
Technician:	JCH	Final:	0.0 PPB
		Specification:	20 PPB

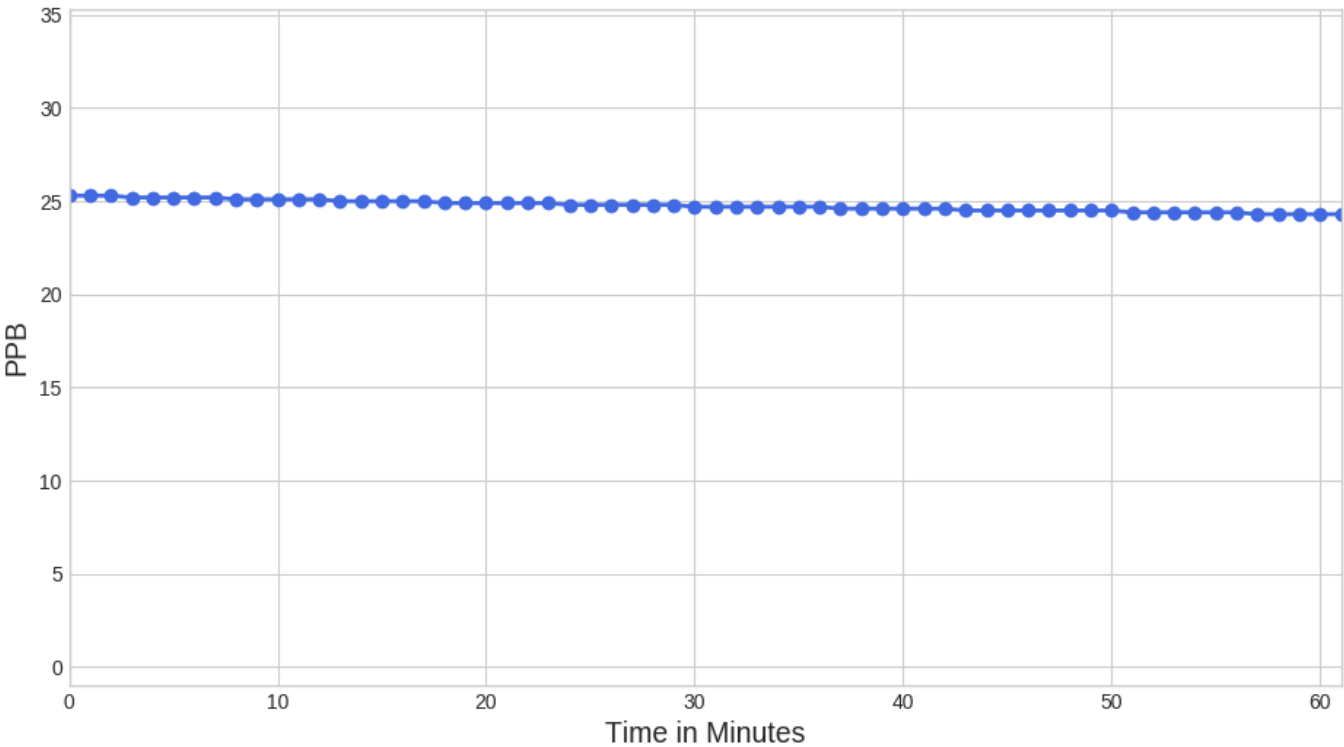
Client:	TEST CLIENT	Analyzer:	Tracer 2
Facility:	QAM HQ	Serial Number:	17367-44-1
Tool / Equipment ID:	TEST123	Calibration Due:	8/2021
System:	PN2	Instrument Flow:	2.3 SCFH
Source ID:	TST-SRC-ID	Start Time/Date:	10:39 03/01/21
Test Point ID:	PN2 POC	Stop Time/Date:	11:40 03/01/21
Test Gas:	Nitrogen	Test Duration:	1 hours 0 minutes 50 seconds
Test Flow:	4.3 SCFH	Average:	24.8 PPB
Technician:	JCH	Final:	24.3 PPB
		Specification:	20 PPB
