Oxygen Test Report

Moisture Test Report

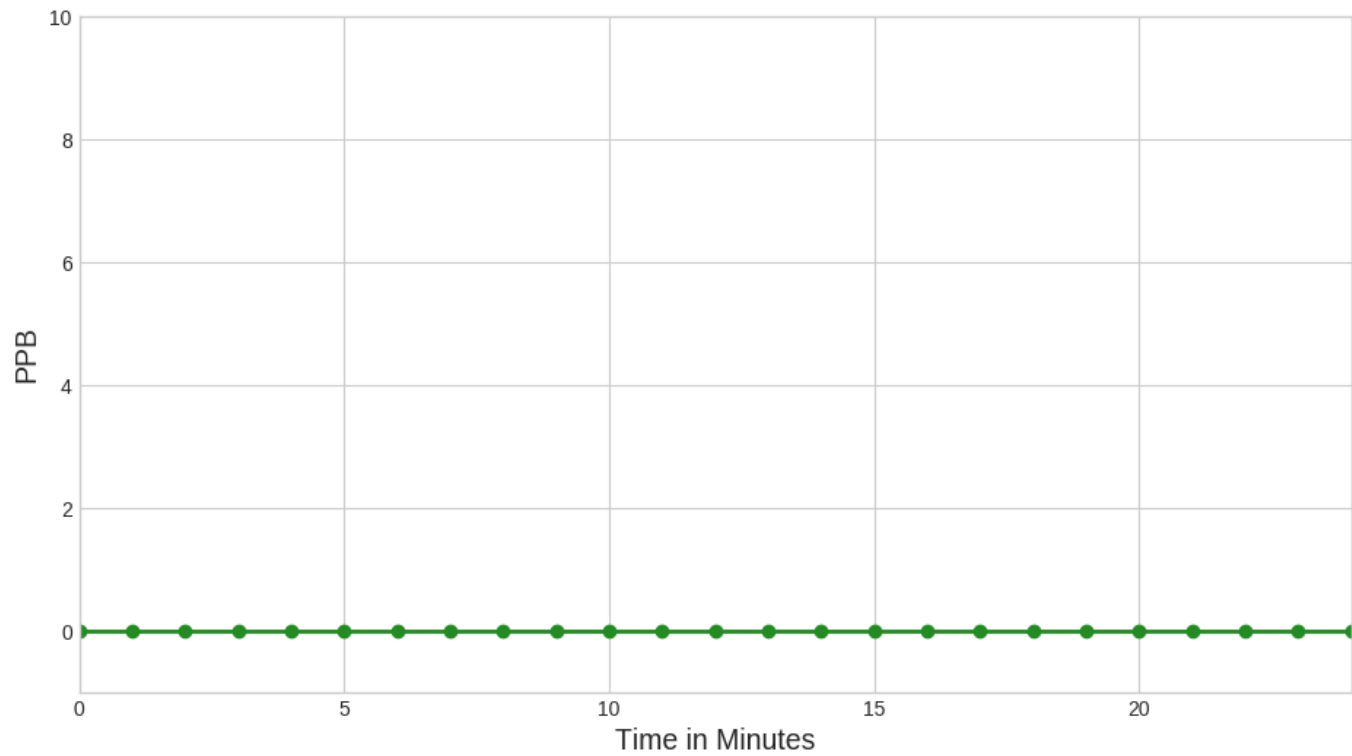
Client:	TEST CLIENT	Analyzer:	Delta F
Facility:	QAM HQ	Serial Number:	PT-18690-V6
Tool / Equipment ID:	TEST123	Calibration Due:	7/2021
System:	PN2	Instrument Flow:	2.0 SCFH
Source ID:	SRC-TST-ID	Start Time/Date:	12:48 02/26/21
Test Point ID:	PN2 LINE	Stop Time/Date:	13:11 02/26/21
Test Gas:	Nitrogen	Test Duration:	22 minutes 43 seconds
Test Flow:	4.3 SCFH	Average:	0.0 PPB
Technician:	JCH	Final:	0.0 PPB
		Specification:	20 PPB

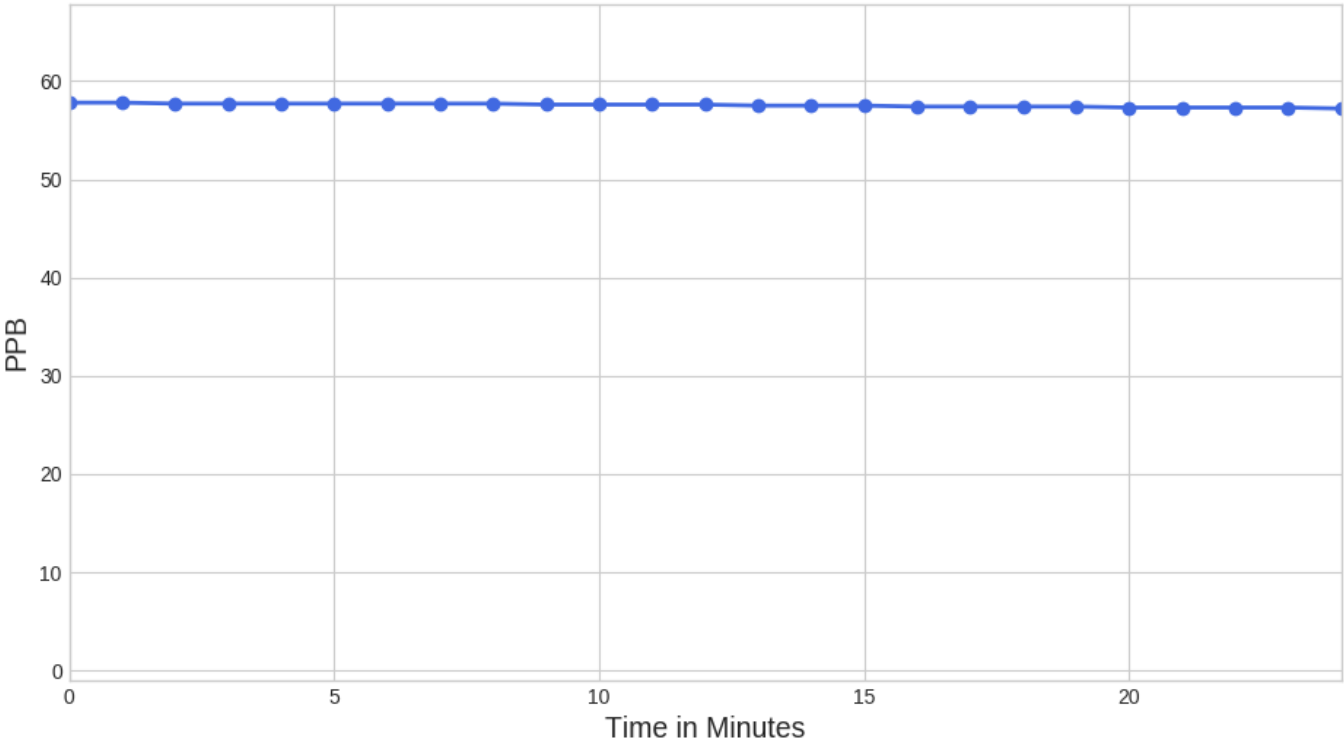
Client:	TEST CLIENT	Analyzer:	Tracer 2
Facility:	QAM HQ	Serial Number:	17367-44-1
Tool / Equipment ID:	TEST123	Calibration Due:	8/2021
System:	PN2	Instrument Flow:	2.3 SCFH
Source ID:	SRC-TST-ID	Start Time/Date:	12:48 02/26/21
Test Point ID:	PN2 LINE	Stop Time/Date:	13:11 02/26/21
Test Gas:	Nitrogen	Test Duration:	22 minutes 43 seconds
Test Flow:	4.3 SCFH	Average:	57.5 PPB
Technician:	JCH	Final:	57.2 PPB
		Specification:	20 PPB
