# Oxygen Test Report

# Moisture Test Report

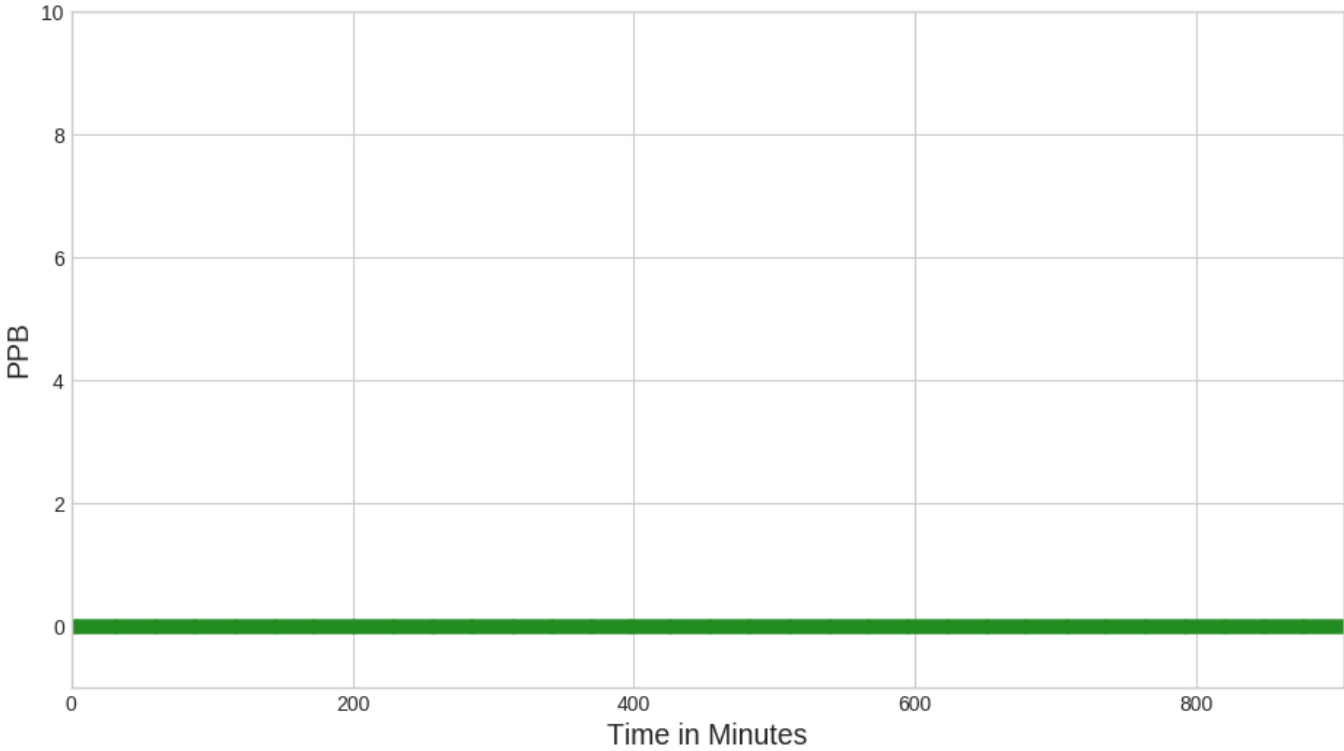
Client:	TEST CLIENT	Analyzer:	Delta F
Facility:	QAM HQ	Serial Number:	PT-18690-V6
Tool / Equipment ID:	test tool	Calibration Due:	7/2021
System:	PN2	Instrument Flow:	2.0 SCFH
Source ID:	test source	Start Time/Date:	16:02 03/01/21
Test Point ID:	PN2 test point	Stop Time/Date:	07:05 03/02/21
Test Gas:	Nitrogen	Test Duration:	15 hours 2 minutes
Test Flow:	4.3 SCFH	Average:	0.0 PPB
Technician:	JCH	Final:	0.0 PPB
		Specification:	20 PPB

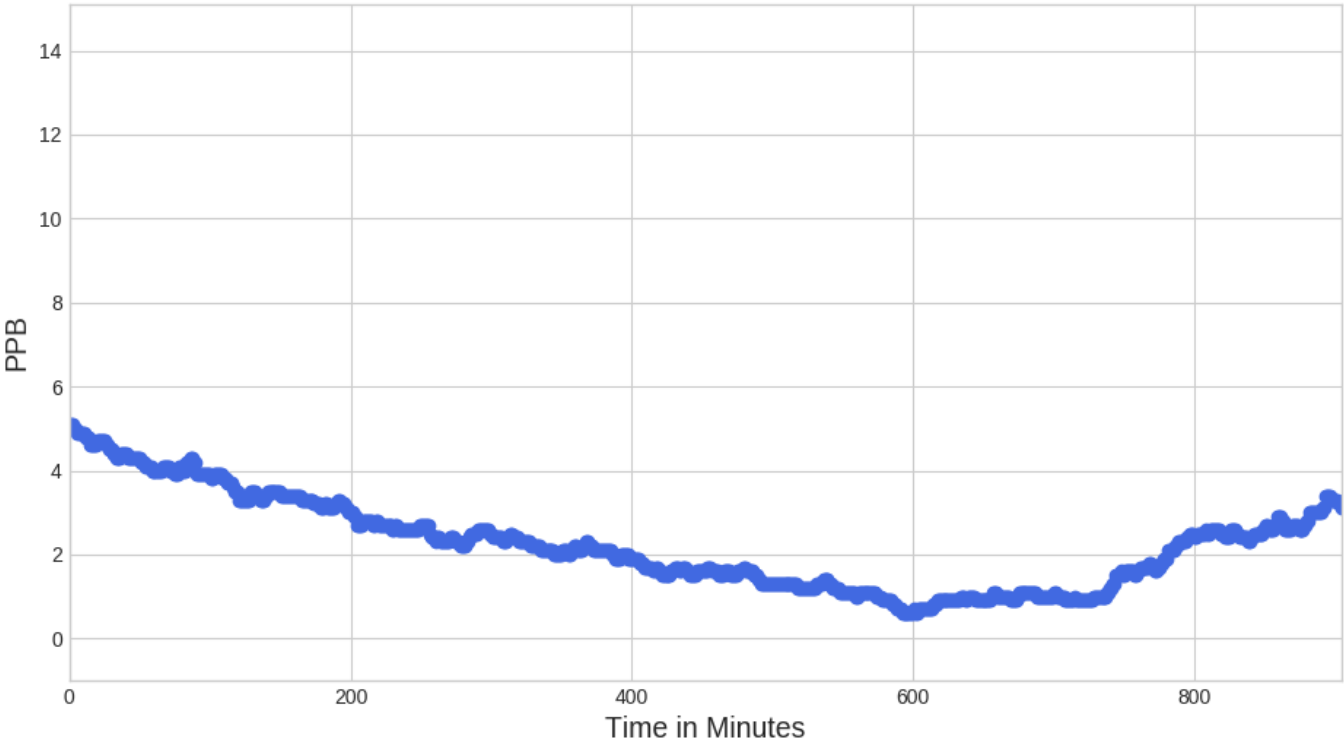
Client:	TEST CLIENT	Analyzer:	Tracer 2
Facility:	QAM HQ	Serial Number:	17367-44-1
Tool / Equipment ID:	test tool	Calibration Due:	8/2021
System:	PN2	Instrument Flow:	2.3 SCFH
Source ID:	test source	Start Time/Date:	16:02 03/01/21
Test Point ID:	PN2 test point	Stop Time/Date:	07:05 03/02/21
Test Gas:	Nitrogen	Test Duration:	15 hours 2 minutes
Test Flow:	4.3 SCFH	Average:	2.3 PPB
Technician:	JCH	Final:	3.1 PPB
		Specification:	20 PPB
