Oxygen Test Report

Client:	TEXAS INSTRUMENTS	Analyzer:	Delta F
Facility:	RFAB	Serial Number:	PT-18690-V6
Tool / Equipment ID:	TESTING123	Calibration Due:	7/2021
System:	PN2	Instrument Flow:	2.0 SCFH
Source ID:	TEST SOURCE	Start Time/Date:	08:37 02/24/21
Test Point ID:	PN2 POC	Stop Time/Date:	08:42 02/24/21
Test Gas:	Nitrogen	Test Duration:	5 minutes
Test Flow:	4.3 SCFH	Average:	0.0 PPB
Technician:	JCH	Final:	0.0 PPB
		Specification:	20 PPB

Moisture Test Report

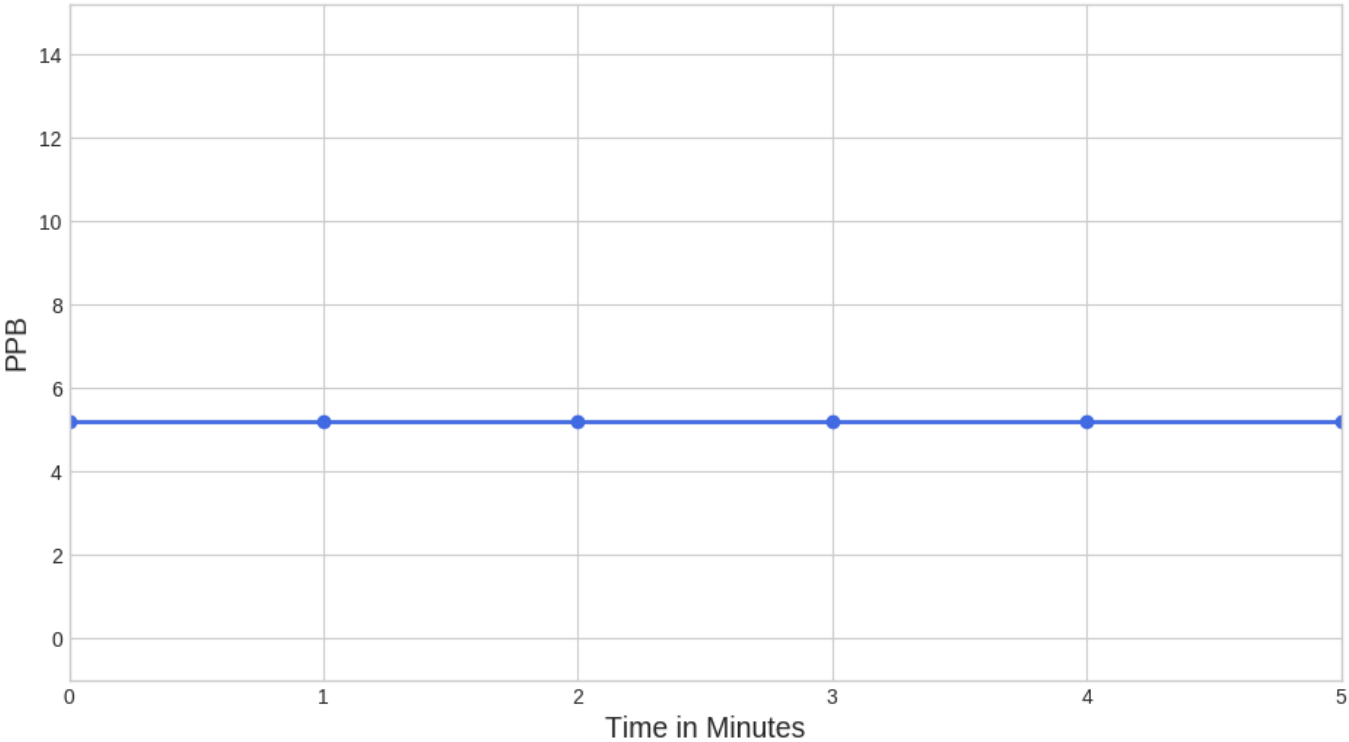
Client:	TEXAS INSTRUMENTS	Analyzer:	Tracer 2
Facility:	RFAB	Serial Number:	17367-44-1
Tool / Equipment ID:	TESTING123	Calibration Due:	8/2021
System:	PN2	Instrument Flow:	2.3 SCFH
Source ID:	TEST SOURCE	Start Time/Date:	08:37 02/24/21
Test Point ID:	PN2 POC	Stop Time/Date:	08:42 02/24/21
Test Gas:	Nitrogen	Test Duration:	5 minutes
Test Flow:	4.3 SCFH	Average:	5.2 PPB
Technician:	JCH	Final:	5.2 PPB
		Specification:	20 PPB
