Oxygen Test Report

Moisture Test Report

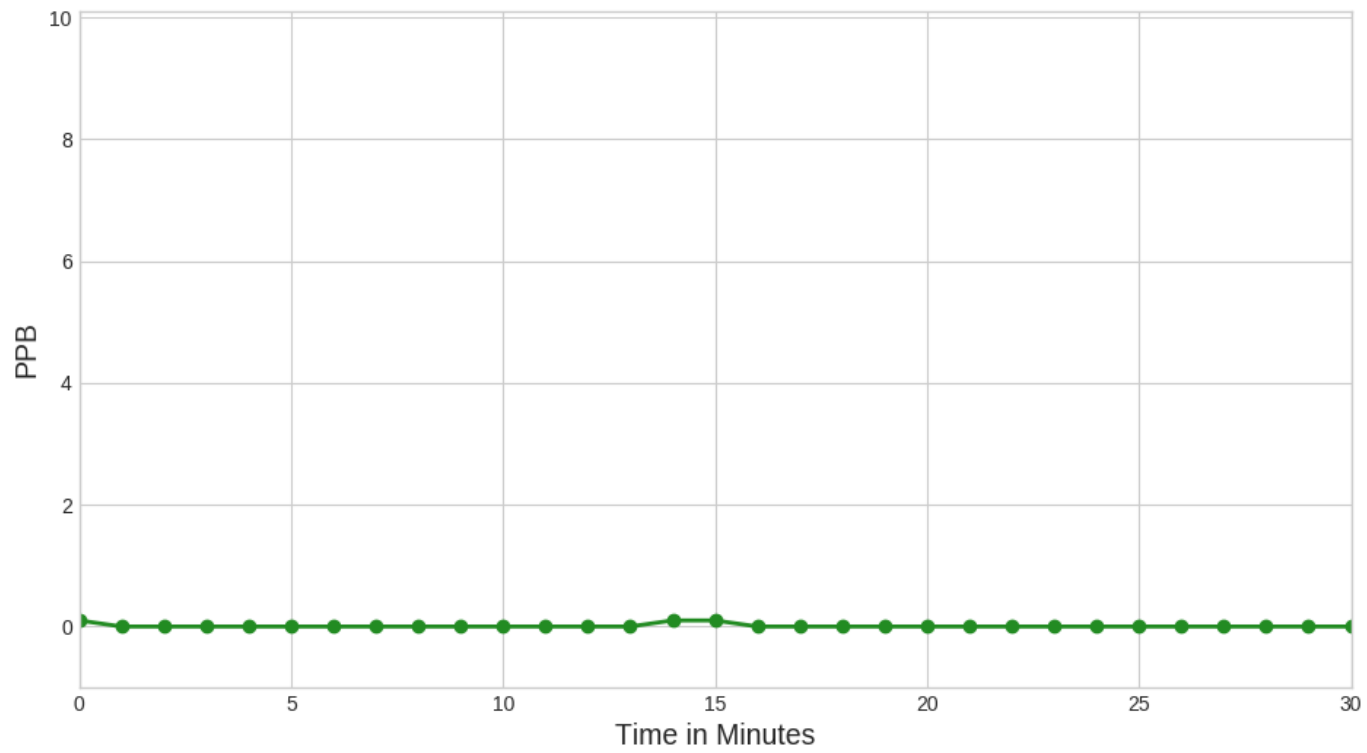
Client:	TEST CLIENT	Analyzer:	Delta F
Facility:	QAM HQ	Serial Number:	PT-18690-V6
Tool / Equipment ID:	TEST123	Calibration Due:	7/2021
System:	PN2	Instrument Flow:	2.0 SCFH
Source ID:	TST-SRC-ID	Start Time/Date:	09:53 02/25/21
Test Point ID:	PN2 POC	Stop Time/Date:	10:23 02/25/21
Test Gas:	Nitrogen	Test Duration:	30 minutes
Test Flow:	4.3 SCFH	Average:	0.0 PPB
Technician:	JCH	Final:	0.0 PPB
		Specification:	20 PPB

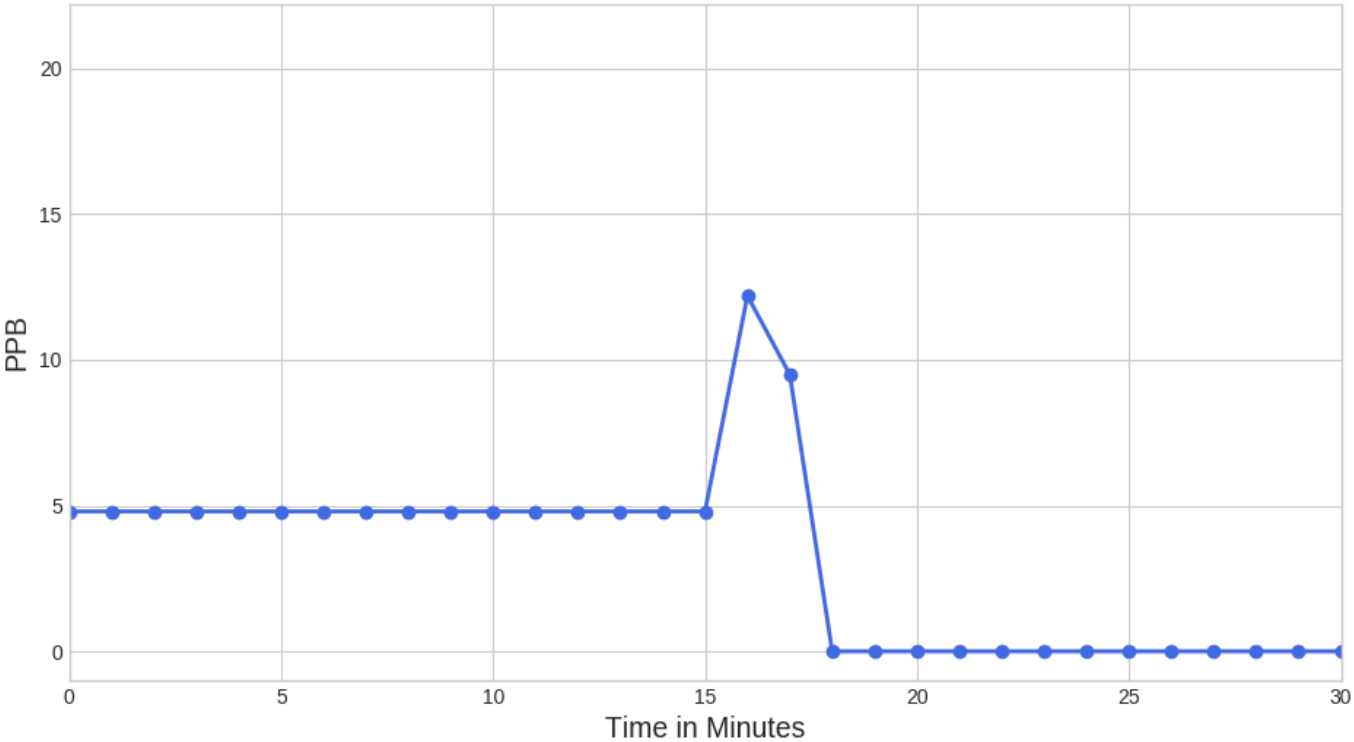
Client:	TEST CLIENT	Analyzer:	Tracer 2
Facility:	QAM HQ	Serial Number:	17367-44-1
Tool / Equipment ID:	TEST123	Calibration Due:	8/2021
System:	PN2	Instrument Flow:	2.3 SCFH
Source ID:	TST-SRC-ID	Start Time/Date:	09:53 02/25/21
Test Point ID:	PN2 POC	Stop Time/Date:	10:23 02/25/21
Test Gas:	Nitrogen	Test Duration:	30 minutes
Test Flow:	4.3 SCFH	Average:	3.2 PPB
Technician:	JCH	Final:	0.0 PPB
		Specification:	20 PPB
