# Oxygen Test Report

# Moisture Test Report

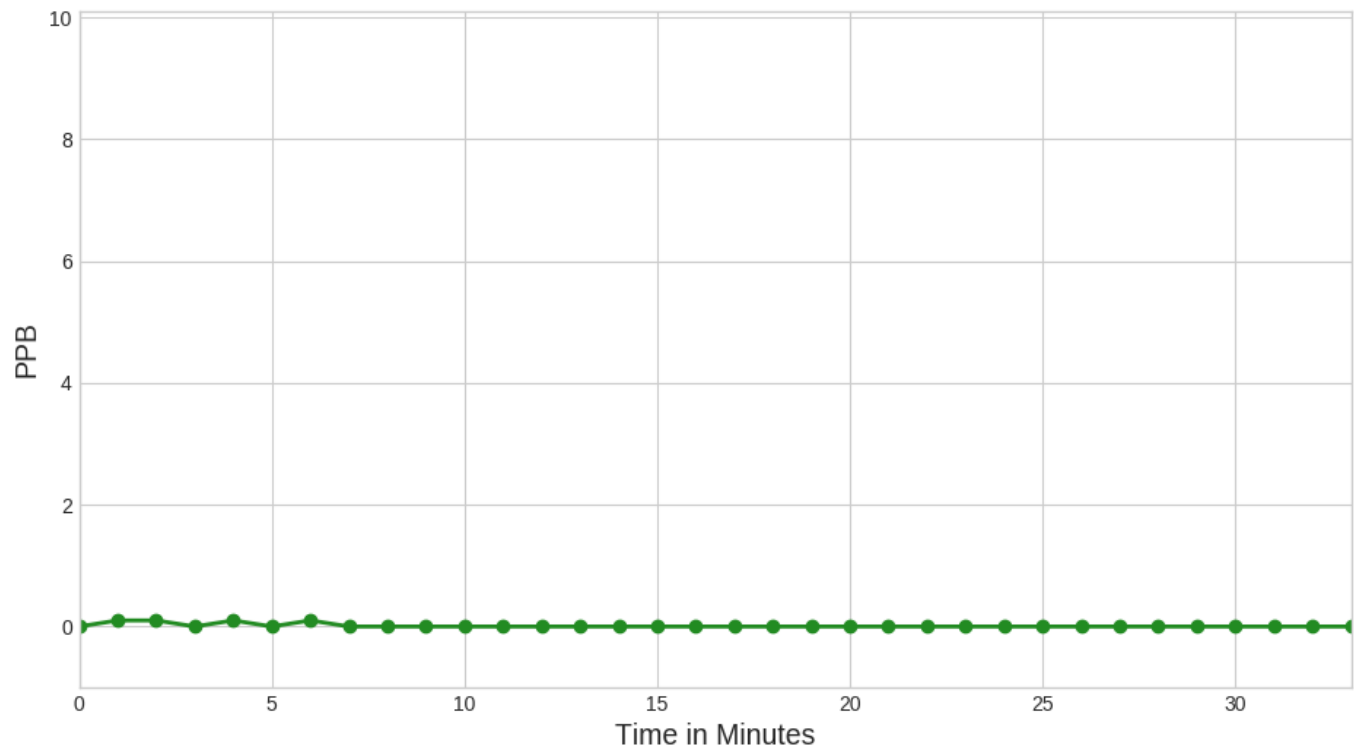
Client:	TEST CLIENT	Analyzer:	Delta F
Facility:	QAM HQ	Serial Number:	PT-18690-V6
Tool / Equipment ID:	TEST321	Calibration Due:	7/2021
System:	PN2	Instrument Flow:	2.0 SCFH
Source ID:	TST-SRC-ID	Start Time/Date:	13:14 02/25/21
Test Point ID:	PN2 POC	Stop Time/Date:	13:46 02/25/21
Test Gas:	Nitrogen	Test Duration:	32 minutes 13 seconds
Test Flow:	4.3 SCFH	Average:	0.0 PPB
Technician:	JCH	Final:	0.0 PPB
		Specification:	20 PPB

Comments: This is a test of the save graph feature

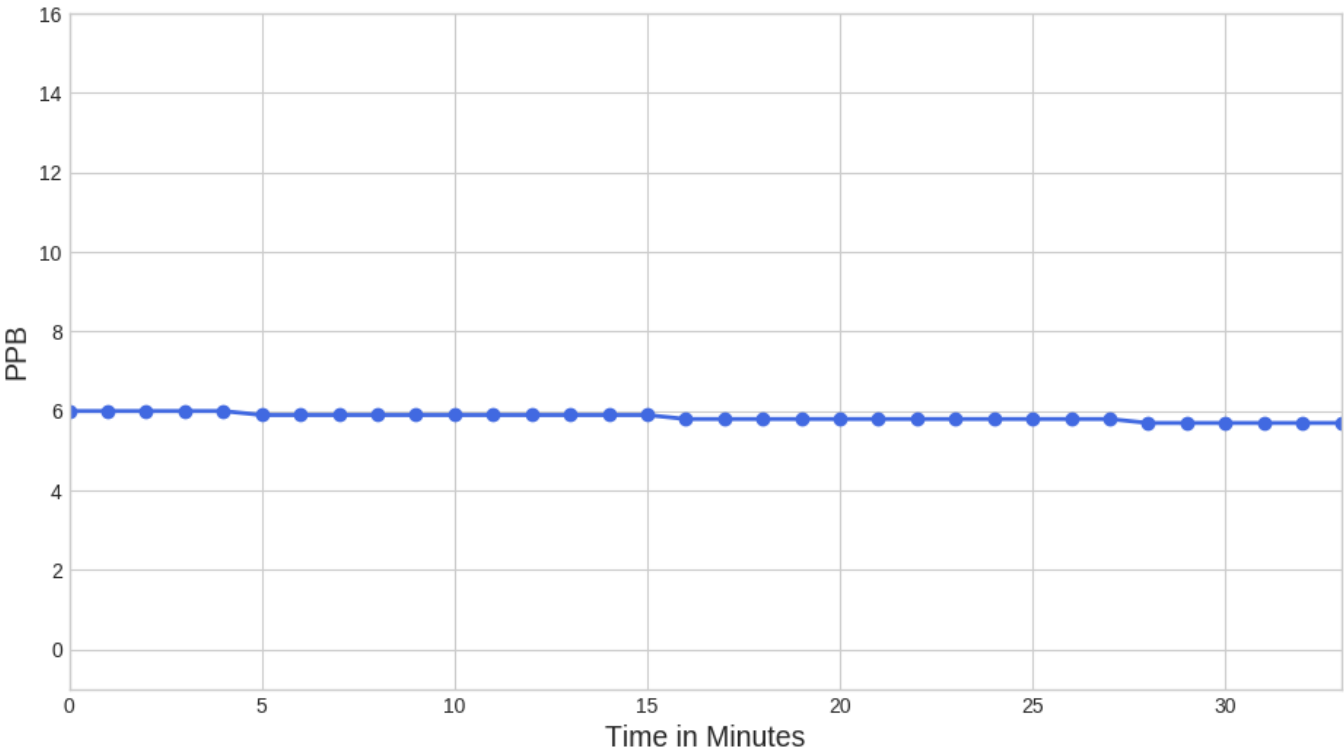
Client:	TEST CLIENT	Analyzer:	Tracer 2
Facility:	QAM HQ	Serial Number:	17367-44-1
Tool / Equipment ID:	TEST321	Calibration Due:	8/2021
System:	PN2	Instrument Flow:	2.3 SCFH
Source ID:	TST-SRC-ID	Start Time/Date:	13:14 02/25/21
Test Point ID:	PN2 POC	Stop Time/Date:	13:46 02/25/21
Test Gas:	Nitrogen	Test Duration:	32 minutes 13 seconds
Test Flow:	4.3 SCFH	Average:	5.8 PPB
Technician:	JCH	Final:	5.7 PPB
		Specification:	20 PPB

Comments: This is a test of the save graph feature
