Quality Assurance Management, Inc.
1620 Valwood Pkwy, Ste. 128
Carrollton, TX 75006
972-331-5800
QAM.com

Oxygen Test Report

Moisture Test Report

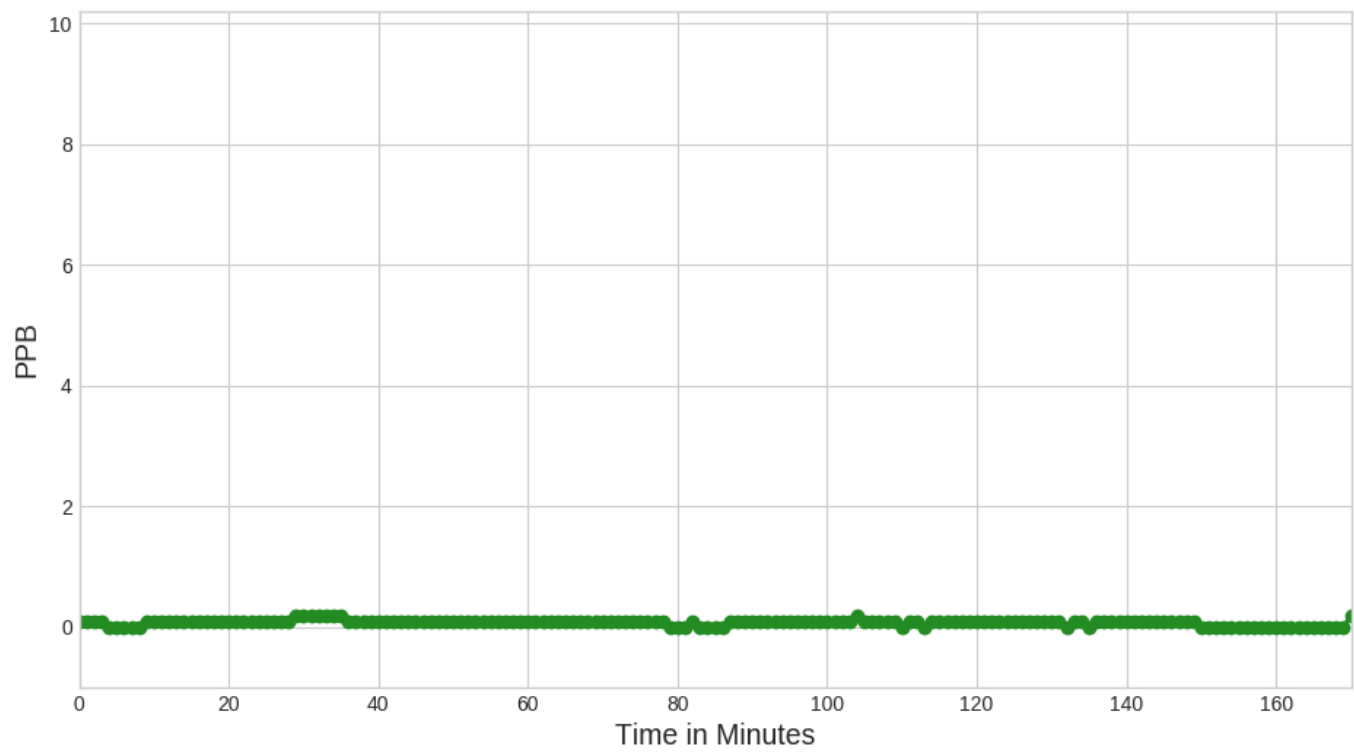
Client:	TEST CLIENT	Analyzer:	Delta F
Facility:	HQ	Serial Number:	PT-18690-V6
Tool / Equipment ID:	TEST123	Calibration Due:	7/2021
System:	PN2	Instrument Flow:	2.0 SCFH
Source ID:	TST-SRC	Start Time/Date:	04:44 02/25/21
Test Point ID:	POC	Stop Time/Date:	07:31 02/25/21
Test Gas:	Nitrogen	Test Duration:	2 hours 47 minutes
Test Flow:	4.3 SCFH	Average:	0.1 PPB
Technician:	JCH	Final:	0.2 PPB
		Specification:	20 PPB

Comments: Modified Test

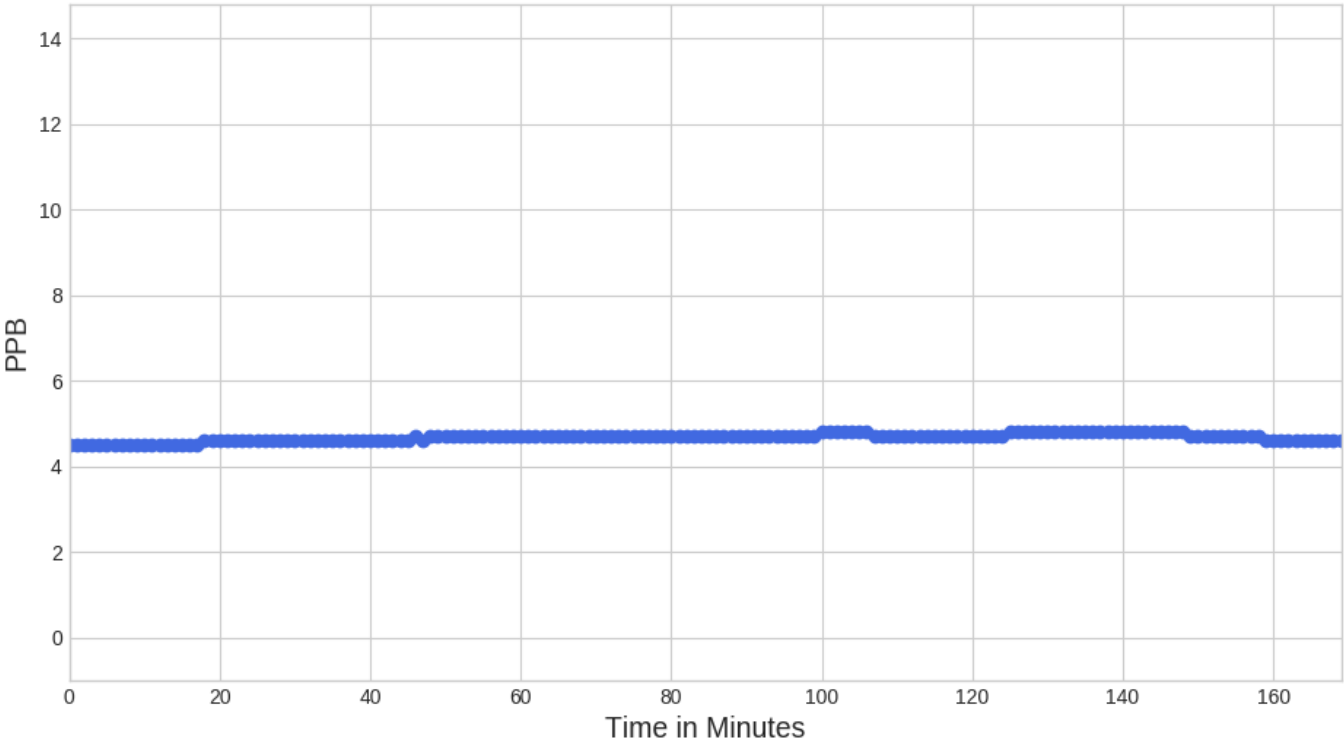
Client:	TEST CLIENT	Analyzer:	Tracer 2
Facility:	HQ	Serial Number:	17367-44-1
Tool / Equipment ID:	TEST123	Calibration Due:	8/2021
System:	PN2	Instrument Flow:	2.3 SCFH
Source ID:	TST-SRC	Start Time/Date:	04:42 02/25/21
Test Point ID:	POC	Stop Time/Date:	07:32 02/25/21
Test Gas:	Nitrogen	Test Duration:	2 hours 49 minutes
Test Flow:	4.3 SCFH	Average:	4.7 PPB
Technician:	JCH	Final:	4.6 PPB
		Specification:	20 PPB

Comments: Modified Test
