Fairfax County and the City of Alexandria, Virginia Shoreline Inventory Report Methods and Guidelines

Special report in Applied Marine Science and Ocean Engineering No. 419 of the Virginia Institute of Marine Science

Fairfax County and the City of Alexandria - Shoreline Inventory Report

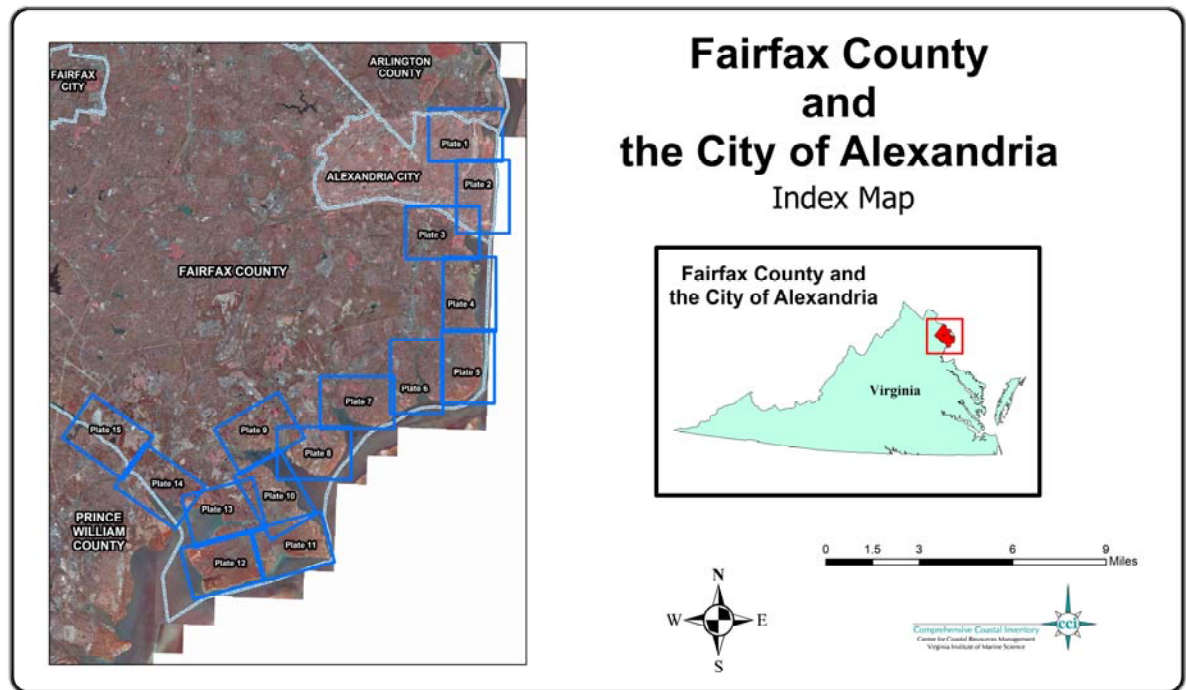
Figure 2. Map index for Fairfax County and the City of Alexandria

For publication purposes Fairfax County and the City of Alexandria are divided into a series of maps. Maps are scaled at 1:12,000 for publication at 11x17. Scale will vary if printed at a different size. There are total of 15 maps that cover Fairfax County and the City of Alexandria. The maps are determined by the geographic size and shape of the region. For each map there are four plates (plate 1a, 1b, 1c, 1d, etc.), for a total of 60 map compositions. On the website (Figure 1), an index is provided to help users locate the area of interest and view the orientation of the maps to each other (Figure 2). Each plate can be individually selected and viewed from the plate list along the left hand column of the index page.

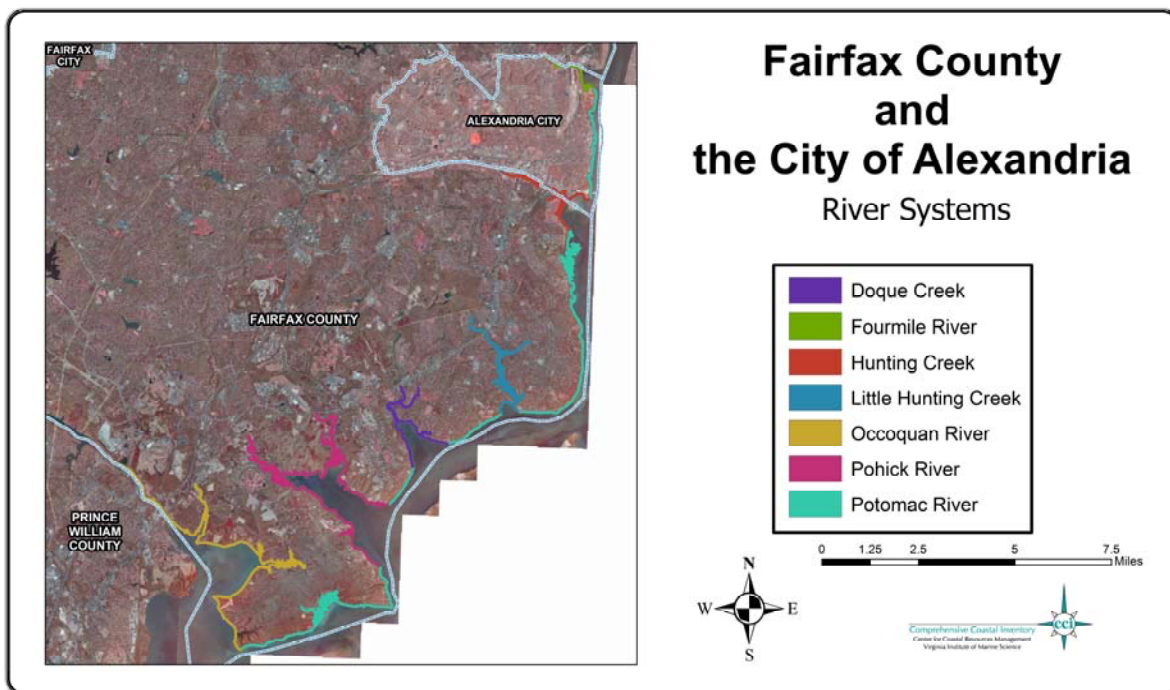
Figure 3. Delineation of river systems used for data reporting

Tables 4, 5, 6 and 7 quantify features and conditions mapped along the rivers using frequency analysis techniques in ArcInfo. The values quantify features by river systems (Figure 3). For linear features, values are reported in actual miles surveyed. Point features are enumerated. The total miles of shoreline surveyed for each tributary is reported. For Fairfax County and the City of Alexandria, a total of 98.87 miles were surveyed in the field. Approximately 28.39 miles of shoreline were surveyed using remote sensing techniques. Figure 4 illustrates where field surveys were conducted and where remote sensing techniques were applied. Remote sensing occurred in places where navigation was restricted. Table 6 reports the survey dates, miles surveyed, and miles surveyed remotely.

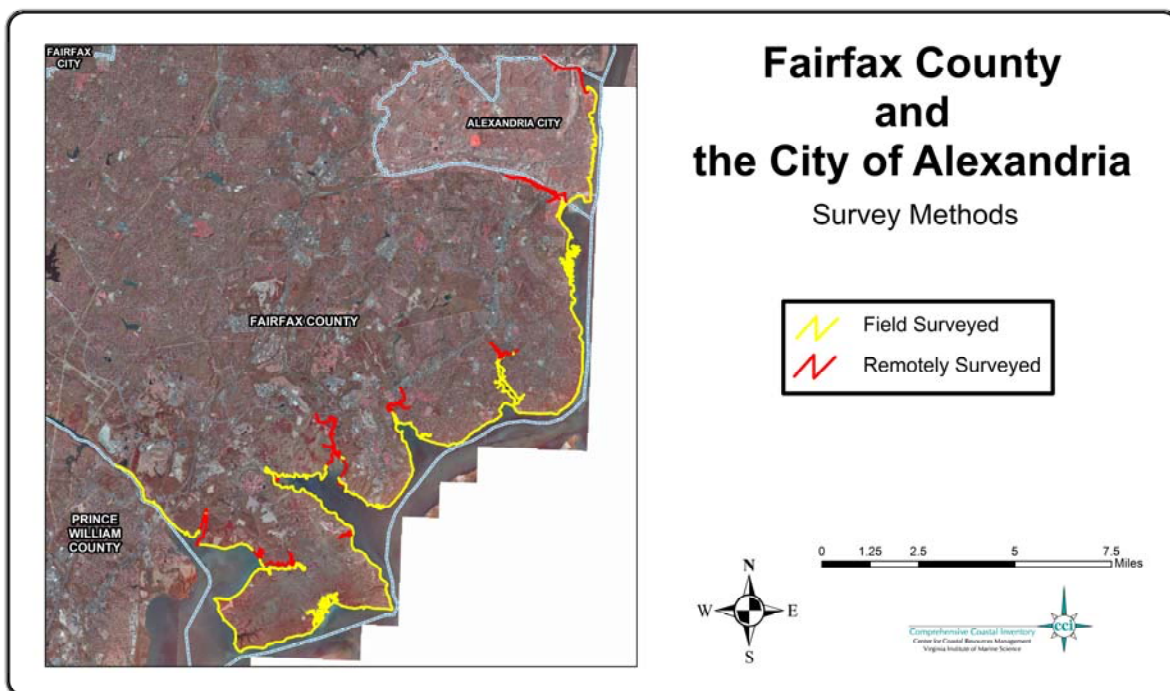
Figure 4. Location of field surveys and remotely sensed data collection.

Shoreline condition is described for Fairfax County and the City of Alexandria and along primary and secondary shoreline. Characteristics are described for all navigable tidal waterways contiguous to these shorelines. A total of 98.87 miles of the total 120.38 miles of shoreline are described. Less than 30 miles (28.39 miles) were coded remotely

shoreline that could not be accessed by boat occurs in well protected, low fetch environments, the remote coding assumes that upland banks are well protected by vegetation, and erosion is low. It is possible, however, for these banks to experience undercutting from tidal currents. This cannot be verified since field visits were not performed. Bank height conditions along reaches characterized using remote sensing techniques were estimated from USGS 1:24,000 topographic maps.

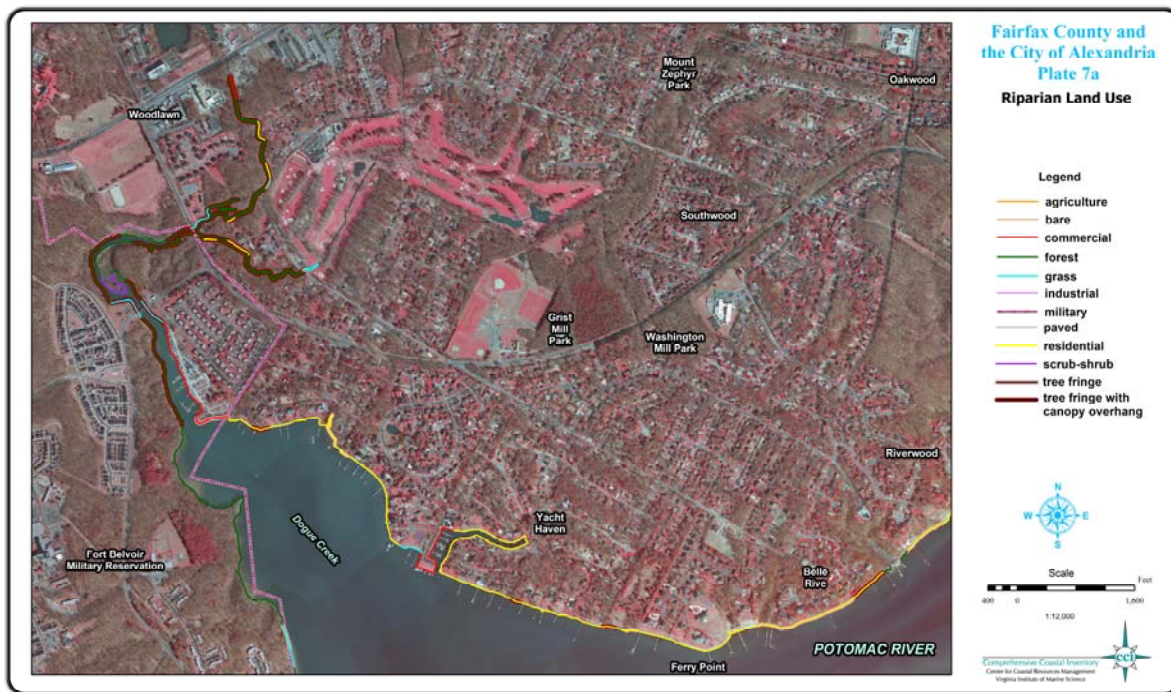
Figure 6. Sample riparian land use map for Fairfax County and the City of Alexandria

Plate A describes the riparian land use as color-coded bars along the shore. If the line is highlighted underneath with pale pink, there is tree fringe on site. If the line is highlighted underneath with brown, there is tree fringe with canopy overhang. The background imagery is natural color VBMP imagery at a publication scale of 1:12,000. Users should note that the imagery is sometime rotated in order to meet the scale requirements. This means that “north” is not always to the top of the page.

Data collected for the shoreline inventory can assist with targeting efforts for designating AOCs. AOCs can be areas where riparian buffers are fragmented, and could be restored. Use Plate “a” to identify forested upland. Breaks in the continuity of the riparian forest can be easily observed in the line segments, and background image. Land use between the breaks relates to potential opportunity for restoring the buffer where fragmentation has occurred. Agricultural

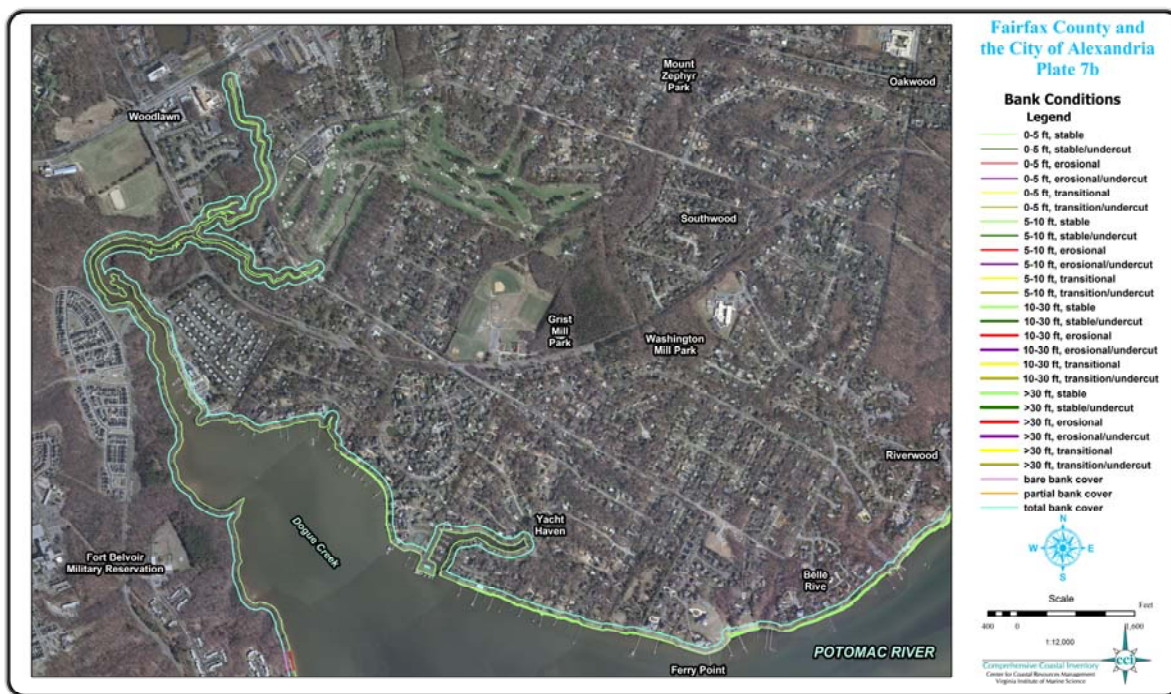
Figure 7. Map illustrating bank conditions for plate 7

Plate B depicts the condition of the bank; specifically bank stability and bank height. The colors light green, red and yellow are used to report if the bank is stable, erosional, or transitional, respectively. If each of these conditions occurs with undercutting at the base of the bank, the colors become, dark green, fuchsia, olive green, respectively. The thickness of the line reflects the bank height; where the thickest lines designate the highest banks (> 30 feet). Plate B uses natural color VBMP imagery for the backdrop.

Plates “b” and “d” can be used to identify sites for BMPs. Look for where eroding bank conditions persist. The thickness of the line tells something about the bank height. The fetch, or the distance of exposure across the water, can offer some insight into the type of BMP that might be most appropriate. Marsh planting may be difficult to establish at the toe of a bank with high exposure to wave conditions. Look for other marsh fringe on Plate “d” in the vicinity as an indicator that marshes can successfully grow. A riparian forest may include a tree canopy with overhang that could be trimmed to increase sunlight to promote marsh growth. Plate “c” should be checked for existing shoreline erosion structures in place. We can combine this information with the above to determine if structural control is really necessary.

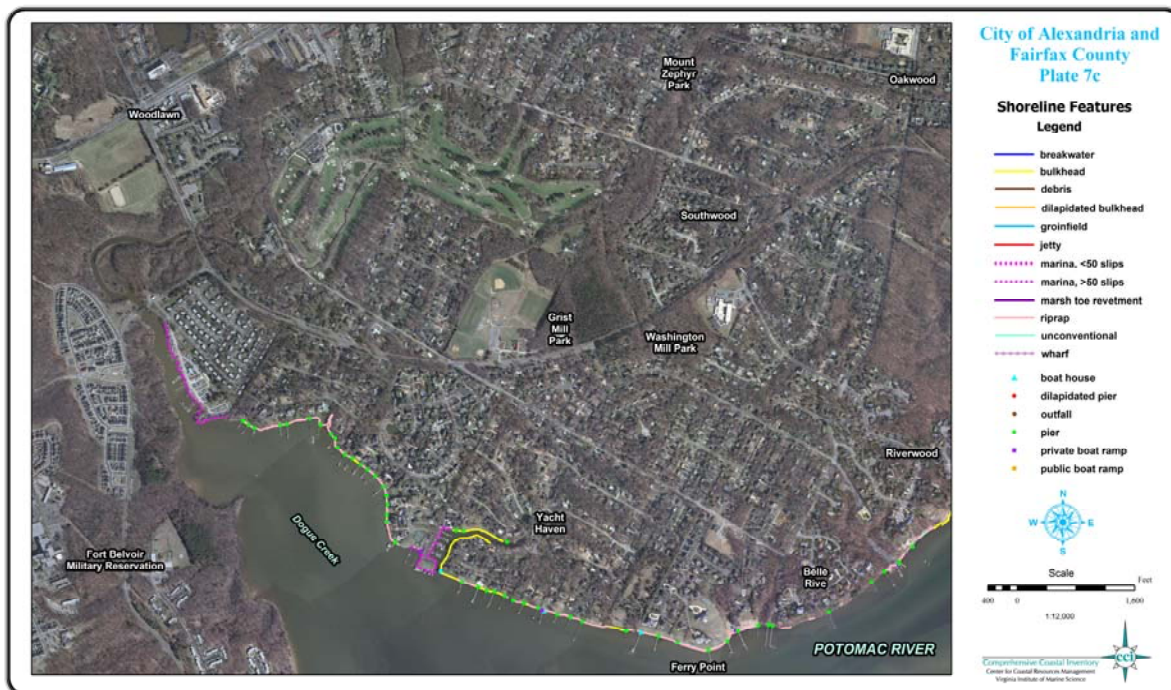
Figure 8. Map illustrating shoreline features for plate 7

Plate C combines recreational and shoreline protection structures in a composition called Shoreline Features. These are generally anthropogenic alterations constructed to gain access to the water or to stabilize a shoreline from existing and future bank erosion. Linear features, described previously (Table 3), are mapped using color coded bar symbols that follow the orientation of the shoreline. Point features use a combination of colors and symbols to plot the positions on the map. Natural color imagery is used as a backdrop.

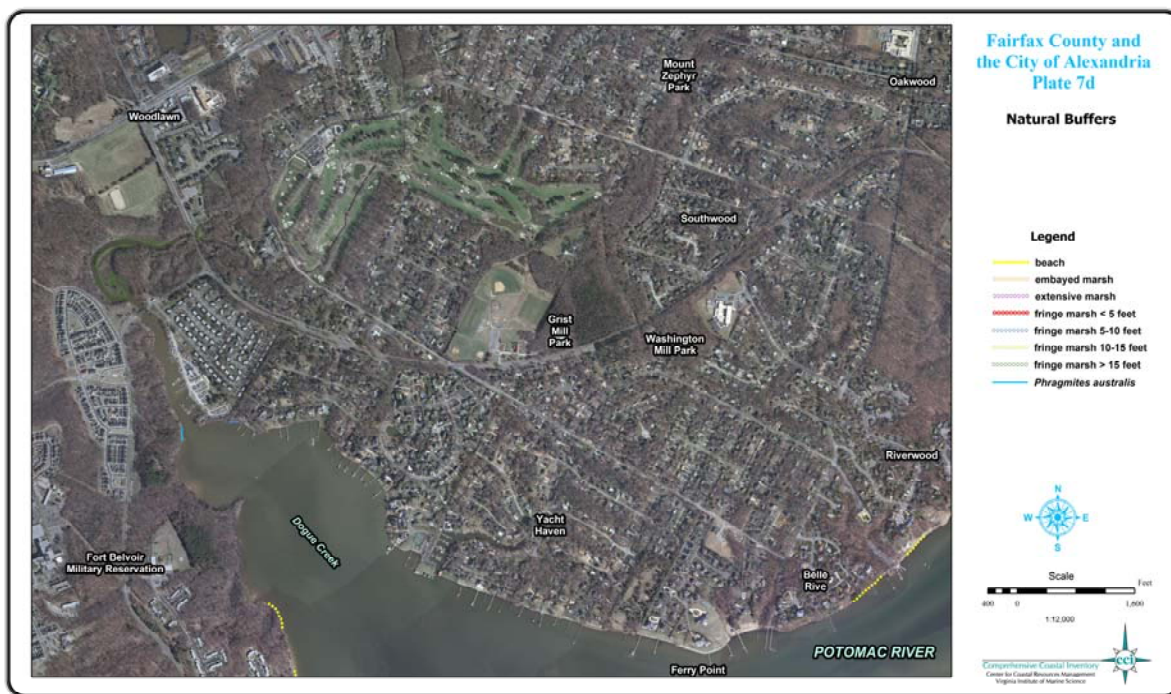
Figure 9. Map illustrating natural buffers for plate 7

On Plate D a pattern of small colored circles along the shoreline describes any natural buffers present. These are limited to marshes and beaches. Orange open circles represent embayed marshes. Purple open circles are extensive marshes. Red open circles indicate the presence of fringe marshes that are less than 5 feet in width. Dark blue open circles represent fringe marshes that are 5-10 feet in width. Fringe marshes 10-15 wide are depicted with light green open circles. If the fringe marsh is greater than 15 feet the open circles will be dark green. The invasive species *Phragmites australis* is designated with blue line shown behind the shoreline. Beaches, if present are delineated with solid yellow balls.
