Northampton County, Virginia Shoreline Inventory Report Methods and Guidelines

Special report in Applied Marine Science and Ocean Engineering No. 427 of the Virginia Institute of Marine Science

Northampton County - Shoreline Inventory Report

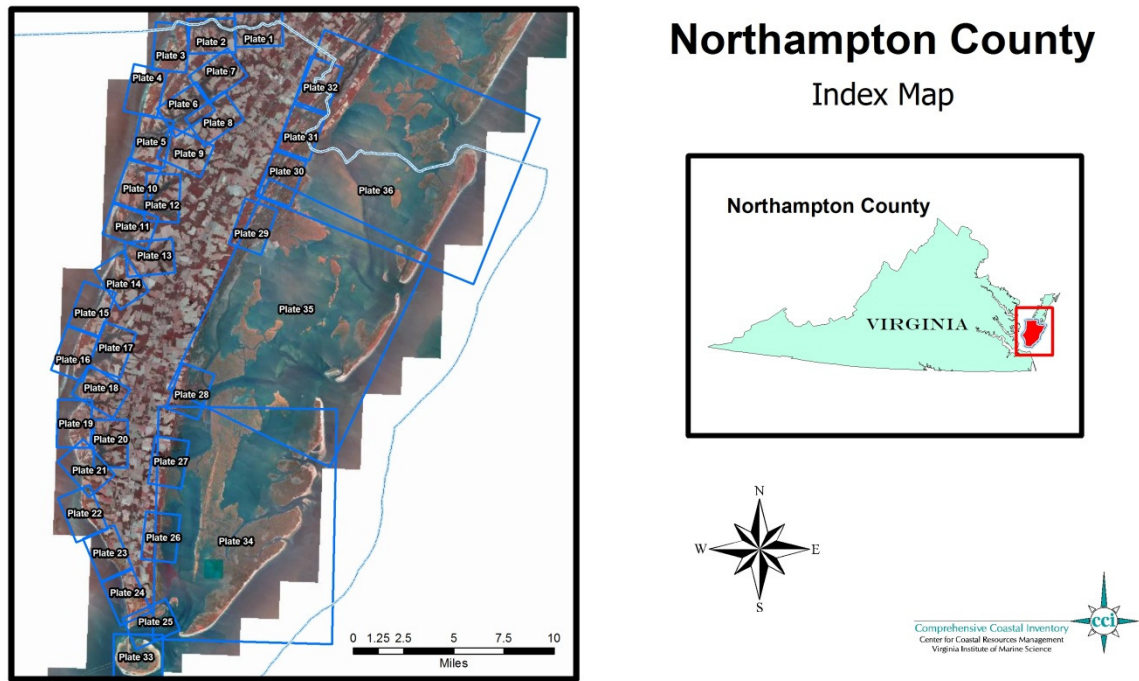
Figure 2. Map index for Northampton County

For publication purposes Northampton County is divided into a series of maps. There are a total of 36 maps that cover Northampton County. The majority of the maps (maps 1- 32) are scaled at 1:12,000 for publication at 11x17. Scale will vary if printed at a different size. Maps 33 to 36 are presented at a smaller scale to accommodate the geographic area. The maps are determined by the geographic size and shape of the region. For maps 1 through 33, there are four plates, a-d illustrating land use, bank condition, shoreline features, and natural buffers, respectively. For maps 34 through 36 there is only one plate per map, which condenses all available Inventory data for those areas. On the website (Figure 1), an index is provided to help users locate the area of interest and view the orientation of the maps to each other (Figure 2). Each plate can be individually selected and viewed from the plate list along the left hand column of the index page.

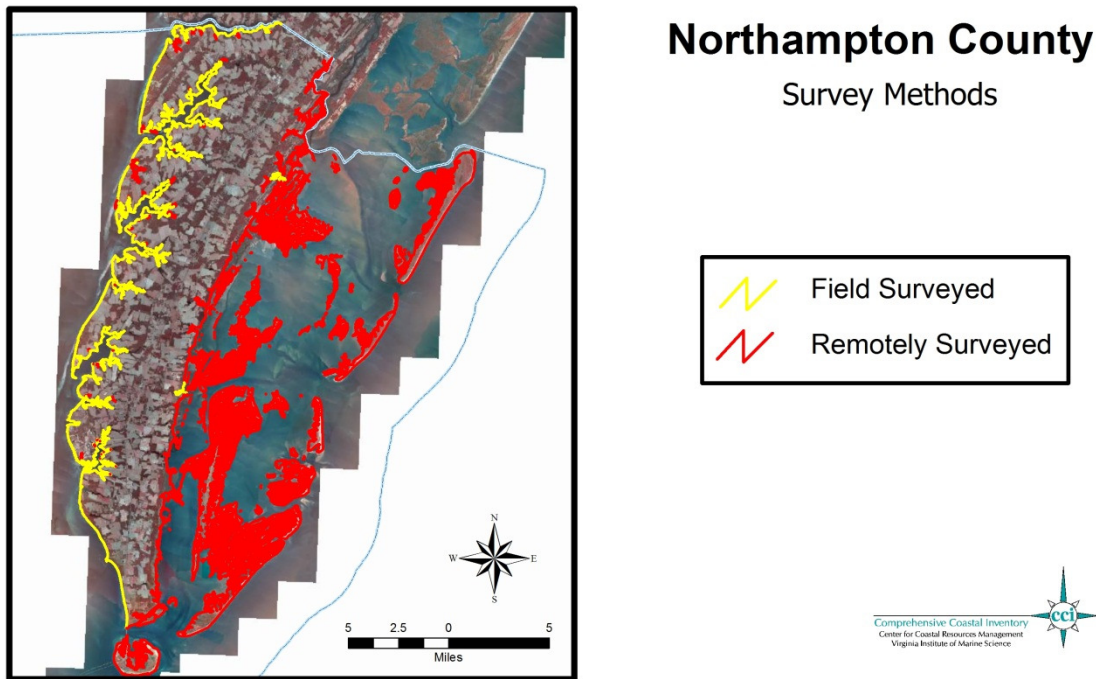
Figure 3. Location of field surveys and remotely sensed data collection.

Shoreline condition is described for Northampton County and along primary and secondary shoreline. Characteristics are described for all navigable tidal waterways contiguous to these shorelines. A total of 1915.94 miles of shoreline are described. Less than 1720 miles (1717.65 miles) were coded remotely because access could not be gained by boat.

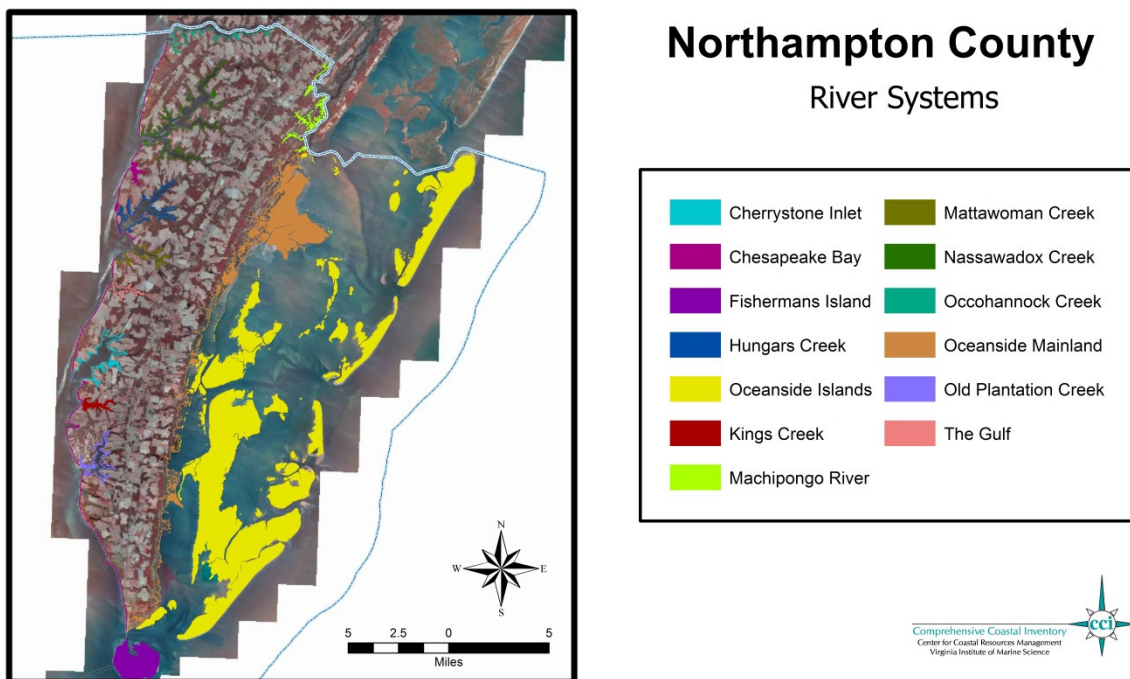
Figure 4. Delineation of river systems used for data reporting

Tables 5, 6, 7 and 8 quantify features and conditions mapped along the rivers using frequency analysis techniques in ArcInfo. The values quantify features by river systems (Figure 4). For linear features, values are reported in actual miles surveyed. Point features are enumerated. Polygon features are reported in acres surveyed.

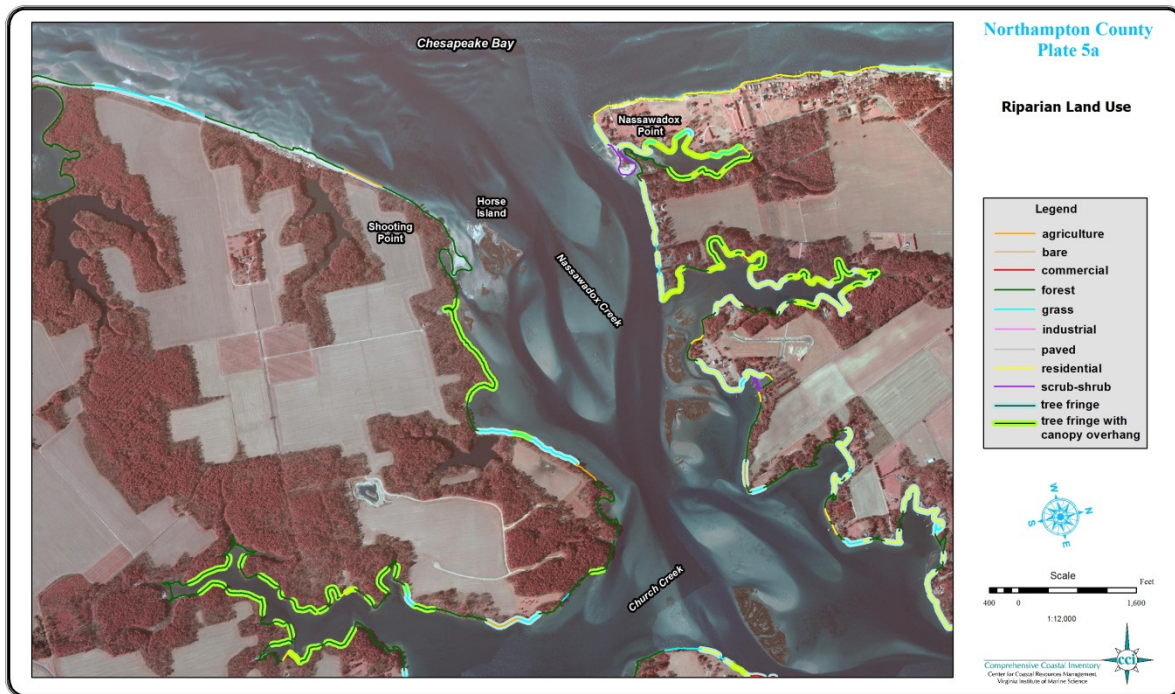
Figure 6. Sample riparian land use map for Northampton County

Plate A describes the riparian land use as color-coded bars along the shore. If the line is highlighted underneath with pale turquoise, there is tree fringe on site. Tree fringe suggests a spattering of trees along the shoreline but not at a density sufficient to classify the lot as being forested. If the line is highlighted underneath with light green, there is tree fringe with canopy overhang. Canopy overhang is captured because of its attribute value in developing management strategies. The background imagery is infrared color VBMP imagery at a publication scale of 1:12,000. Users should note that the imagery is sometime rotated in order to meet the scale requirements. This means that “north” is not always to the top of the page.

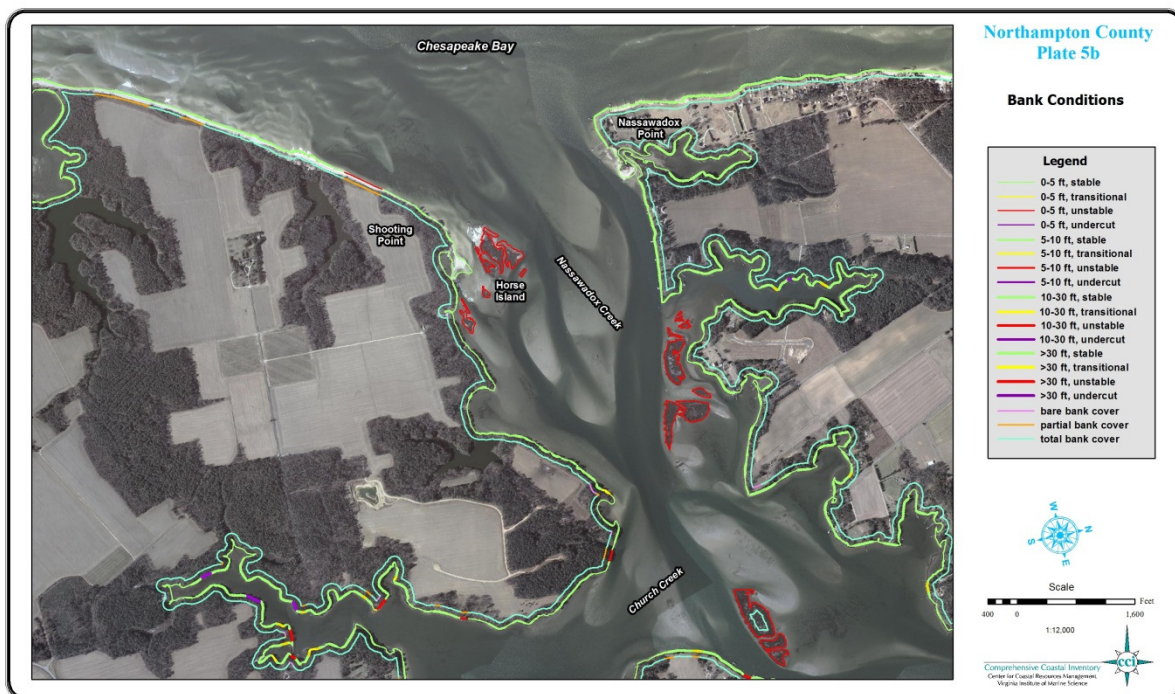
Figure 7. Map illustrating bank conditions for plate 5

Plate B depicts stability, height and cover of the bank. The shoreline is color-coded light green, red and yellow to report if the bank is stable, unstable, or transitional, respectively. If undercutting is present at the base of the bank the line is shaded purple. The thickness of the line reflects the bank height; where the thickest lines designate the highest banks (> 30 feet).

Once you determine which plate you want, the scroll down menu on the left has links to the four part series for each plate (Figure 5). At the top of the scroll bar Riparian Land Use (plate a) is first. You can scroll down to see links to maps illustrating Bank Conditions (plate b), Shoreline Features (plate c), and Natural Buffers (plate d). The content and details of the four part plate series was described in detail in Chapter 2. The actual map will come up when you click on the plate number. For example, Figure 6 is the riparian land use map for plate 5. Figure 7 is the map illustrating bank conditions for the same area. Figure 8 shows all the shoreline features for plate 5, and Figure 9 the natural buffers associated with that section.

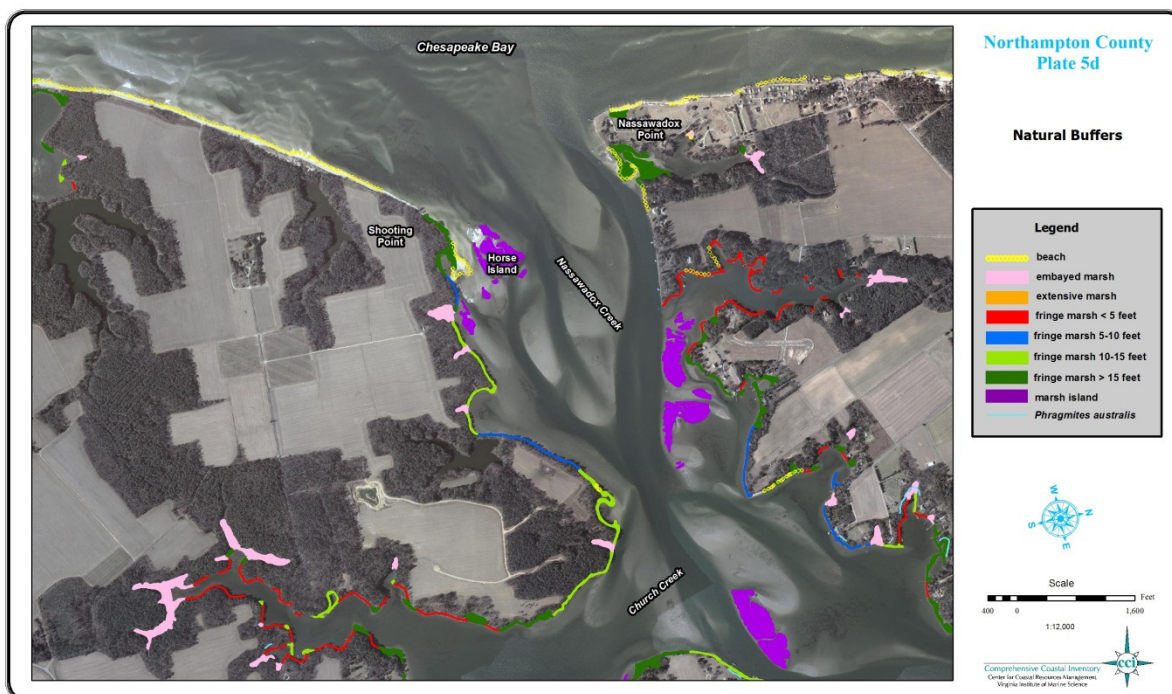
Figure 9. Map illustrating natural buffers for plate 5

marsh is greater than 15 feet the polygon will be dark green. The invasive species *Phragmites australis* is designated with a blue line shown inland of the shoreline. Beaches, if present, are delineated with yellow circles. Plate D uses natural color VBMP imagery for the backdrop.
