Stafford County, Virginia Shoreline Situation Report Methods and Guidelines

Prepared By:
Comprehensive Coastal Inventory Program
Center for Coastal Resources
Management
Virginia Institute of Marine Science, College of William and Mary
Gloucester Point, Virginia
May, 2006

Special report in Applied Marine Science and Ocean Engineering No. 394 of the Virginia Institute of Marine Science

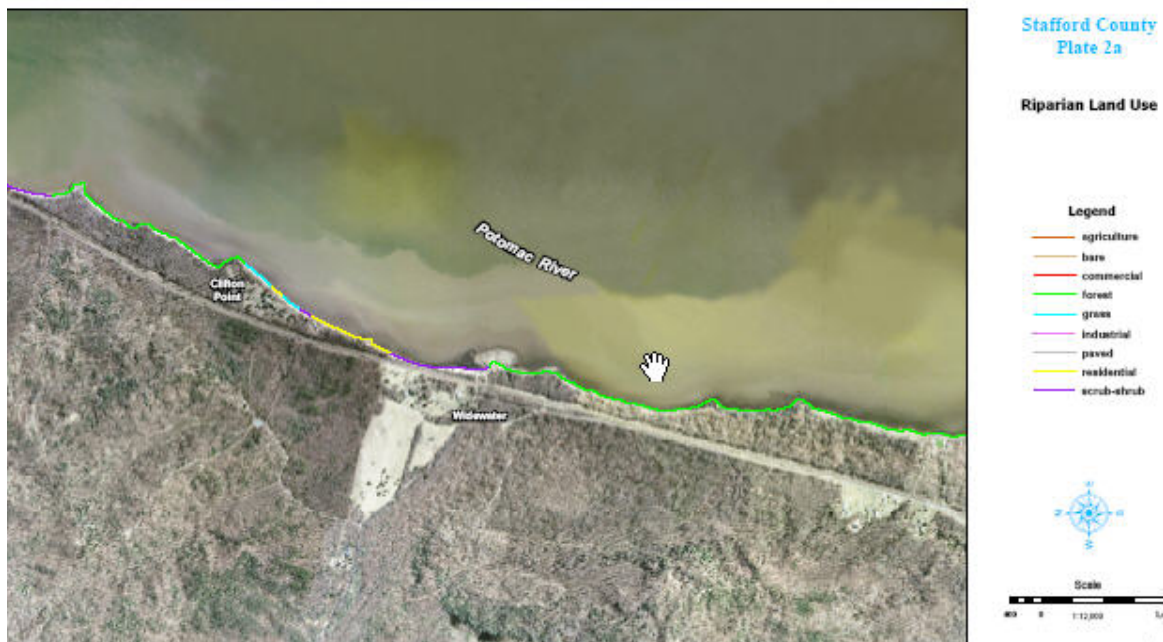
Figure 4. Riparian Land Use map for Stafford County

Plate A describes the riparian land use as color-coded bars along the shore. A legend keys the color to the type of land use. The background imagery is the natural color VBMP imagery at a publication scale of 1:12,000. Users should note that the imagery is sometime rotated in order to meet the scale requirements. This means that “north” is not always to the top of the page.

Once you determine which plate you want, the scroll down menu on the left has links to the three part series for each plate. Riparian Land Use is first (Figure 3). You can scroll down to see the link to Bank and Buffer conditions and Shoreline Features. The content and details of the three part plate series was described in detail in Chapter 2. The actual map will come up when you click on the plate number. For example, Figure 4 is the riparian land use map for plate 2. Figure 5 is the map illustrating Bank and Buffer conditions for plate 2, and Figure 6 shows all the shoreline features for that same area. You may open all three plates for the series, but can view only one at a time in most browsers. Tools for zooming and panning should be on the tool bar. The maps can be printed at full resolution up to 11x17 color. Color printers are necessary. Summary statistics for all data are reported in tables (see link).

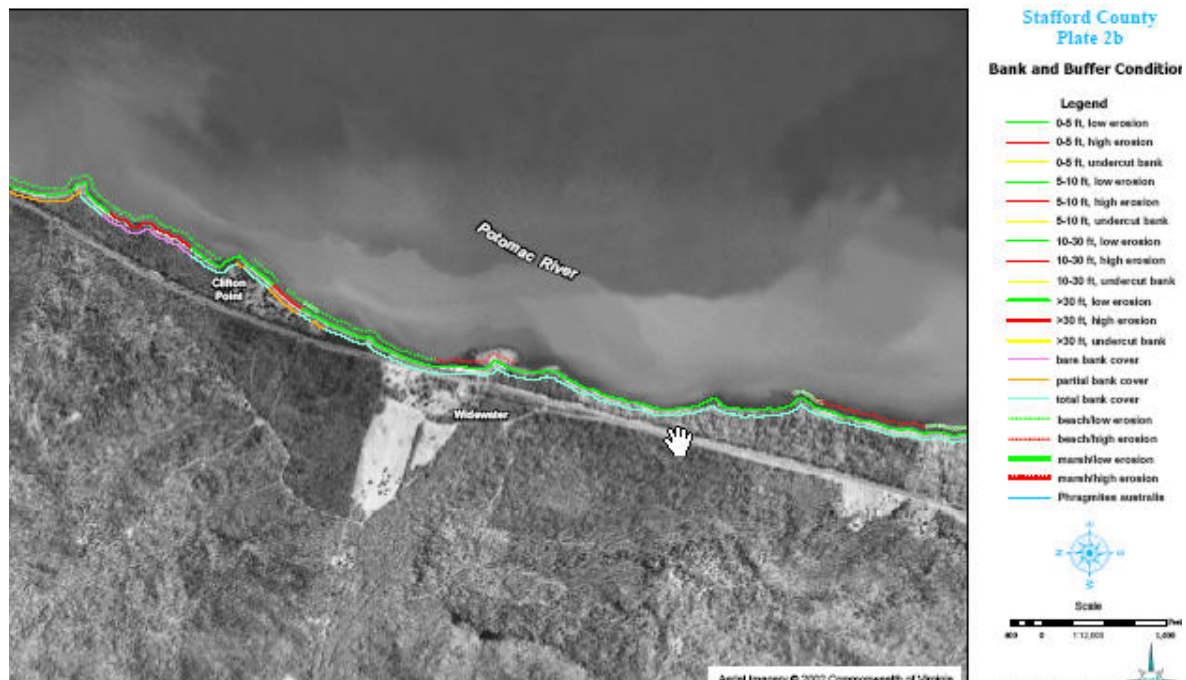
Figure 5. Map illustrating bank and buffer conditions for plate 2 in Stafford County

Plate B depicts the condition of the bank and any natural buffers present. Four lines, and a combination of color and pattern symbology give rise to a vast amount of bank and natural buffer information. The line furthest inland describes the bank cover. Bank cover is distinguished by colors. Bare banks (<25% cover) are illustrated in pale pink, partial cover (25-75%) is pale orange line, and total cover (>75%) is indicated by a pale blue line. Moving toward the water, the next line represents bank height and stability. Bank height varies with the thickness of the line; where the thickest lines designate the highest banks (> 30 feet). A red line indicates the bank is unstable. A green line indicates stability, and a yellow line indicates the bank is undercut. If present a darker blue line will indicate the presence of *Phragmites australis*.

A pattern of small circles just channel ward of the shoreline describes any natural buffers present. Open circles represent a natural fringe marsh along the base of the bank. Solid circles indicate a sand beach buffer at the base of the bank. It is possible to have both. If the buffer exhibits erosion the circles will be red, and green if the buffers are stable. The length of the each of these symbols described along the shore reflects the length alongshore that the features persist. The symbology changes as conditions change. Plate B uses a gray scale version of the natural color VBMP image for the backdrop.

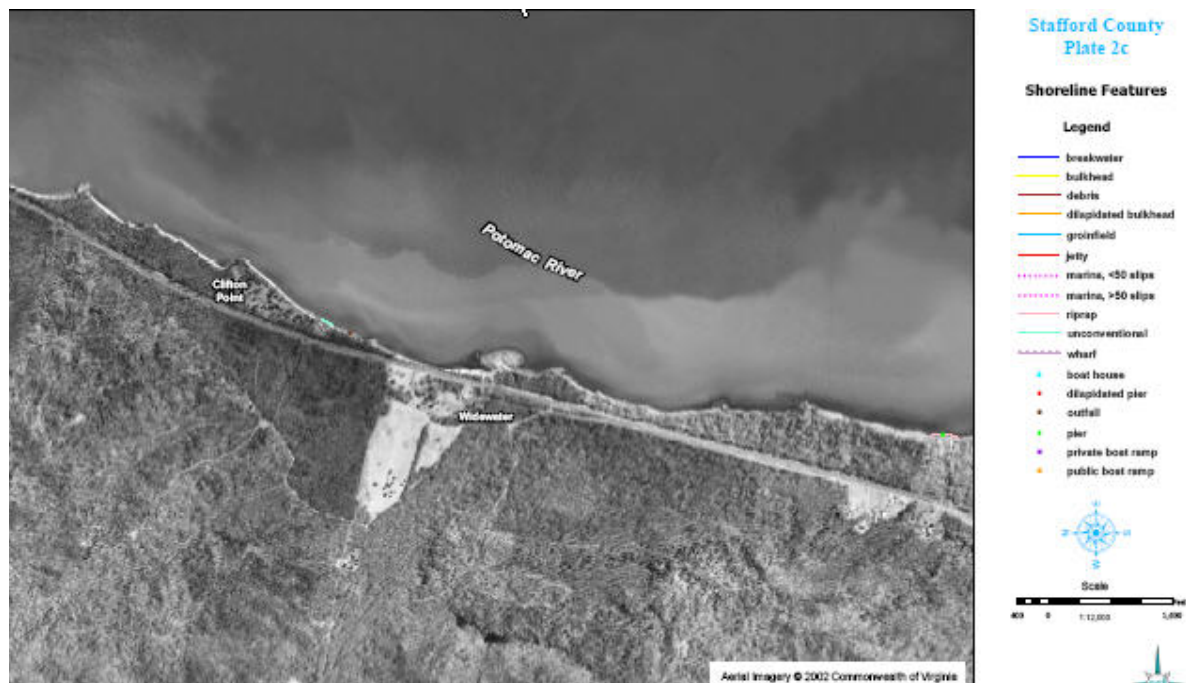
Figure 6. Map illustrating shoreline features for plate 2 in Stafford County

Plate C combines recreational and shoreline protection structures in a composition called Shoreline Features. Linear features, described previously (Table 3), are mapped using color coded bar symbols that follow the orientation of the shoreline. Point features use a combination of colors and symbols to plot the positions on the map. Grey scale VBMP imagery is used as a backdrop, upon which all shoreline feature data are superimposed.
