Henrico County, Virginia Shoreline Inventory Report Methods and Guidelines

**Comprehensive Coastal Inventory Program
Center for Coastal Resources Management
Virginia Institute of Marine Science, College of William and Mary
Gloucester Point, Virginia
October, 2012**

Special report in Applied Marine Science and Ocean Engineering No. 432 of the Virginia Institute of Marine Science

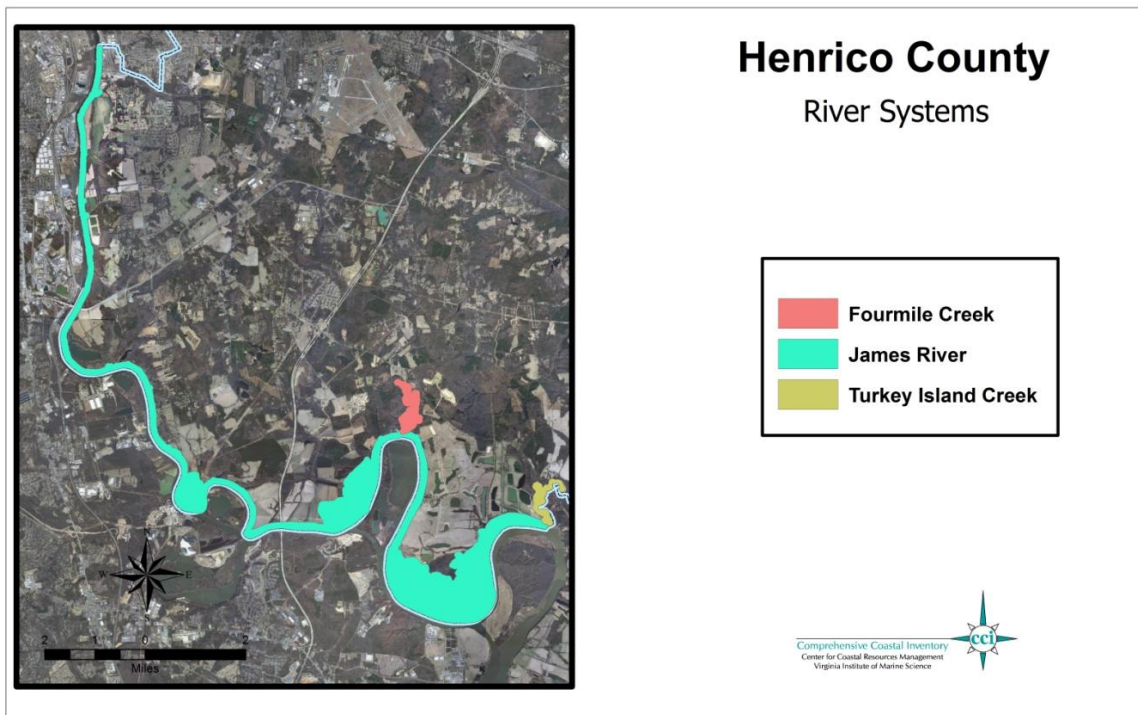
Figure 2. River System in Henrico County

Summary tables quantify conditions observed on the basis of river systems (Figure 2). The total miles surveyed in the field and using remote sensing techniques is reported in Table 4.

The top toolbar also includes tabs to access some important status information for the locality. By clicking on the “River System Pie Charts” button, users can obtain a statistical summary distribution of the riparian land use and amount of hardened shoreline for a specific water body which is selected from the drop down menu in the upper left (Figure 8). More detailed results in table format can be found by clicking the Henrico County Summary PDF button also in the window. The summary statistics are reported by river systems (Figure 2).

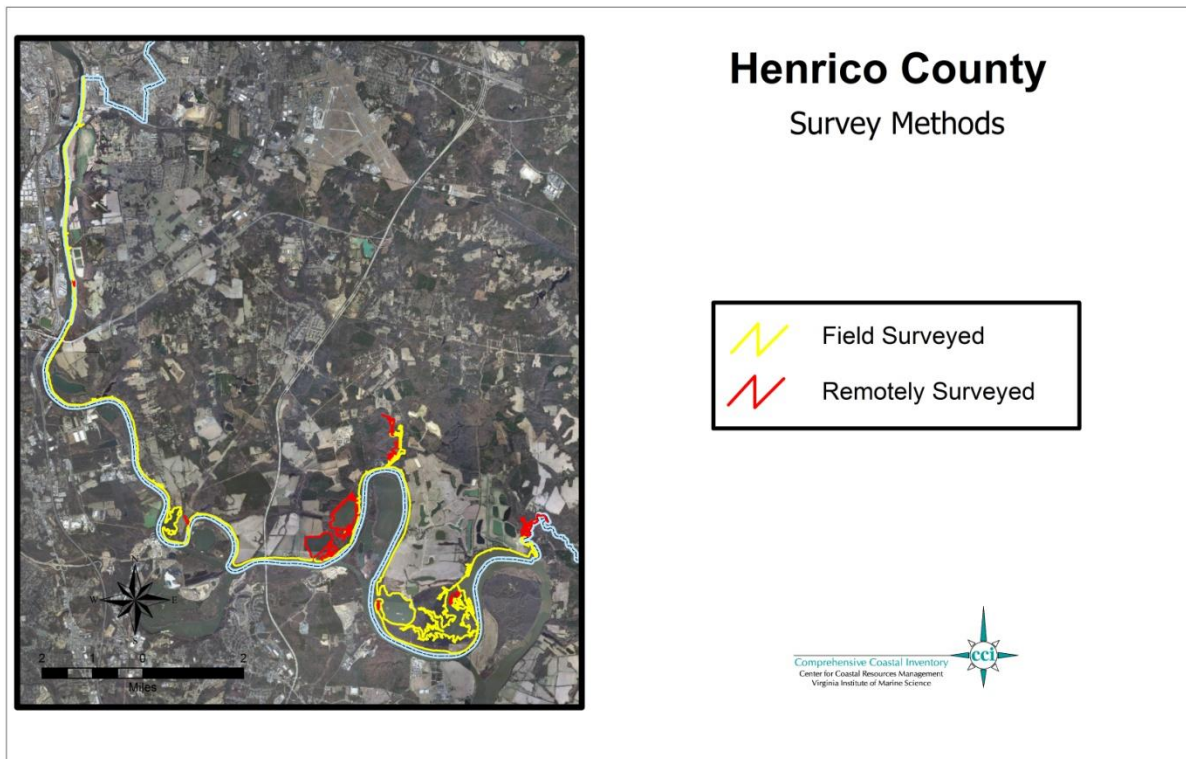
Figure 3. Survey Methodology in Henrico County

In Henrico County, 55 miles of shoreline were surveyed in the field. An additional 18.37 miles of shoreline were surveyed remotely. Remotely sensed areas comprise the small, shallow creeks that have restricted water depths prohibiting access by boat. All these areas are noted in Table 4 along with either survey dates and/or the image year class used for remote coding. Refer to Figure 2 for the location of these rivers. Figure 3 illustrates which rivers have been surveyed in the field and which rivers were coded remotely.

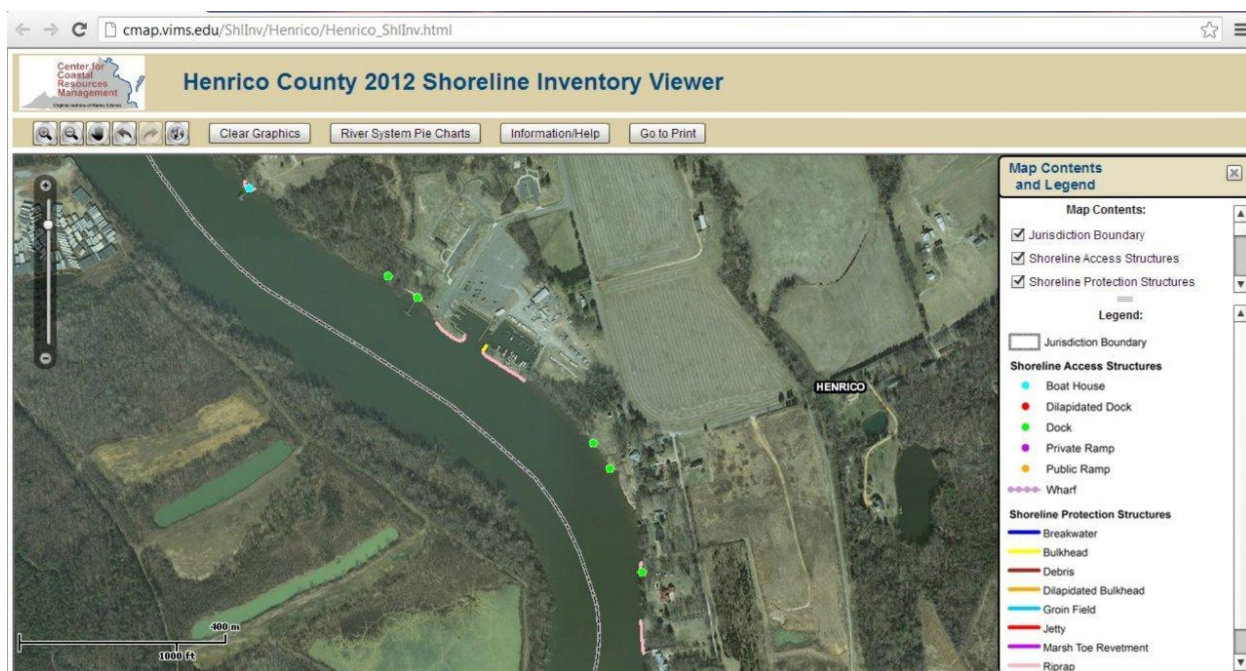
Figure 5. Map Viewer illustrates Shoreline Access and Protection Structures.

In Figure 5 Shoreline Access Structures, and Shoreline Protection structures have been selected along with the boundary. Shoreline Access structures are point features that includes piers and boat ramps. The actual footprint of these structures is not measured; only their location. Shoreline Protection Structures are line features and are mapped and illustrated in the viewer to show where they occur along the shoreline. Figure 6 illustrates riparian land use.
