Charles City County, Virginia Shoreline Inventory Report Methods and Guidelines

**Comprehensive Coastal Inventory Program
Center for Coastal Resources Management
Virginia Institute of Marine Science, College of William and Mary
Gloucester Point, Virginia
October, 2013**

Special report in Applied Marine Science and Ocean Engineering No. 436 of the Virginia Institute of Marine Science

Charles City County - Shoreline Inventory Report

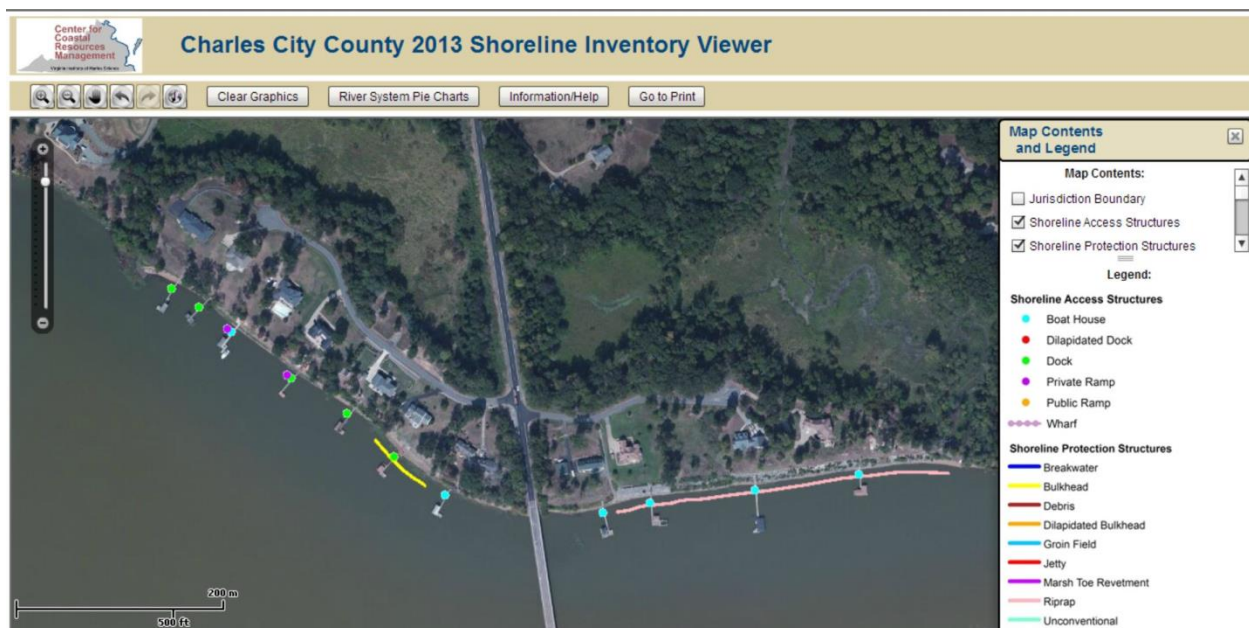
Figure 5. Map Viewer illustrates Shoreline Access and Protection Structures.

In Figure 5 Shoreline Access Structures, and Shoreline Protection structures have been selected along with the boundary. Shoreline Access structures are point features that includes piers and boat ramps. The actual footprint of these structures is not measured; only their location. Shoreline Protection Structures are line features and are mapped and illustrated in the viewer to show where they occur along the shoreline. Figure 6 illustrates riparian land use.
