New Kent County, Virginia Shoreline Inventory Report Methods and Guidelines

Special report in Applied Marine Science and Ocean Engineering No. 406 of the Virginia Institute of Marine Science

New Kent County- Shoreline Inventory Report

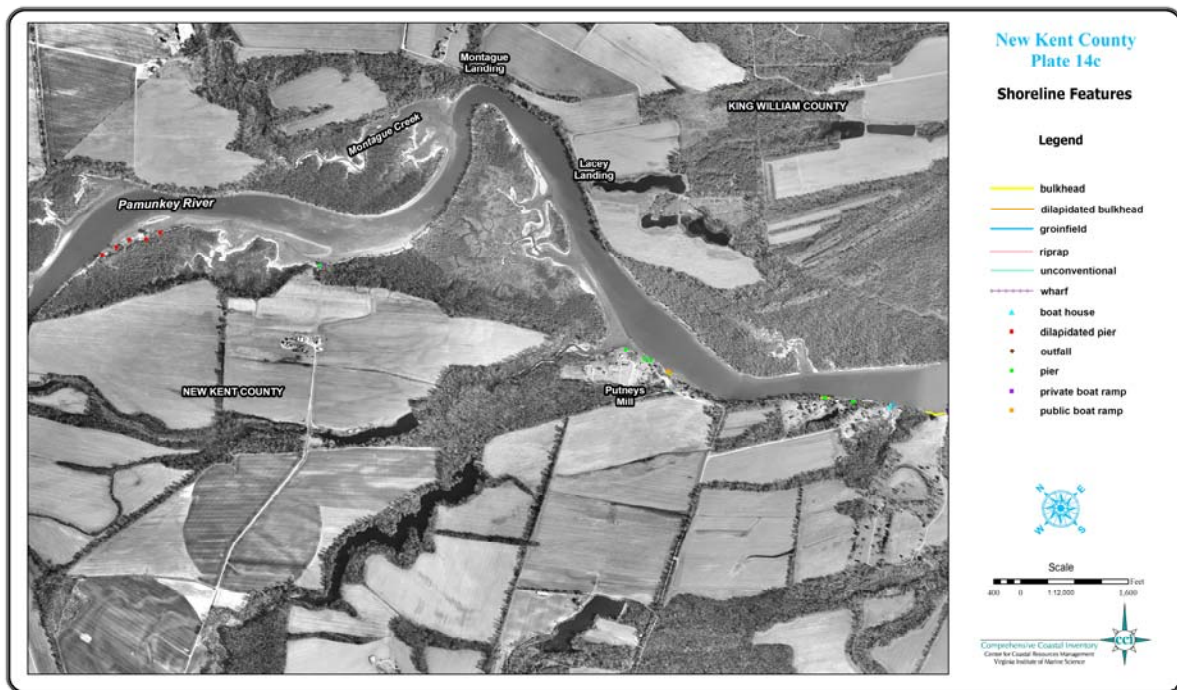
Figure 6. Map illustrating shoreline features for plate 14 in New Kent County

Plate C combines recreational and shoreline protection structures in a composition called Shoreline Features. Linear features, described previously (Table 3), are mapped using color coded bar symbols that follow the orientation of the shoreline. Point features use a combination

of colors and symbols to plot the positions on the map. Gray scale imagery is used as a backdrop.
