City of Suffolk, Virginia Shoreline Inventory Report Methods and Guidelines

**Comprehensive Coastal Inventory Program
Center for Coastal Resources Management
Virginia Institute of Marine Science, College of William and Mary
Gloucester Point, Virginia
October, 2013**

Special report in Applied Marine Science and Ocean Engineering No. 437 of the Virginia Institute of Marine Science

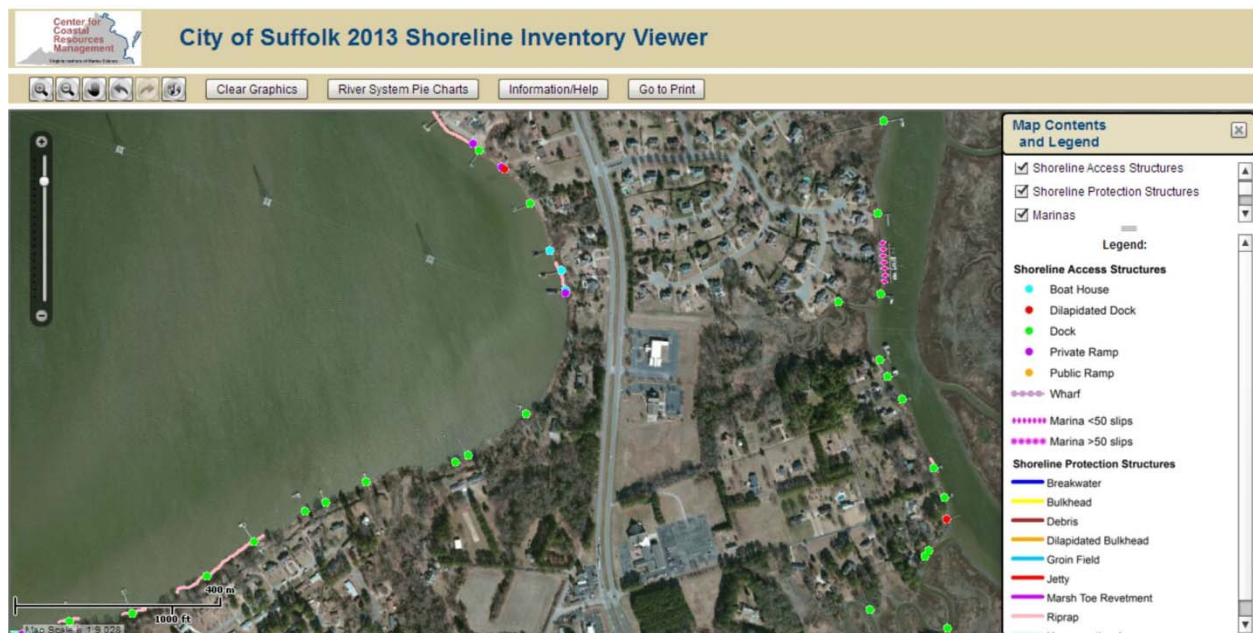
Figure 5. Map Viewer illustrates Shoreline Access and Protection Structures.

In Figure 5 Shoreline Access Structures, and Shoreline Protection structures have been selected along with the boundary. Shoreline Access structures are point features that includes piers and boat ramps. The actual footprint of these structures is not measured; only their location. Shoreline Protection Structures are line features and are mapped and illustrated in the viewer to show where they occur along the shoreline. Figure 6 illustrates riparian land use.

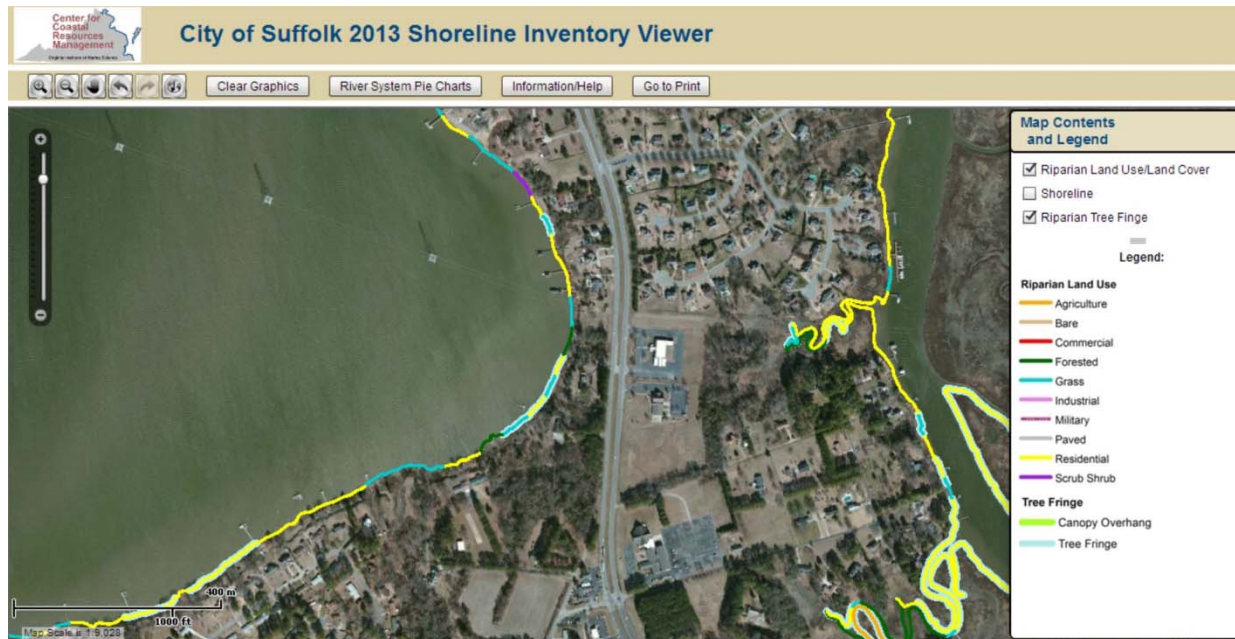
Figure 6. Distribution of land use in the riparian zone is displayed for this region of the City.
