Rehoboth Bay, Delaware Shoreline Inventory Report Methods and Guidelines

Special report in Applied Marine Science and Ocean Engineering No. 435 of the Virginia Institute of Marine Science

Rehoboth Bay- Shoreline Inventory Report

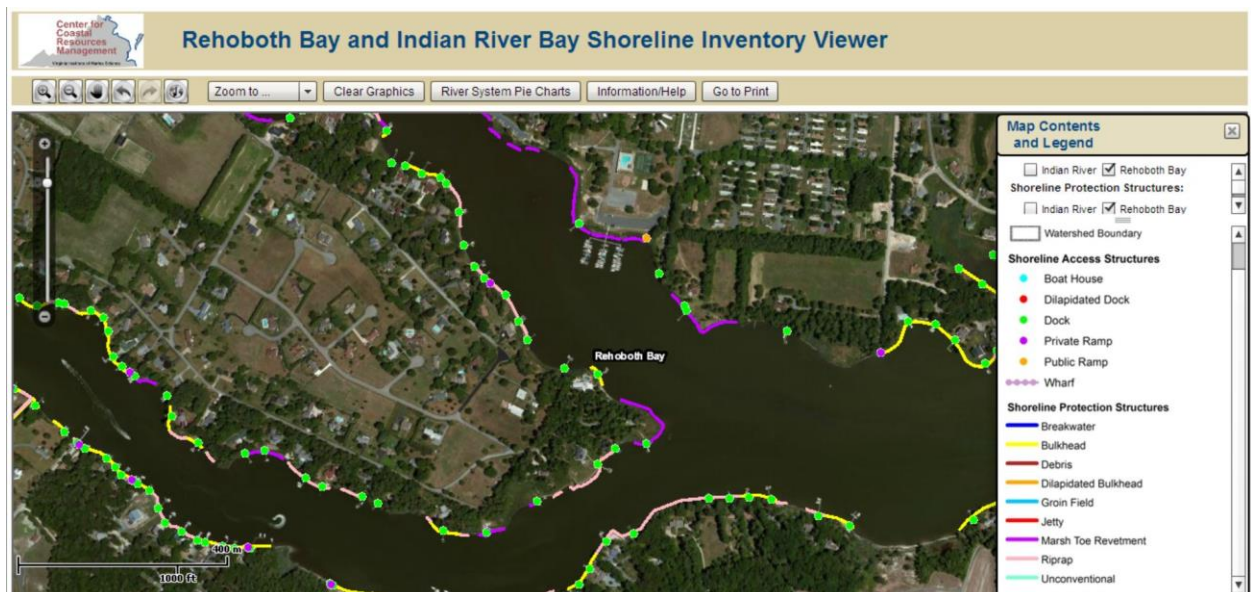
Figure 5. Map Viewer illustrates Shoreline Access and Shoreline Protection Structures.

In Figure 5 Shoreline Access Structures, and Shoreline Protection structures have been selected along with the boundary. Shoreline Access structures are point features that includes

piers and boat ramps. The actual footprint of these structures is not measured; only their location. Shoreline Protection Structures are line features and are mapped and illustrated in the viewer to show where they occur along the shoreline. Figure 6 illustrates riparian land use.
