Mathews County, Virginia Shoreline Inventory Report Methods and Guidelines

**Comprehensive Coastal Inventory Program
Center for Coastal Resources Management
Virginia Institute of Marine Science, College of William and Mary
Gloucester Point, Virginia
May, 2009**

Special report in Applied Marine Science and Ocean Engineering No. 411 of the Virginia Institute of Marine Science

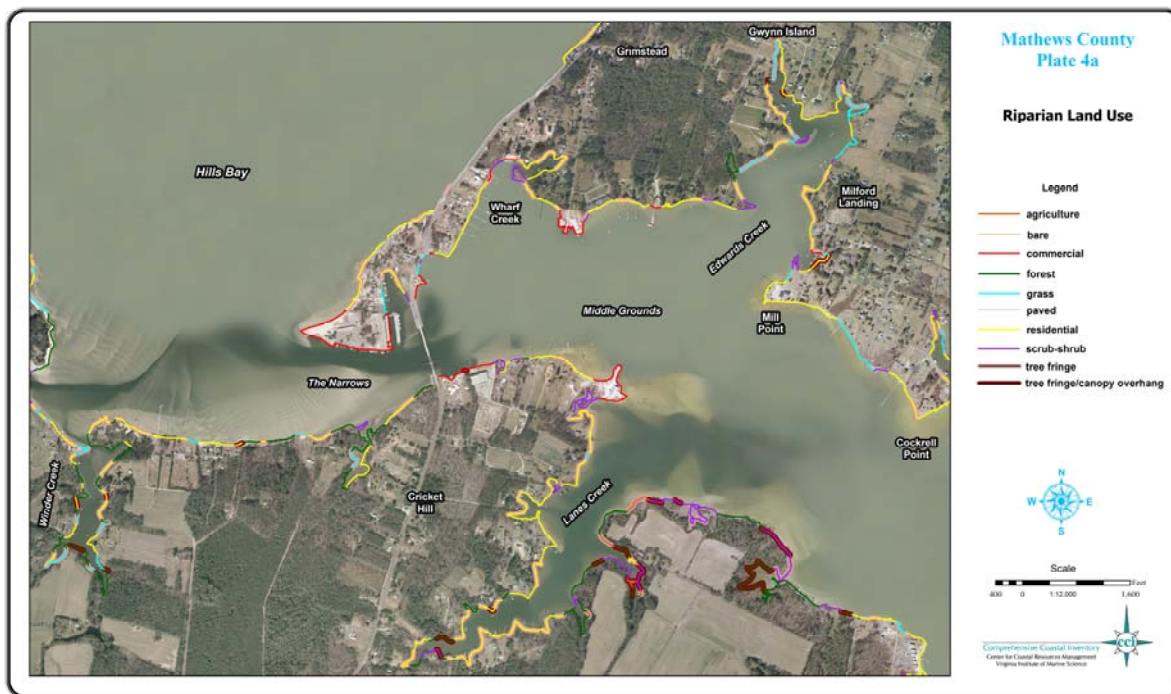
Figure 4. Sample riparian land use map for the County of Mathews

Plate A describes the riparian land use as color-coded bars along the shore. If the line is highlighted underneath with pale pink, there is tree fringe on site. If the line is highlighted underneath with brown, there is tree fringe with canopy overhang. The background imagery is natural color VBMP imagery at a publication scale of 1:12,000. Users should note that the imagery is sometime rotated in order to meet the scale requirements. This means that “north” is not always to the top of the page.

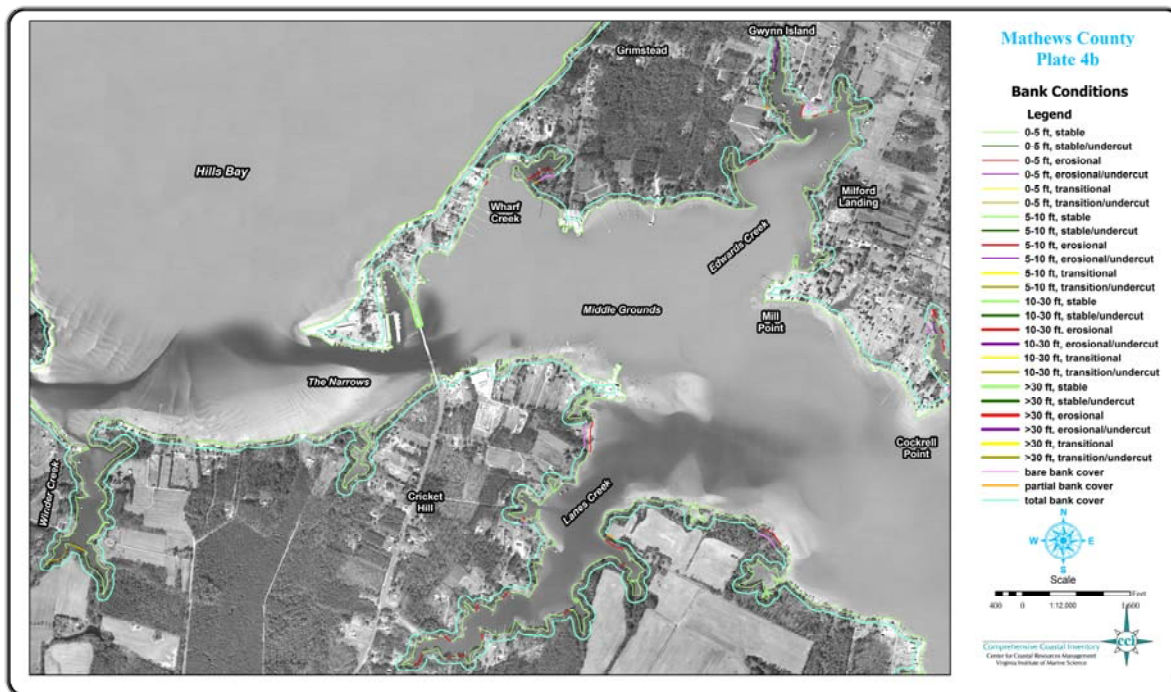
Figure 5. Map illustrating bank conditions for plate 4 in the County of Mathews

Plate B depicts the condition of the bank; specifically bank stability and bank height. The colors light green, red and yellow are used to report if the bank is stable, erosional, or transitional, respectively. If each of these conditions occurs with undercutting at the base of the

bank, the colors become, dark green, fuchsia, olive green, respectively. The thickness of the line reflects the bank height; where the thickest lines designate the highest banks (> 30 feet). Plate B uses a grey scale version of the natural color image for the backdrop.

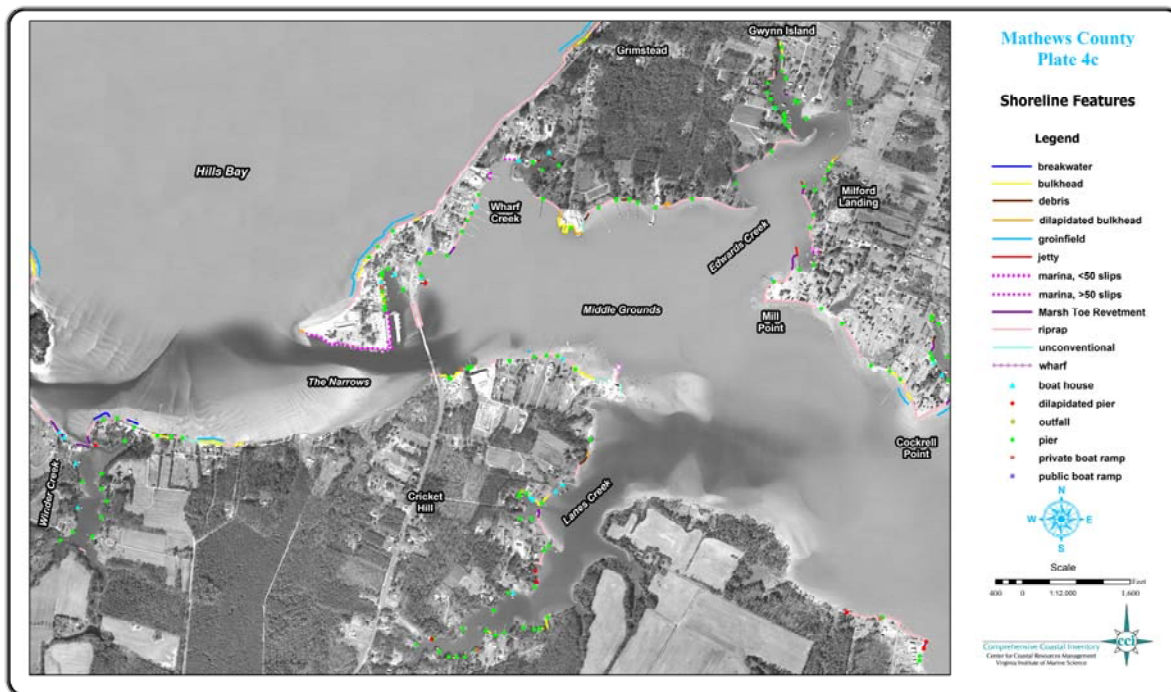
Figure 6. Map illustrating shoreline features for plate 4 in the County of Mathews

Plate C combines recreational and shoreline protection structures in a composition called Shoreline Features. These are generally anthropogenic alterations constructed to gain access to the water or to stabilize a shoreline from existing and future bank erosion. Linear features, described previously (Table 3), are mapped using color coded bar symbols that follow the orientation of the shoreline. Point features use a combination of colors and symbols to plot the positions on the map. Gray scale imagery is used as a backdrop.

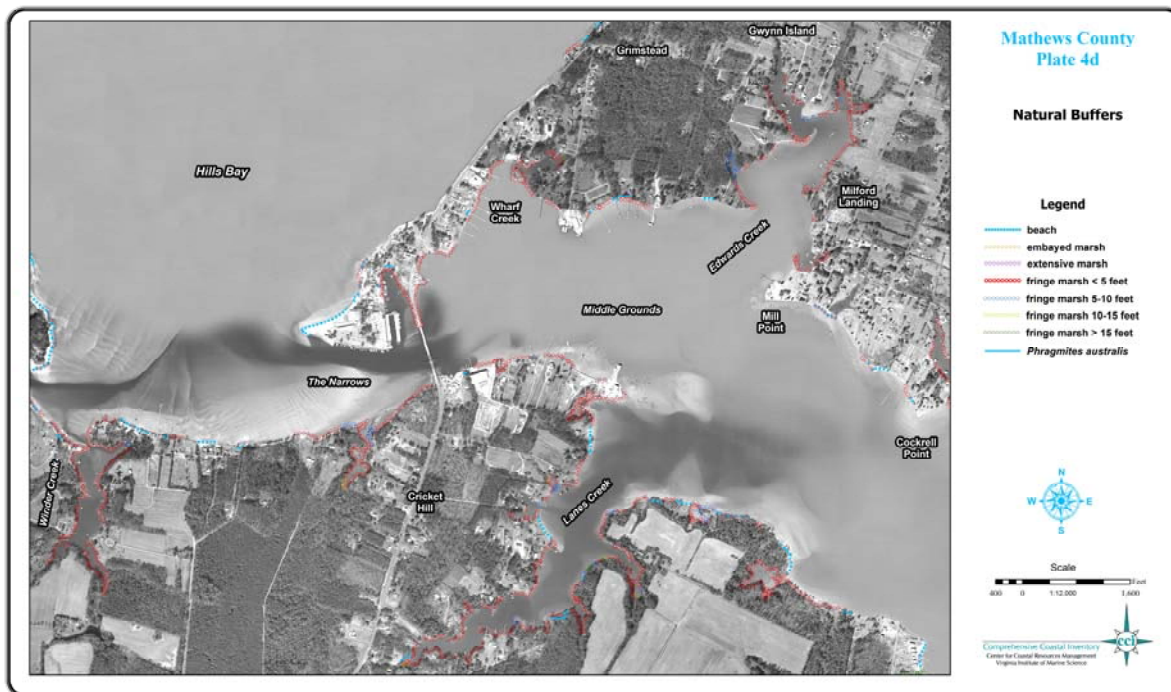
Figure 7. Map illustrating natural buffers for plate 4 in the County of Mathews

On Plate D a pattern of small colored circles along the shoreline describes any natural buffers present. These are limited to marshes and beaches. Orange open circles represent embayed marshes. Purple open circles are extensive marshes. Red open circles indicate the presence of fringe marshes that are less than 5 feet in width. Dark blue open circles represent fringe marshes that are 5-10 feet in width. Fringe marshes 10-15 wide are depicted with light green open circles. If the fringe marsh is greater than 15 feet the open circles will be dark green. The invasive species *Phragmites australis* is designated with blue line shown behind the shoreline. Beaches, if present are delineated with solid blue balls.

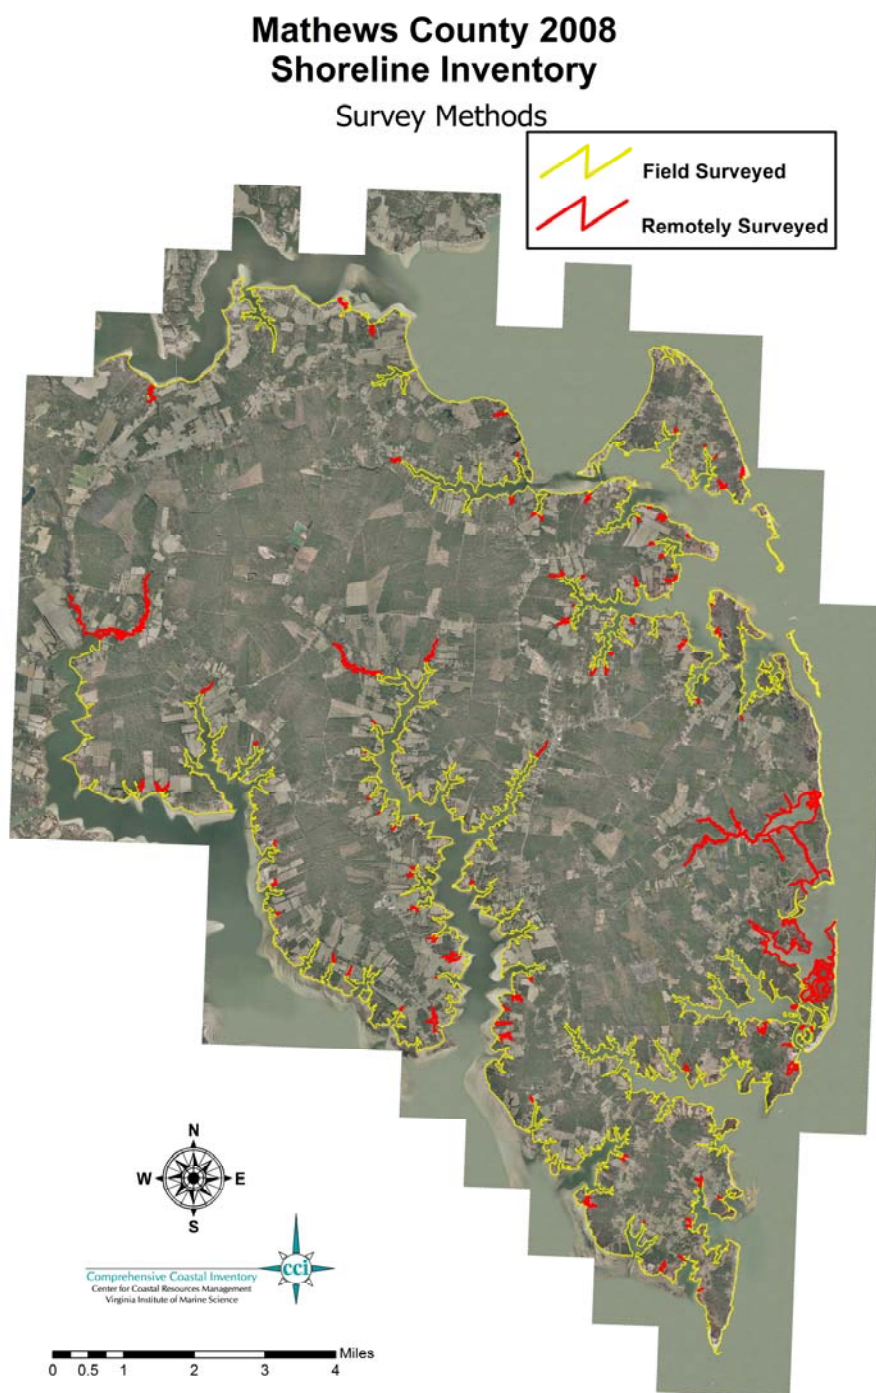
Figure 8. Mathews County Index Map for Remotely Coded Areas

For the 61.60 miles of remotely coded shoreline, an index is provided that identifies where these areas are (Figure 8). Along these areas, photo interpretation of the 2007 VBMP imagery occurred to detect land use, natural buffers, and shoreline structures where possible. Since most shoreline that could not be accessed by boat occurs in well protected, low fetch environments, the remote coding assumes that upland banks are well protected by vegetation, and erosion is low. It is possible, however, for these banks to experience undercutting from tidal currents. This cannot be verified since field visits were not performed. Bank height conditions along reaches characterized using remote sensing techniques were estimated from USGS 1:24,000 topographic maps.
