York County, Virginia Shoreline Inventory Report Methods and Guidelines

**Comprehensive Coastal Inventory Program
Center for Coastal Resources Management
Virginia Institute of Marine Science, College of William and Mary
Gloucester Point, Virginia
November, 2013**

Special report in Applied Marine Science and Ocean Engineering No. 439 of the Virginia Institute of Marine Science

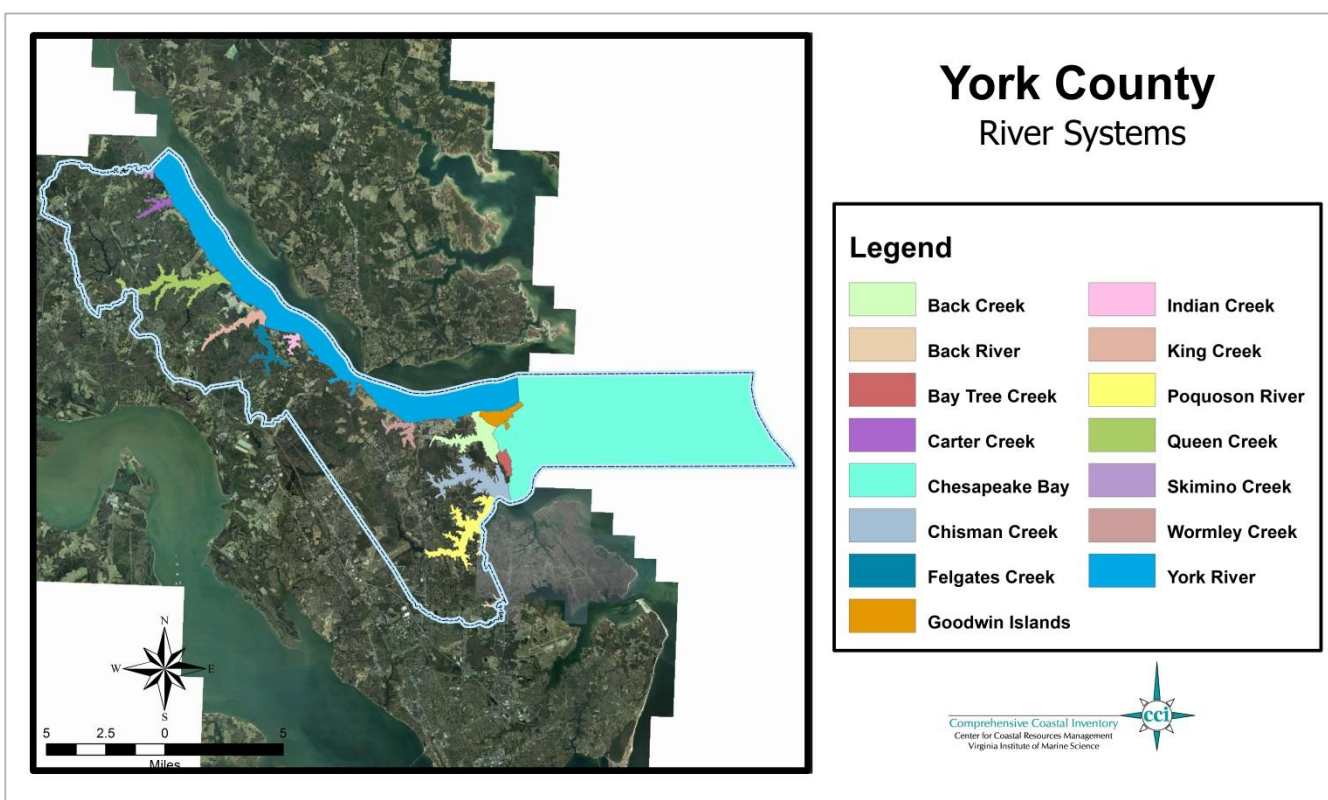
Figure 2. River Systems in York County

Summary tables (Tables 4-8) quantify conditions observed on the basis of river systems (Figure 2). In York County, 223.50 miles of shoreline were remotely updated. All these areas

are noted in Table 4 along with the original survey field dates. Refer to Figure 2 for the location of these rivers systems.

The top toolbar also includes tabs to access some important status information for the locality. By clicking on the “River System Pie Charts” button, users can obtain a statistical summary distribution of the riparian land use and amount of hardened shoreline for a specific water body which is selected from the drop down menu in the upper left (Figure 7). More detailed results in table format can be found by clicking the York County Summary PDF button also in the window. The summary statistics are reported by river systems (Figure 2).

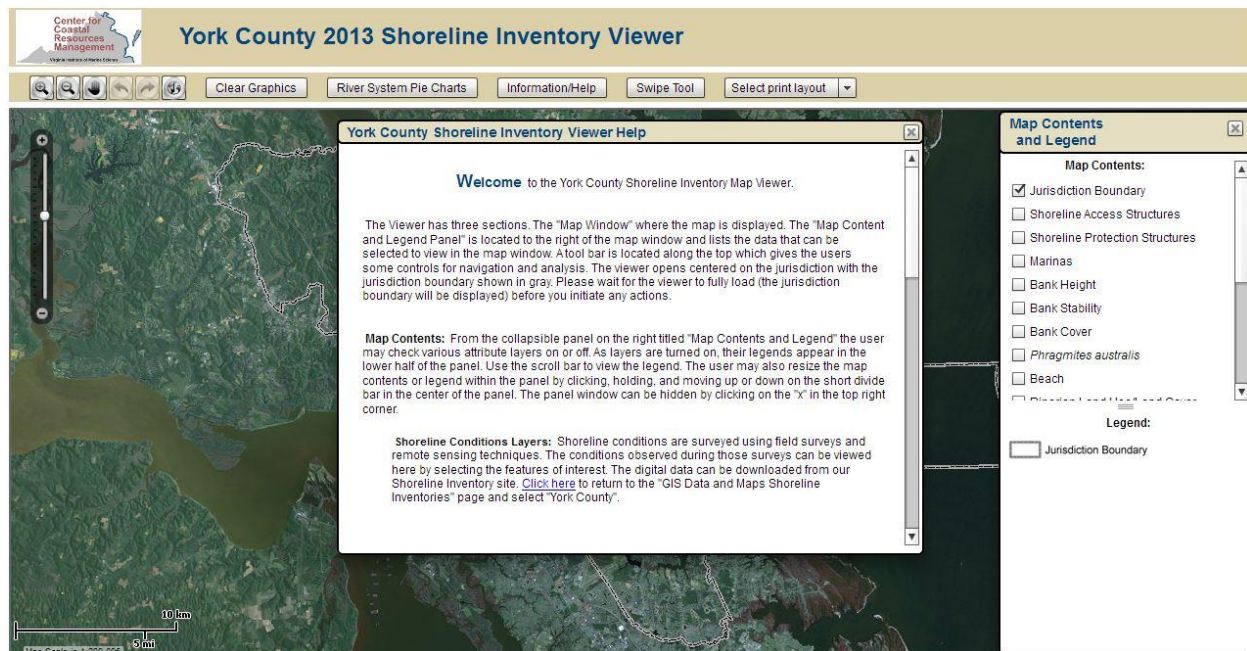
Figure 3. Opening page for the York County Shoreline Inventory Viewer

The Viewer has two panels: “Map Window”, where the map is displayed and “Map Contents and Legend”, where data that can be selected and viewed in the map window are listed. A tool bar is located along the top of the “Map Window” which gives users some controls for navigation and analysis (Figure 3.).

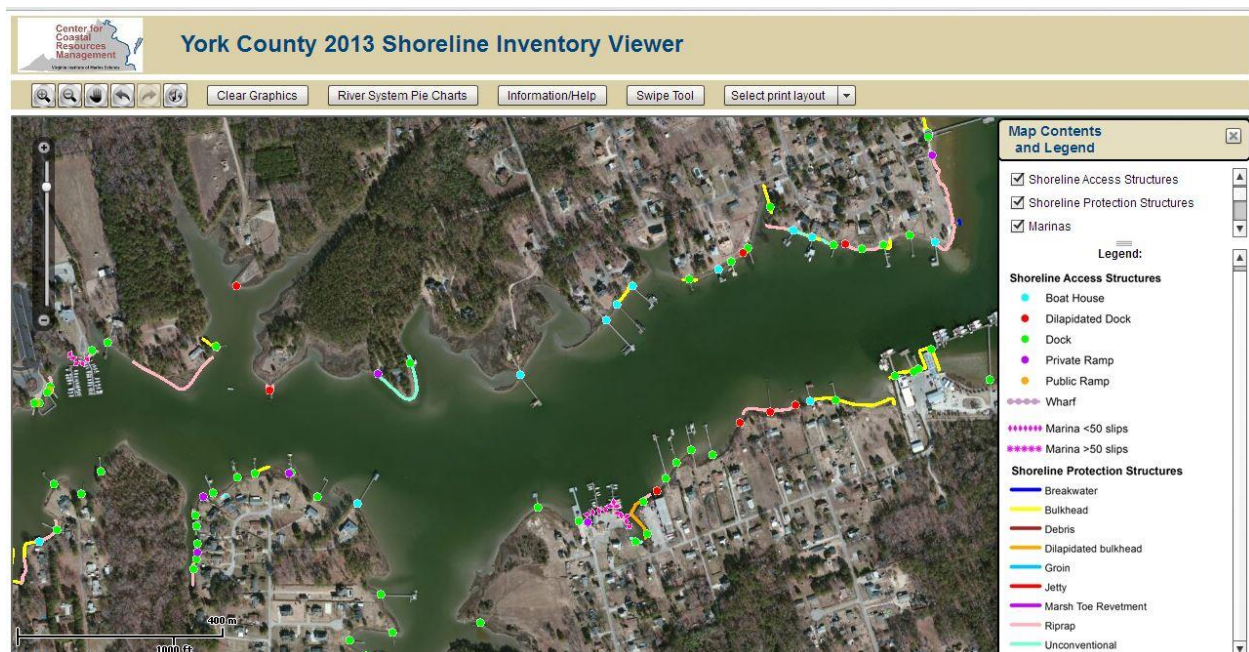
Figure 4. Map Viewer illustrates Shoreline Access and Protection Structures.

From the “Map Contents and Legend” the user may check various attribute layers on or off. The user must use the scroll bar on the far right to see the complete list of attributes available. When layers are turned on, the corresponding legend appears in the lower half of the panel, and the data are displayed in the “Map Window” (Figure 4).

In Figure 4 Shoreline Access Structures, and Shoreline Protection structures are selected along with the boundary. Shoreline Access structures are point features that includes piers and boat ramps. The actual footprint of these structures is not measured; only their location. Shoreline Protection Structures are line features and are mapped and illustrated in the viewer to show where they occur along the shoreline. Figure5 illustrates riparian land use.

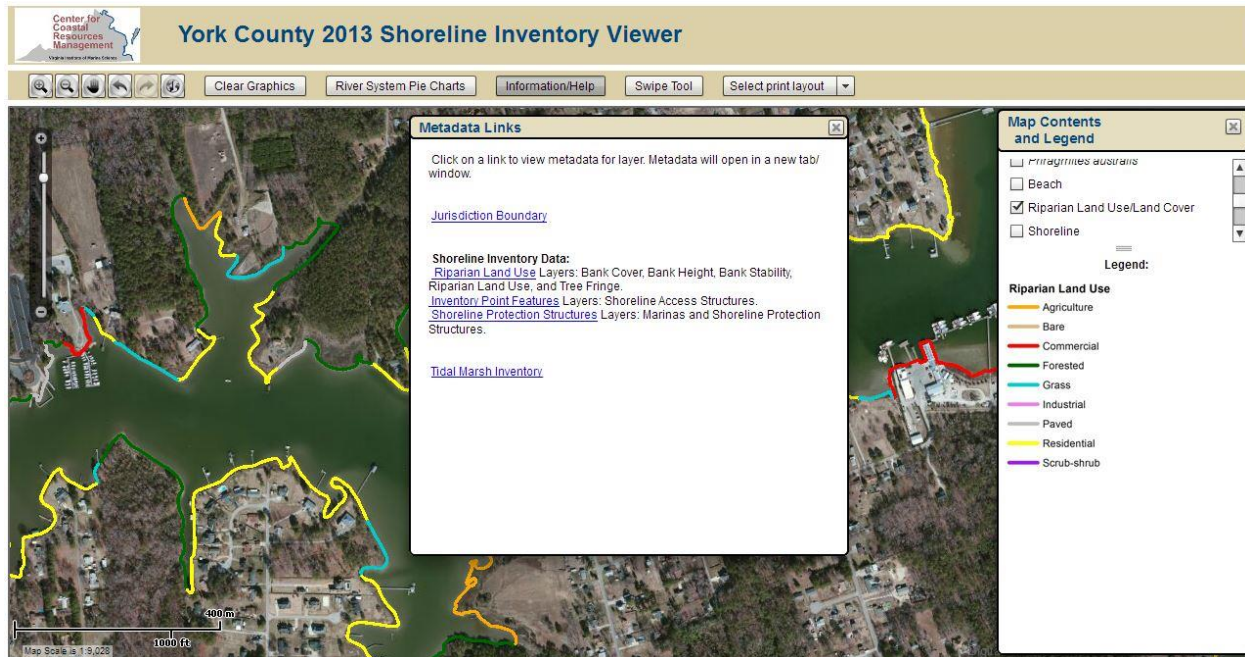
Figure 6. Link to Metadata records has been selected from the top Information tab in the toolbar.

The user can use the zoom and pan tools from the top toolbar or the slide bar on the left side of the map window to change their map extent. If the map resolution is exceeded the window will become illegible. Detailed information can be obtained about the data by selecting the “Information/Help” tab at the top of the map viewer. From here the inventory glossary and metadata records can be easily accessed. In Figure 6 the selection for metadata has been made and 5 possible records can be retrieved.

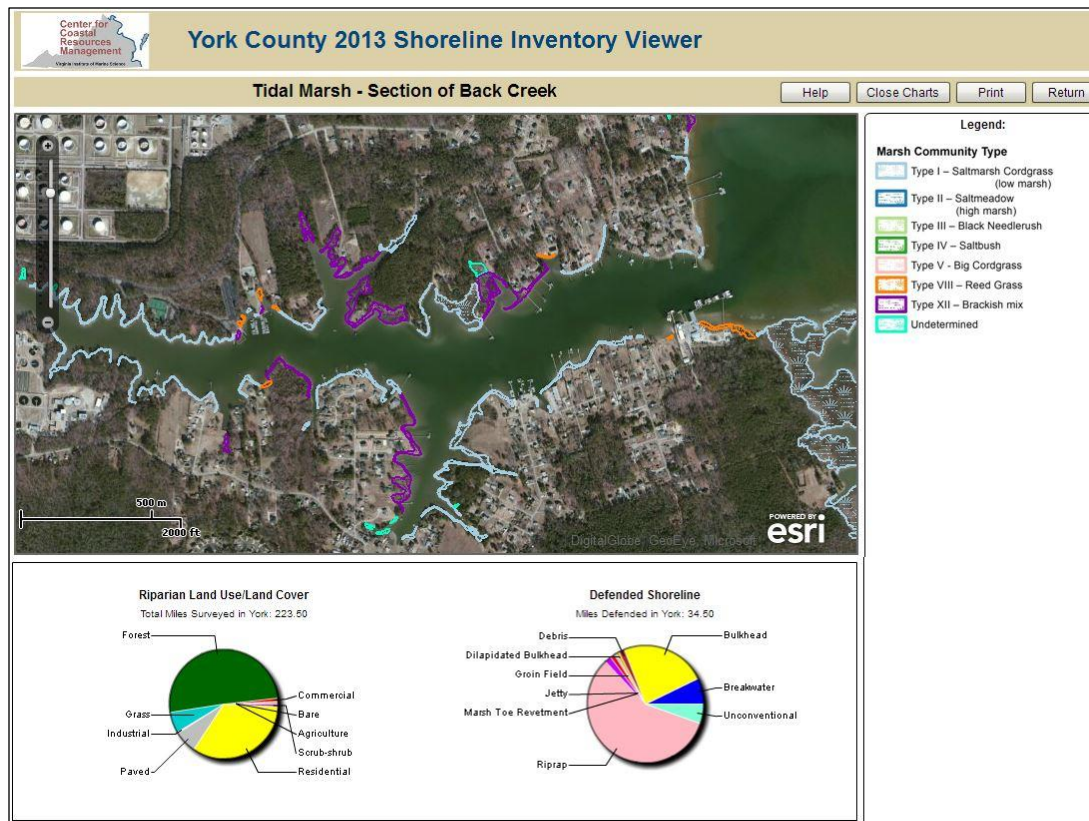
Figure 8. Customized print window for a section of Back Creek.

Finally, users have the option to personalize their own maps (i.e. map extent, data displayed, map title, etc) and print them by clicking “Go to Print” button. The map legend and the charts display below the map. The page can be set up for printing to 8.5 x 11 portrait or landscape style. Figure 8 is an example of a customized map generated for a section of the Back Creek. Here the tidal marsh communities are displayed, and the community type is reported in the legend beside the illustration. Also illustrated are the summary pie charts showing land use and shoreline hardening along the entire County.
