# Home Safety Improvement Report

*Date: April 27, 2025*

## Fall Prevention Home Safety Report

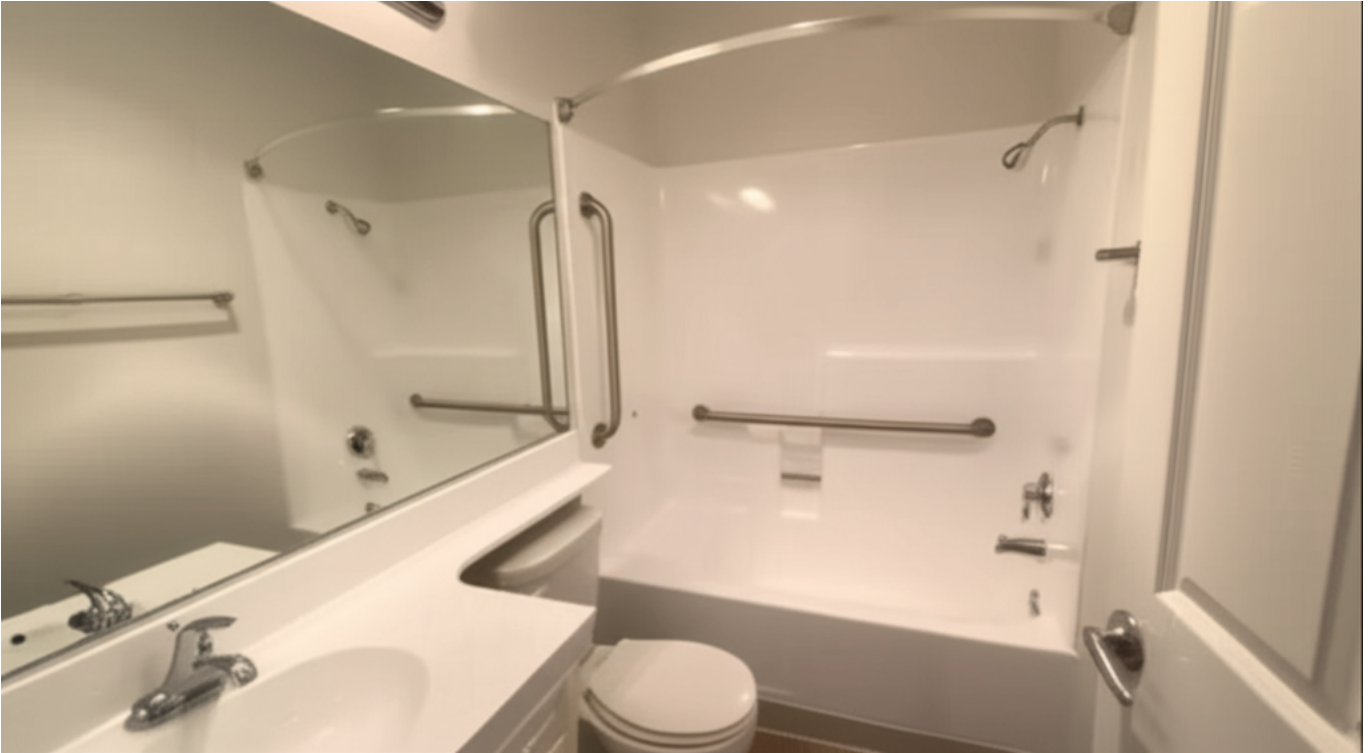
The high tub wall presents a significant fall risk during entry and exit for someone with mobility and balance issues. Grab bars provide crucial support points for stabilization, reducing the likelihood of slips and falls, aligning with fall prevention best practices.

Install multiple grab bars in the tub/shower area: one vertical bar near the entry on the side wall, and one horizontal bar along the back wall. Consider an additional angled bar on the control wall if space allows.

Requires locating wall studs or using appropriate heavy-duty wall anchors. Bars are securely screwed into the wall structure. Professional installation recommended to ensure proper weight-bearing capacity.

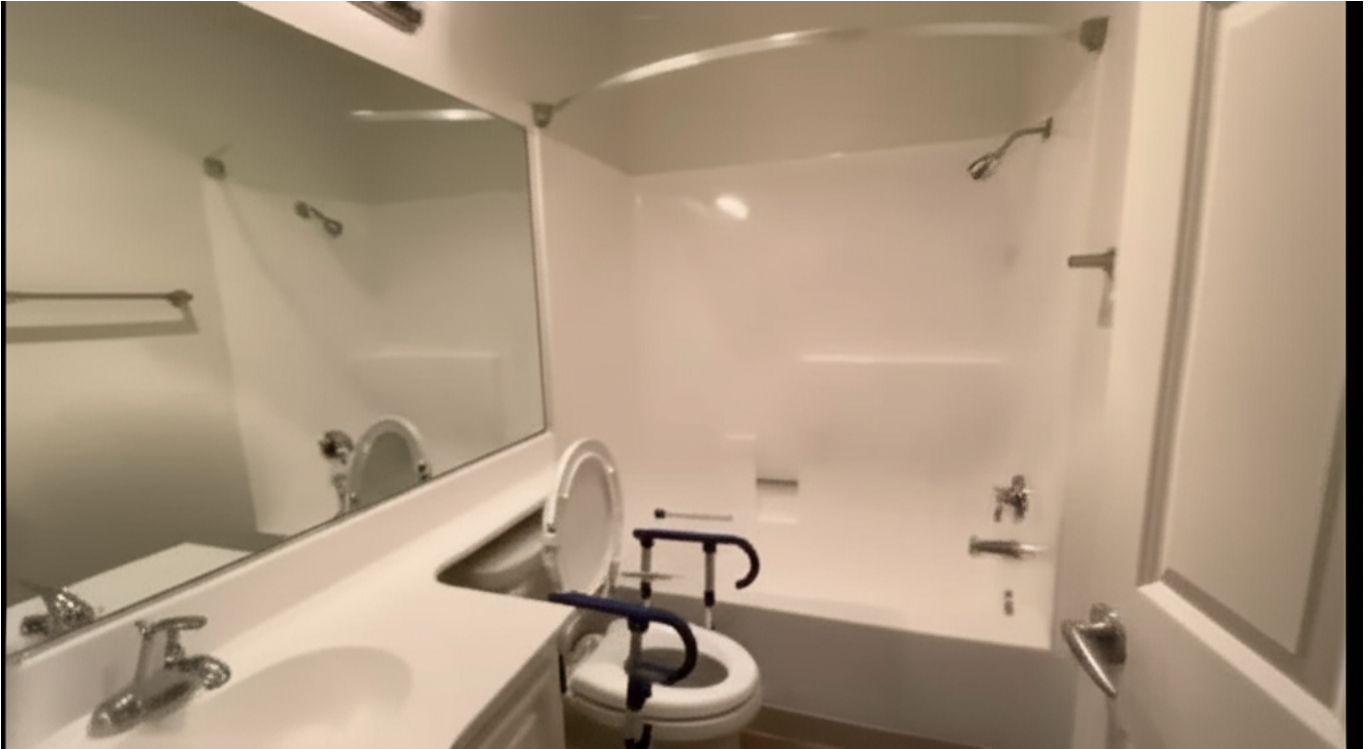
A standard height toilet can be difficult to sit down on and stand up from for individuals with reduced leg strength, mobility limitations, or balance problems. A taller toilet reduces the distance and effort required, making transfers safer and easier, conserving energy, and decreasing fall risk during toileting.

Replace the standard height toilet with an ADA-compliant 'comfort height' toilet (typically 17-19 inches high from floor to seat) OR add a raised toilet seat with integrated armrests to the existing toilet.

Replacing the toilet involves shutting off water, draining, removing the old toilet, setting a new wax ring, installing the new toilet, and reconnecting the water supply. A raised seat simply clamps onto the existing bowl. Adding grab bars (separate suggestion, but often done concurrently) involves

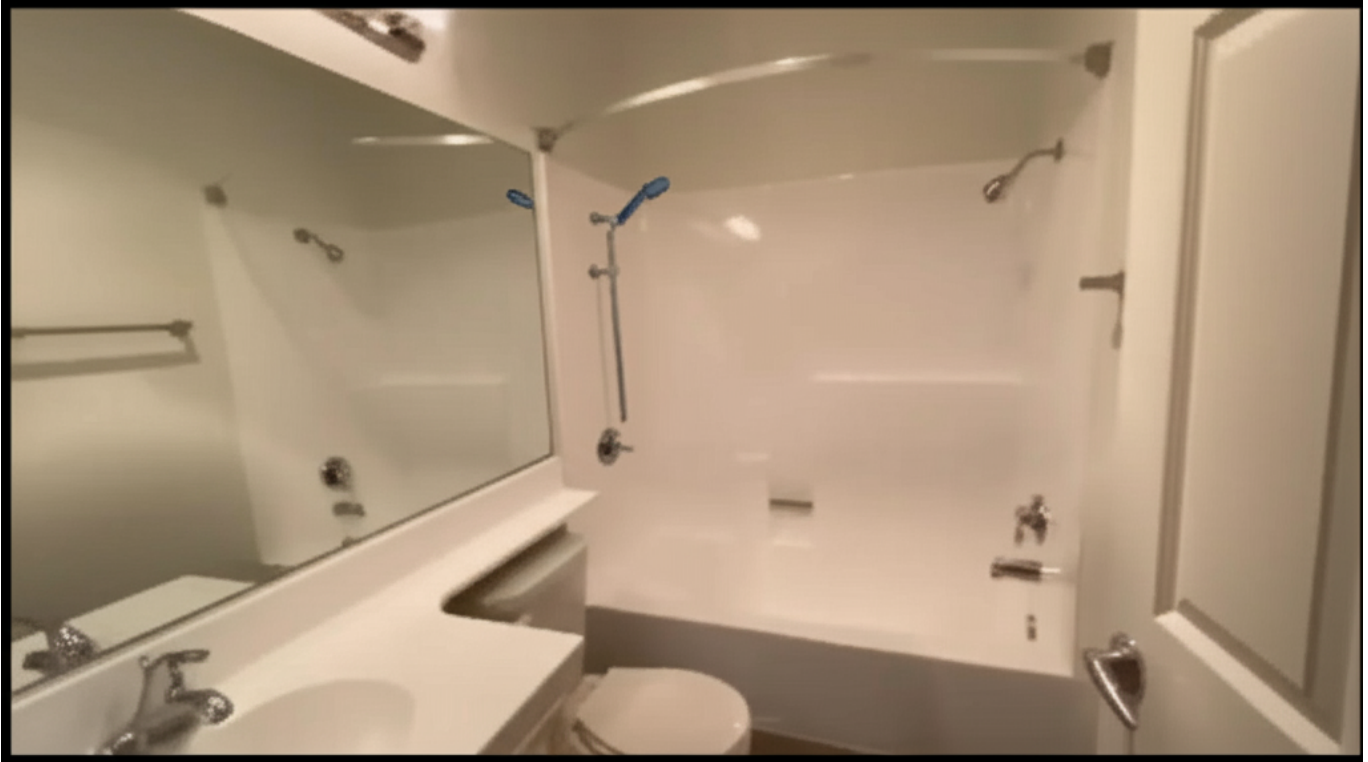
A handheld shower head allows the user to direct water flow while seated or standing, accommodating varying mobility levels and improving bathing independence and thoroughness. The adjustable bar allows positioning for different heights. An anti-scald valve prevents burns, crucial for those who may have slower reaction times or difficulty adjusting controls quickly.

Replace the fixed shower head with a handheld shower head mounted on an adjustable vertical slide bar. Ensure the controls incorporate an anti-scald valve.

Typically involves unscrewing the old shower head/arm and screwing in the new slide bar and handheld unit components. May require minor plumbing adjustments depending on existing connections. Anti-scald valve installation is more involved, often requiring plumber access behind the wall.
