DTC	B0138/72	Short in P/T Squib (LH) Circuit (to B+)
-----	----------	---

CIRCUIT DESCRIPTION

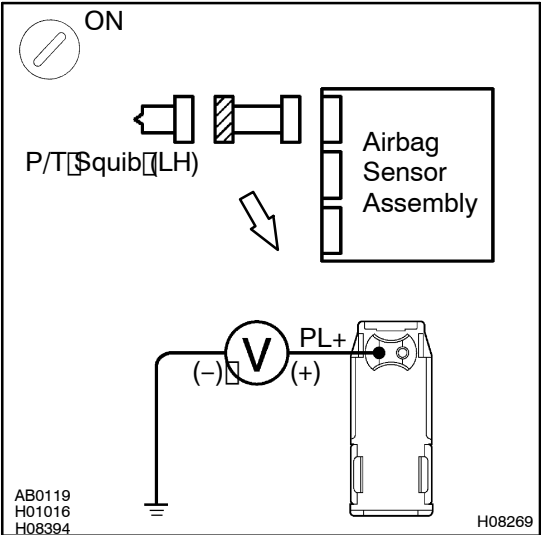
2	Check P/T squib (LH) circuit.
---	-------------------------------

- (a) Turn the ignition switch to ON.
- (b) For the connector (on the seat belt pretensioner side) between the seat belt pretensioner (LH) and the airbag sensor assembly, measure the voltage between PL+ and body ground.

Voltage: 0 V

Repair or replace harness or connector between seat belt pretensioner (LH) and airbag sensor assembly.

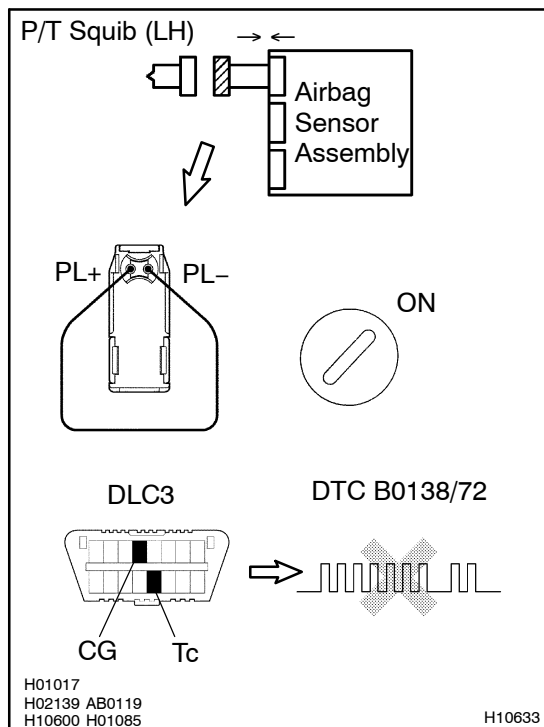
3 Check airbag sensor assembly.

- Connect the connector to the airbag sensor assembly.
- Using a service wire, connect PL+ and PL- of the connector (on the seat belt pretensioner side) between the seat belt pretensioner (LH) and the airbag sensor assembly.
- Connect negative (-) terminal cable to the battery, and wait at least for 2 seconds.

- Turn the ignition switch to ON and wait at least for 20 seconds.
- Clear the DTC stored in memory (See step 5 on [page DI-369](#)).
- Turn the ignition switch to LOCK, and wait at least for 20 seconds.
- Turn the ignition switch to ON, and wait at least for 20 seconds.
- Check the DTC (See [page DI-369](#)).

DTC B0138/72 is not output.

Replace airbag sensor assembly.

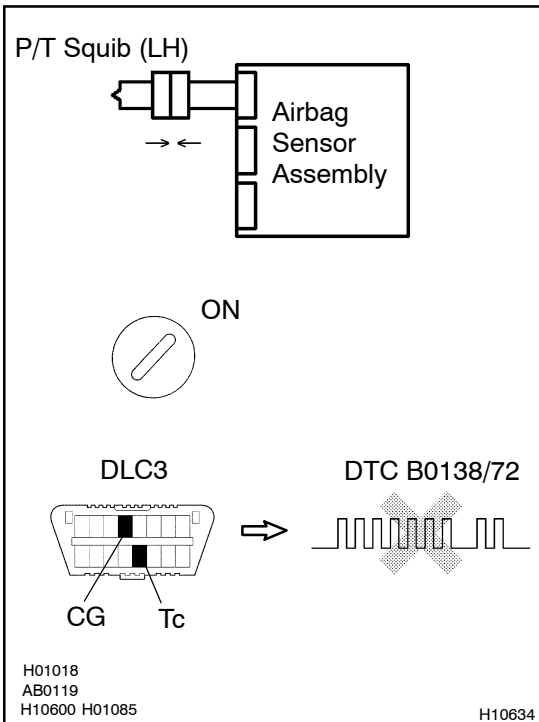
4 Check P/T squib (LH).

- Turn the ignition switch to LOCK.
- Disconnect negative (-) terminal cable from the battery, and wait at least for 90 seconds.
- Connect the seat belt pretensioner (LH) connector.
- Connect negative (-) terminal cable to the battery, and wait at least for 2 seconds.

- Turn the ignition switch to ON, and wait at least for 20 seconds.
- Clear the DTC stored in memory (See step 5 on page DI-369).
- Turn the ignition switch to LOCK, and wait at least for 20 seconds.
- Turn the ignition switch to ON, and wait at least for 20 seconds.
- Check the DTC (See page DI-369).

DTC B0138/72 is not output.

Replace seat belt pretensioner (LH).
