Position of Parts in Body (Before Dec. 2018 Production)

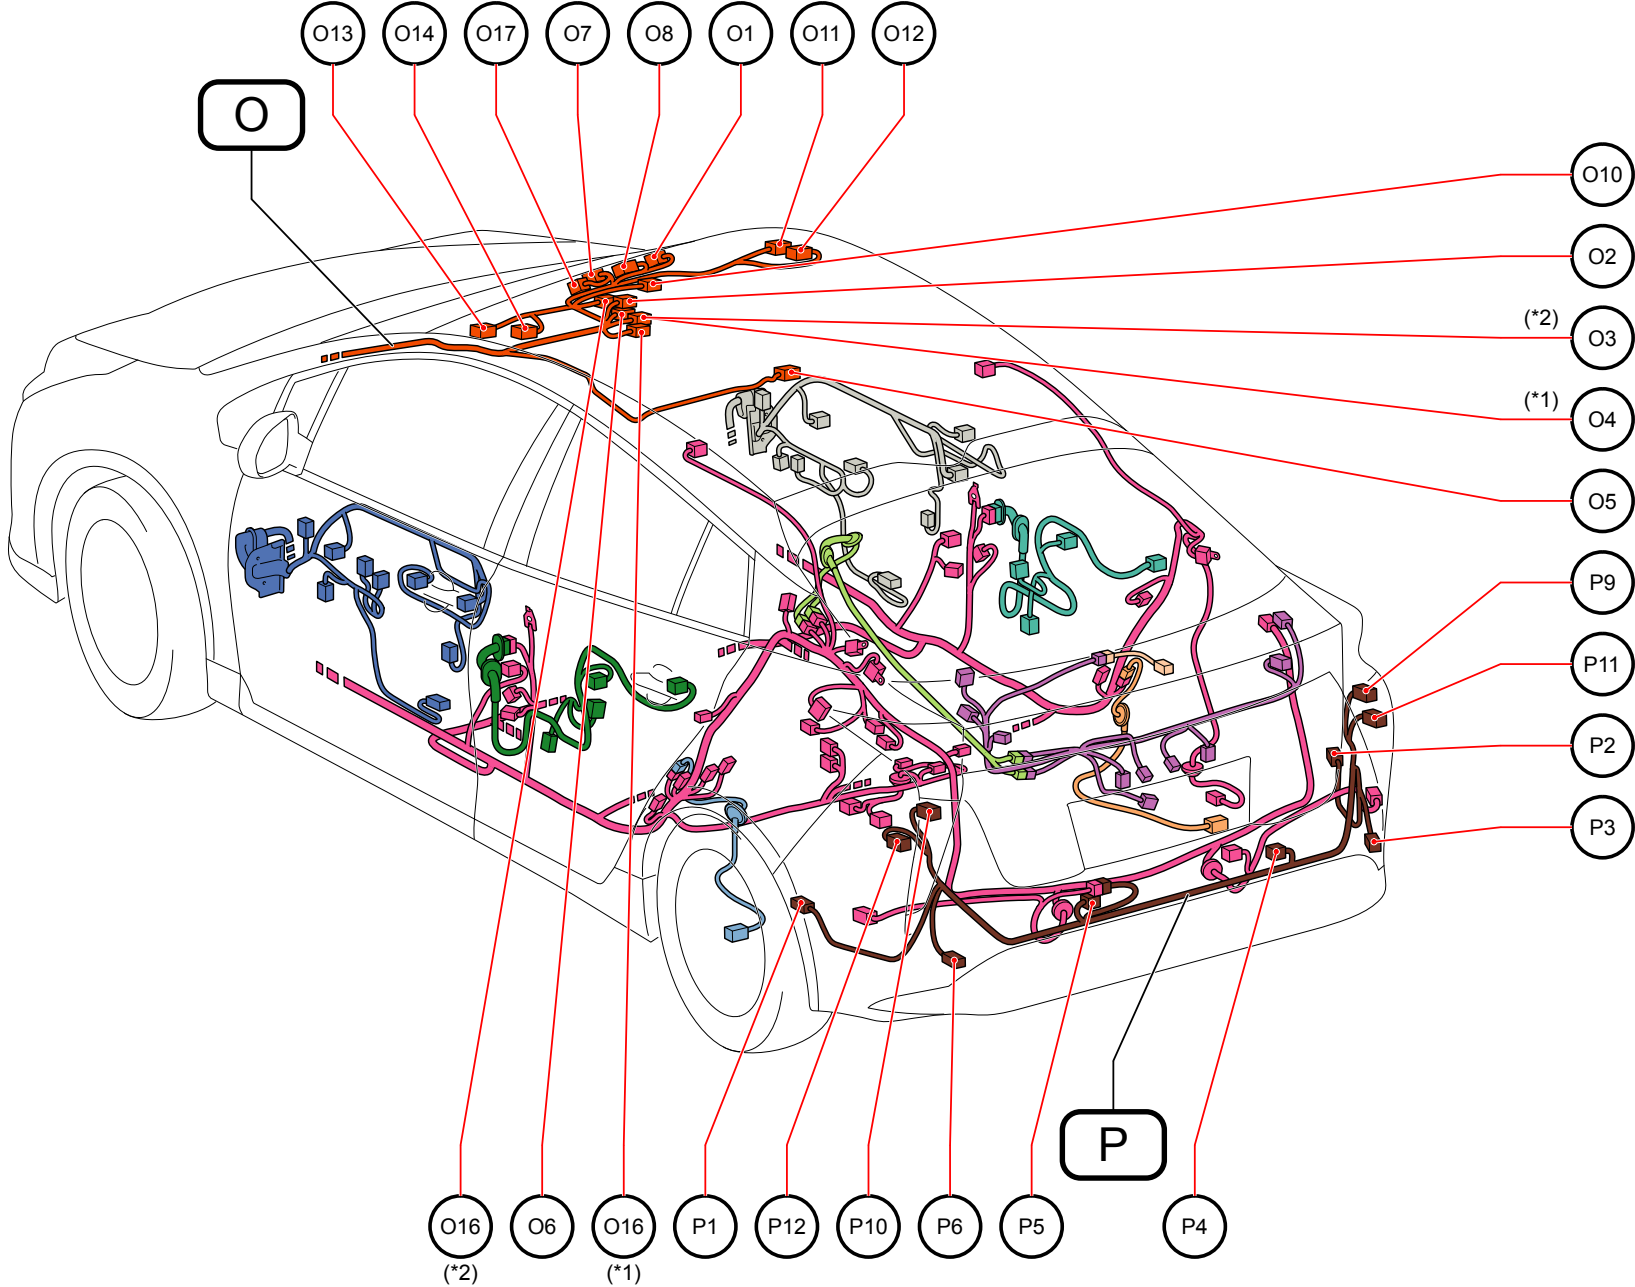
* 1:w/ Sliding Roof
* 2:w/o Sliding Roof

O1 Rain Sensor
O2 Map Light Assembly
O3 Map Light Assembly
O4 Map Light Assembly
O5 No. 1 Room Light Assembly
O6 Map Light Assembly
O7 Forward Recognition Camera
O8 Inner Rear View Mirror Assembly
O10 Sliding Roof Control ECU (Sliding Roof Drive Gear Sub-Assembly)
O11 Visor Assembly RH
O12 Vanity Light Assembly RH
O13 Visor Assembly LH
O14 Vanity Light Assembly LH
O16 No. 18 Junction Connector
O17 Forward Recognition with Heater Hood Sub-Assembly

P1 Rear Ultrasonic Sensor Side LH
P2 Rear Ultrasonic Sensor Side RH
P3 Rear Ultrasonic Sensor Corner RH
P4 Rear Ultrasonic Sensor Center RH
P5 Rear Ultrasonic Sensor Center LH
P6 Rear Ultrasonic Sensor Corner LH
P9 Rear Light Assembly RH
P10 Rear Light Assembly LH
P11 Rear Light Assembly RH
P12 Rear Light Assembly LH
