<b>DTC</b>	<b>B1217 / 17</b>	<b>Rear left door ECU communication stop</b>
------------	-------------------	--

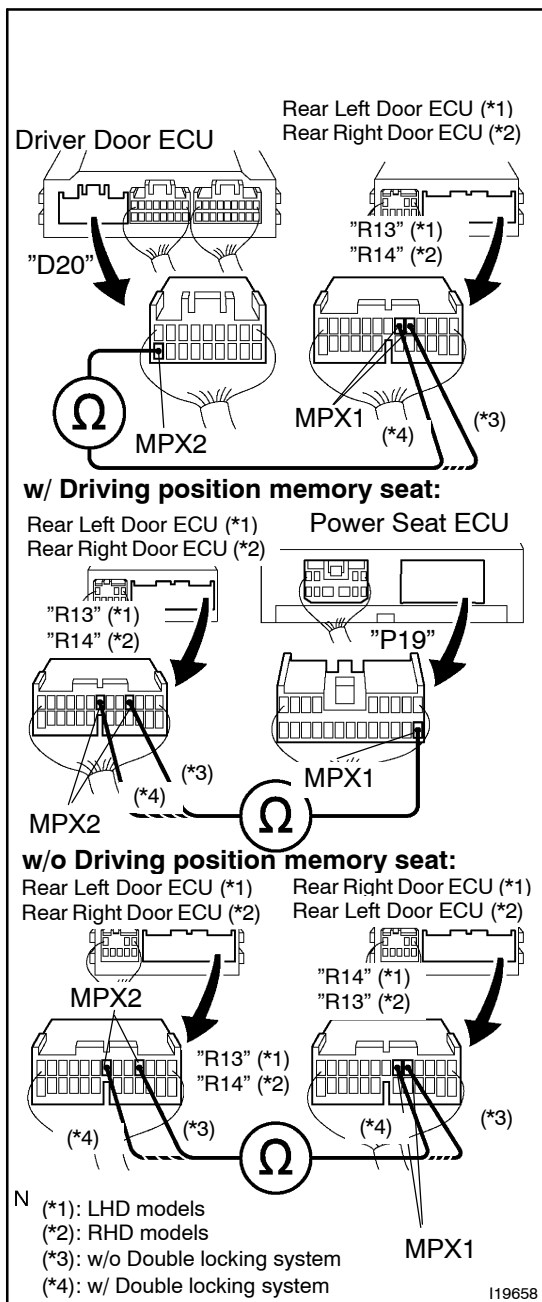
## 2 Check wireharness

Disconnect connector "D20" of driver door ECU, "R14" (or "R13") of rear left (or right) door ECU and "P19" of power seat ECU (or "R14" ("R13") of rear right (or left) door ECU).

- Check continuity between terminals MPX2 of driver door ECU and MPX1 of rear left door ECU.
- w/Seat memory, ( ): RHD models  
Check continuity between terminals MPX2 of rear left (or-right) door ECU and MPX1 of power seat ECU.
- w/o Seat memory, ( ): RHD models  
Check continuity between terminals MPX2 of rear left door ECU and MPX1 of rear right (or left) door ECU.

Continuity exists in wireharness of both (a) and (b) or (a) and (c), (a) or either (b) or (c).

If there is OPEN in wireharness of either (a), (b) or (c), please repair it.

Repair or replace wireharness.
