Mirror Heater, Rear Window Defogger

- * 1 : Before Dec. 2018 Production
- * 2 : From Dec. 2018 Production
- * 3 : From Dec. 2018 Production
until Aug. 2019 Production
- * 6 : From Aug. 2019 Production
- * 7 : w/ Panoramic View Monitor System
- * 8 : w/o Panoramic View Monitor System

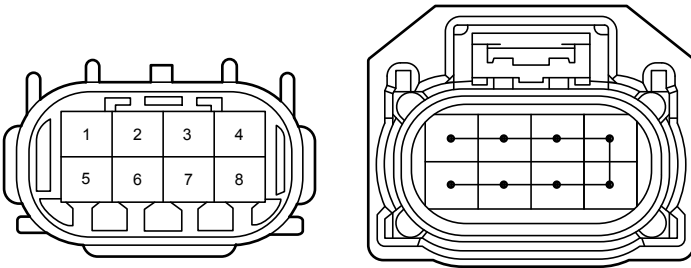
A57
Black

90980-12B56

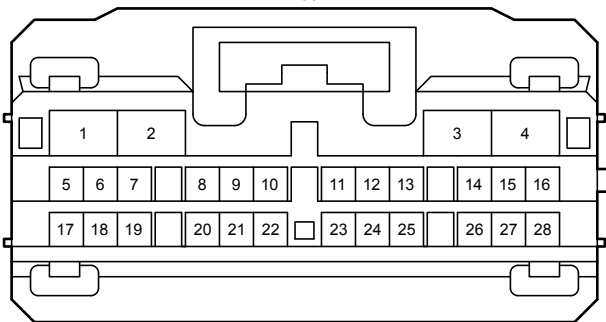
F58
Black

90980-12760

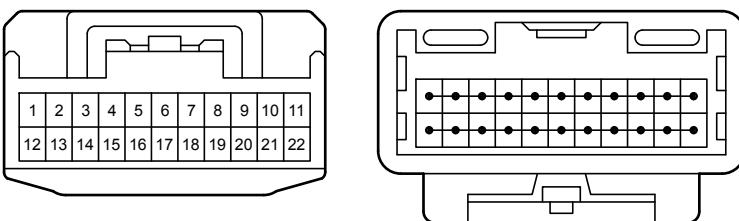
F76
Gray

90980-12372

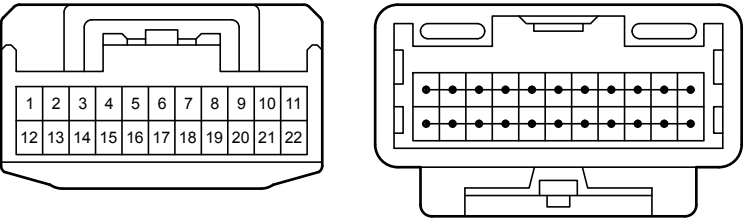
F80
Gray

90980-12372

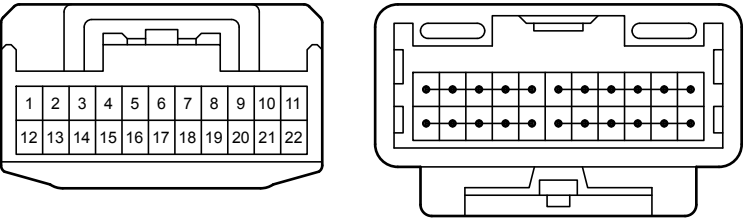
F81
Black

90980-12372

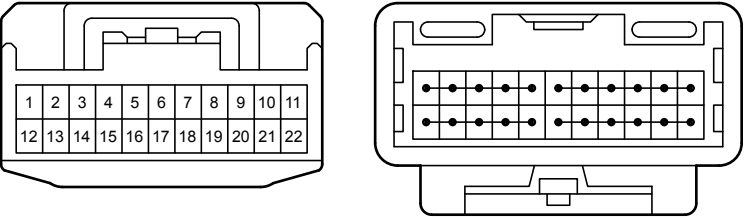
F84
Black

90980-12372

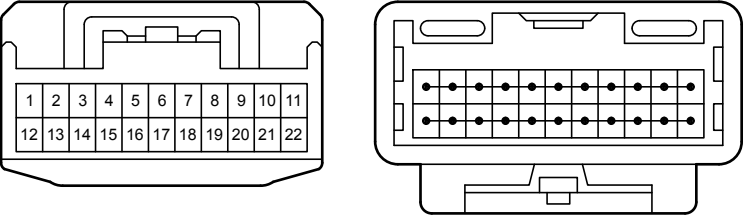
F86
Blue

90980-12372

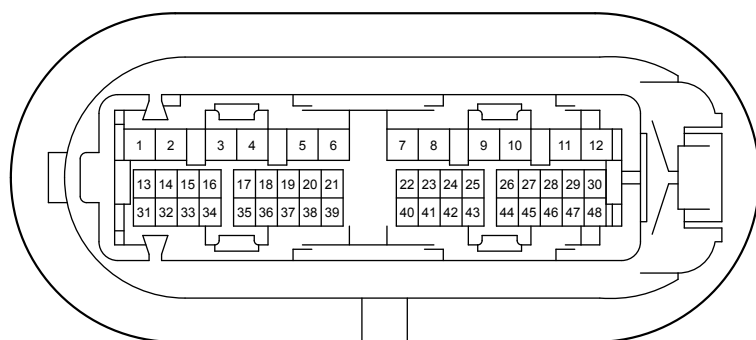
IM1
White

90980-12A09

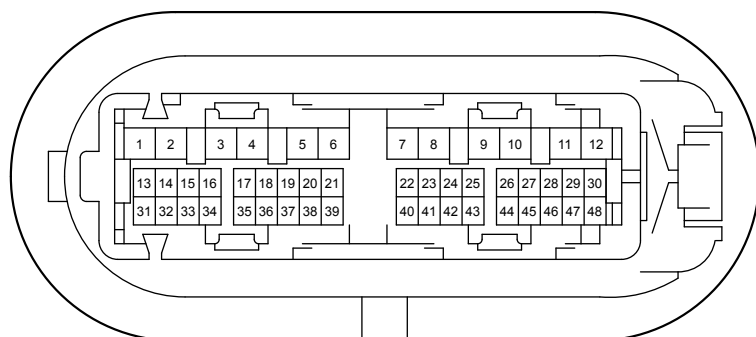
JM1
White

90980-12A09
