Position of Parts in Body (From Dec. 2018 Production)

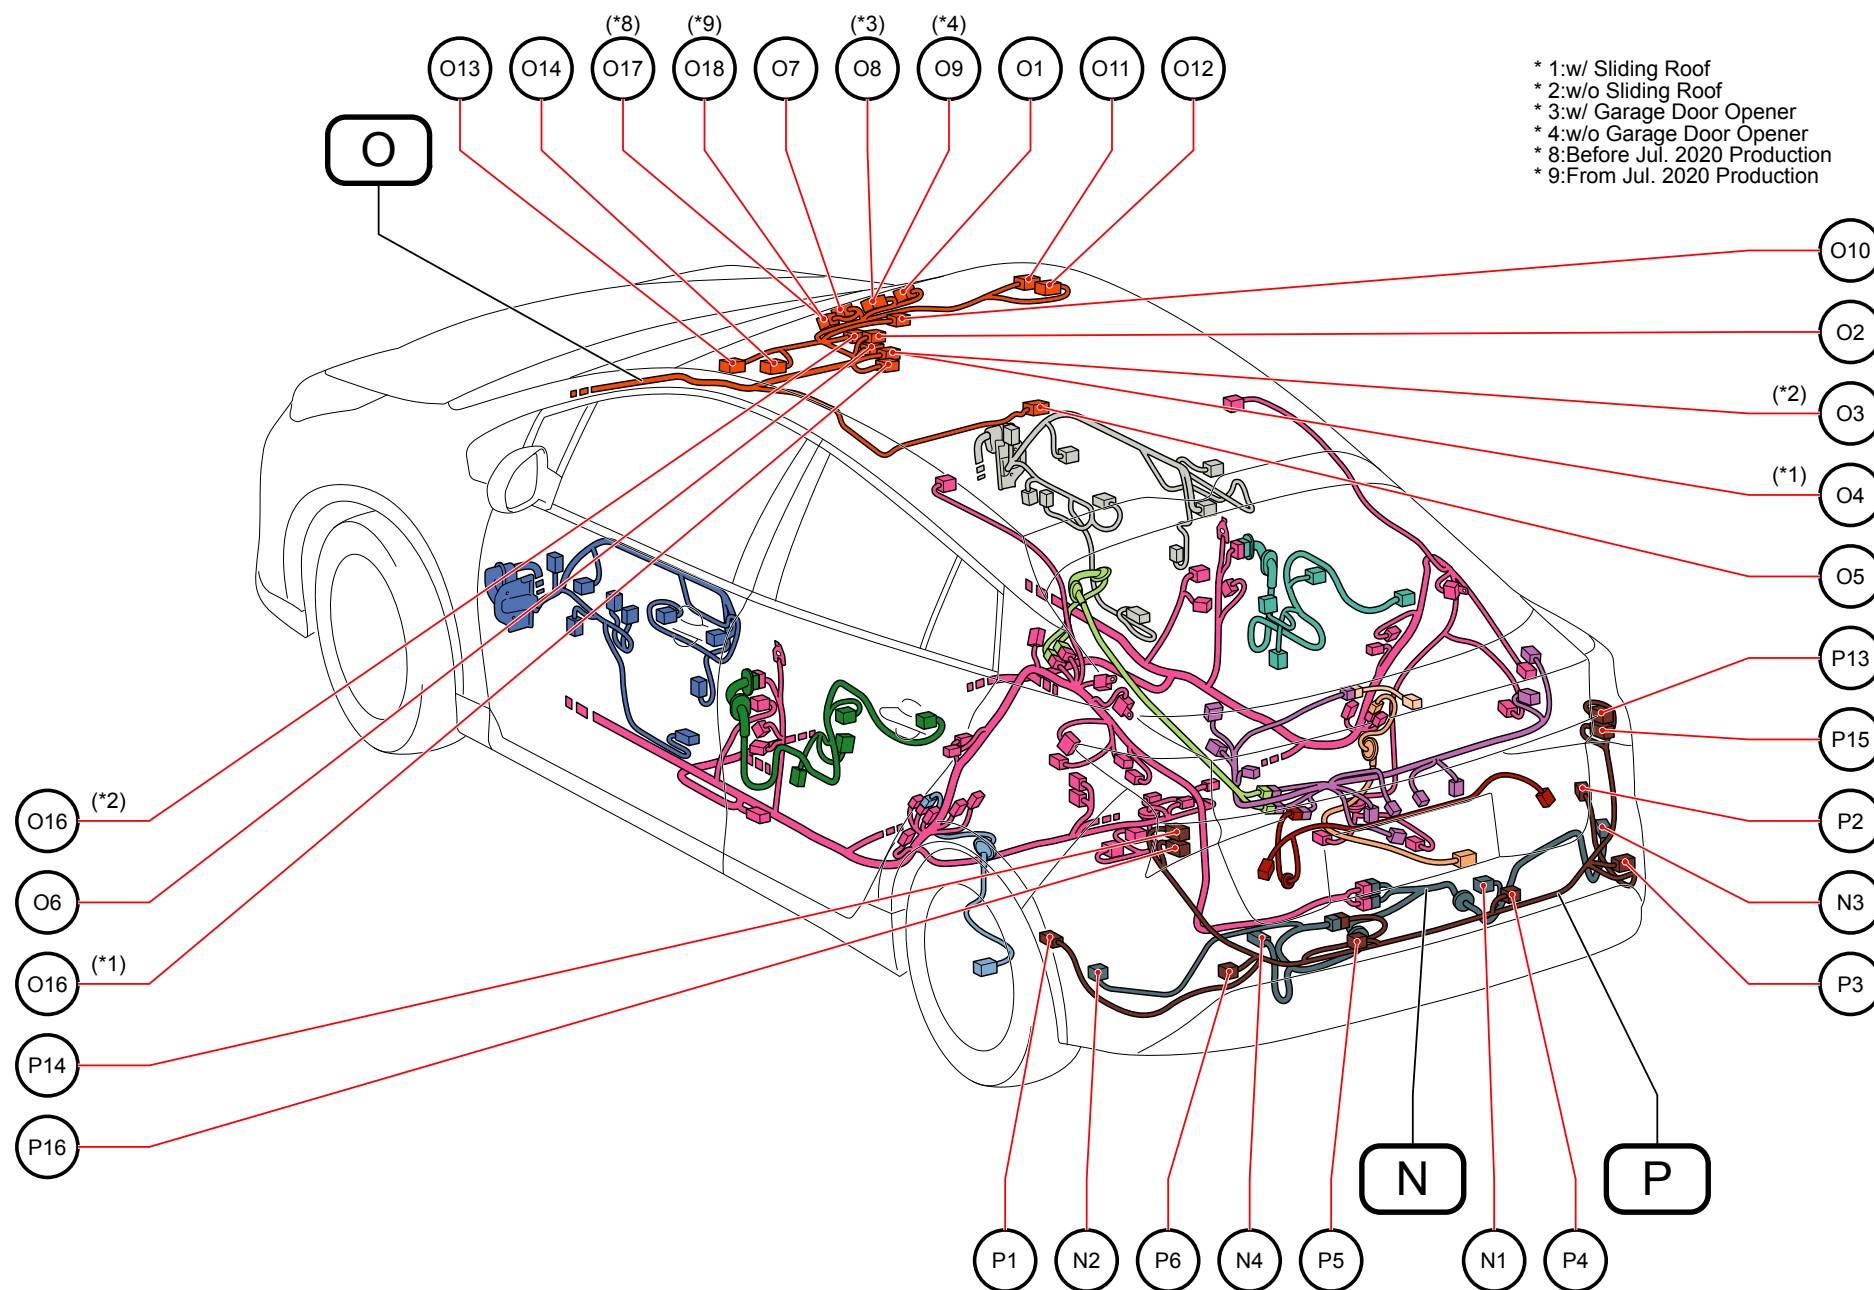
- \* 1:w/ Sliding Roof
- \* 2:w/o Sliding Roof
- \* 3:w/ Garage Door Opener
- \* 4:w/o Garage Door Opener
- \* 8:Before Jul. 2020 Production
- \* 9:From Jul. 2020 Production

N1	Electrical Key Antenna
N2	Blind Spot Monitor Sensor LH
N3	Blind Spot Monitor Sensor RH
N4	Canister Pump Module
O1	Rain Sensor
O2	Map Light Assembly
O3	Map Light Assembly
O4	Map Light Assembly
O5	No. 1 Room Light Assembly
O6	Map Light Assembly
O7	Forward Recognition Camera
O8	Inner Rear View Mirror Assembly
O9	Inner Rear View Mirror Assembly
O10	Sliding Roof Control ECU (Sliding Roof Drive Gear Sub-Assembly)
O11	Visor Assembly RH
O12	Vanity Light Assembly RH
O13	Visor Assembly LH
O14	Vanity Light Assembly LH
O16	No. 18 Junction Connector
O17	Forward Recognition with Heater Hood Sub-Assembly
O18	Forward Recognition with Heater Hood Sub-Assembly
P1	Rear Ultrasonic Sensor Side LH
P2	Rear Ultrasonic Sensor Side RH
P3	Rear Ultrasonic Sensor Corner RH
P4	Rear Ultrasonic Sensor Center RH
P5	Rear Ultrasonic Sensor Center LH
P6	Rear Ultrasonic Sensor Corner LH
P13	No. 2 Rear Combination Light Assembly RH
P14	No. 2 Rear Combination Light Assembly LH

P15	No. 2 Rear Combination Light Assembly RH
P16	No. 2 Rear Combination Light Assembly LH
