**Ice Mechanics, Loads on  
Structures and Instrumentation**

**FIELD WORK**

Tidal motion effect on ice and constructions at Kapp  
Amsterdam, Svea

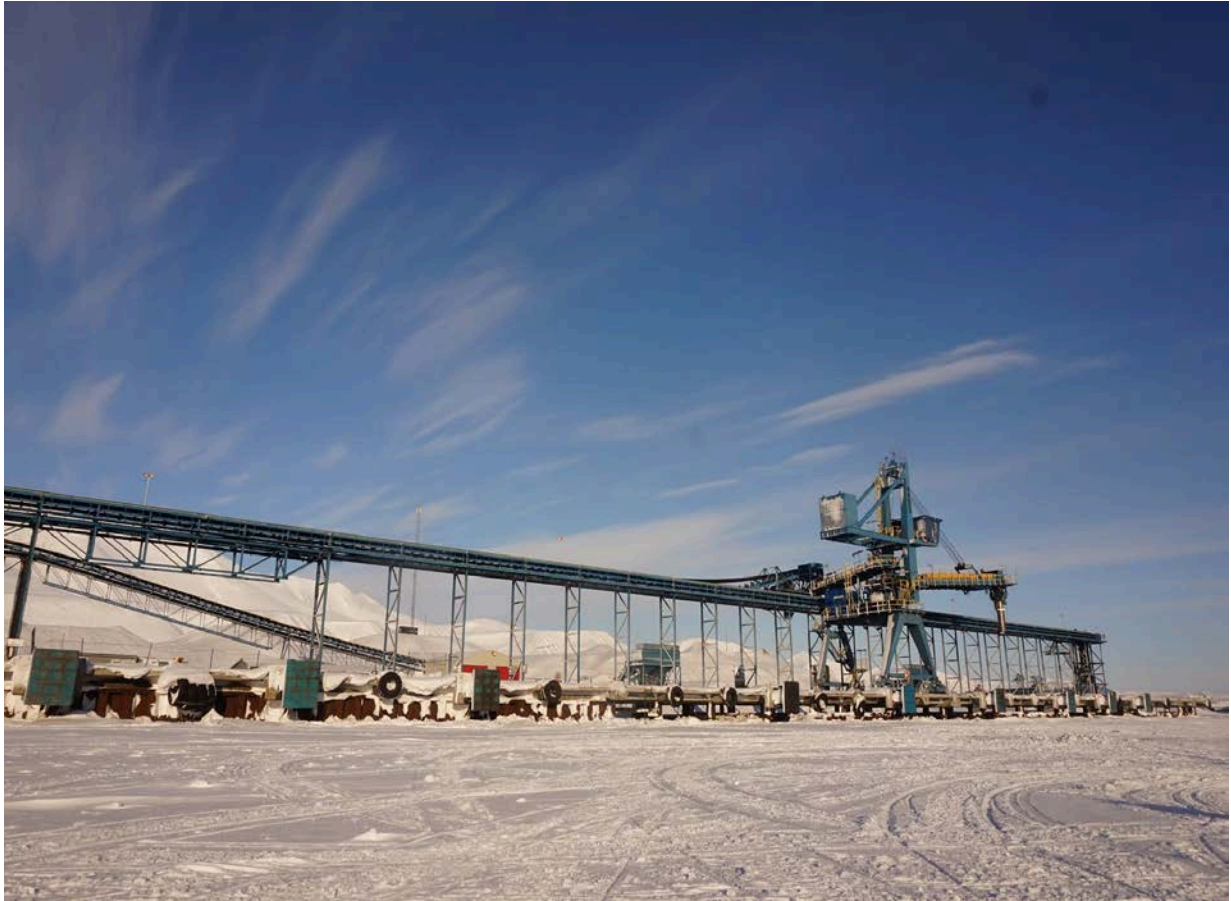
Figure 2. Kapp Amsterdam overview

Kapp Amsterdam Quay is located in Sveabukta in the inner part of the Van Mijen fjord on Spitsbergen. The entrance is closed by the island of Akseløya, and the quay is therefore naturally protected from wave actions and drifting sea ice (fig.1). The quay is the main location for unloading of coal from the Svea mine into cargo vessels with dead weights up to 70 000 t. The quay fundament is a grid of vertical steel piles with a diameter of 800 mm, connected to the seabed and steel joggle skirts (cofferdams) connected to some of the piles. Each cofferdam has two walls perpendicular to the shore and one frontal wall against the sea side of the quay. The two lateral walls are extended and fixed on the shore outside the quay. The total length of the quay is 195m, and its width is 15m. Each section has dimensions 20m in length and 15m width. (Fig.2).

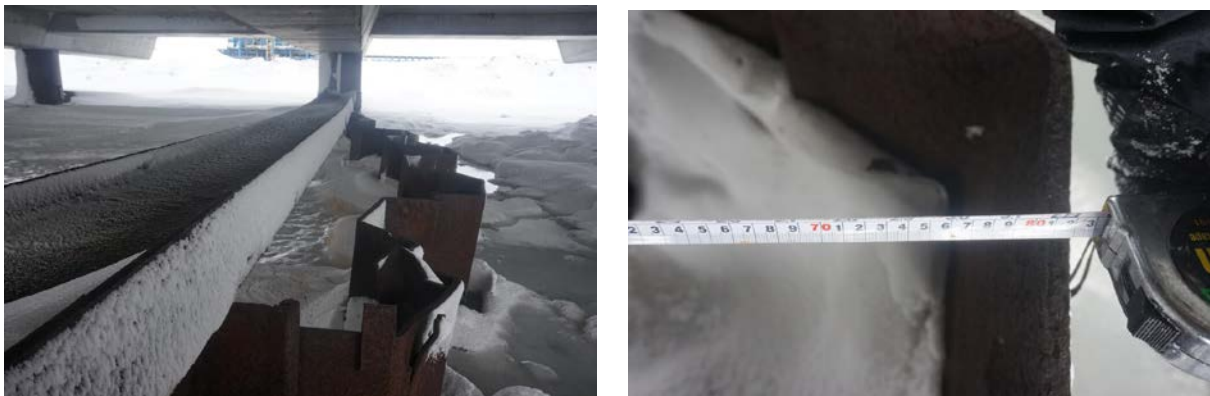
**Figure 3. Deformation of sheet piling**

Significant deformations of the sheet piling were observed in alongshore direction. The sheet piling is gouged out from the inside and leans up to approximately 85 cm outward from the filled part of the foundation (from the line connecting the vertical piles supporting the quay in the middle part of the skirt) (fig.3). The largest deformations observed, are marked as red lines in figure 4. Distance measurements in this figure are given in meters.

The steel rods with bolts were used to stop the deformation of the skirt. Some of the rods were broken off. Therefore the construction was reinforced and the steel plates were welded in addition to stop the deformation. Small displacements in parts of the skirt in the horizontal direction were visible. The origin for the skirt deformation is unknown and can relate either to soil or ice actions or both.

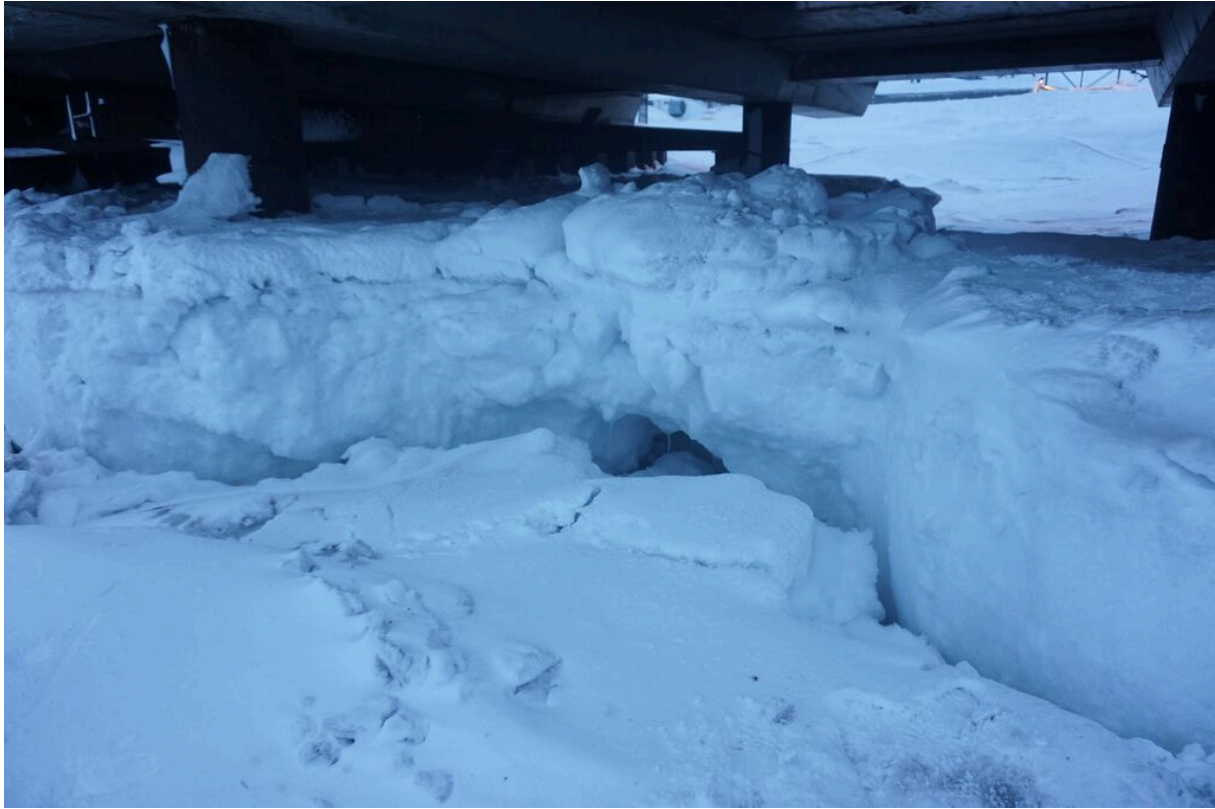
Figure 5. Ice bustles on the piles

In wintertime, the ice below the quay is frozen to the cofferdam and hangs on the walls (fig.5). The ice between the quay and the shore is grounded. At low tide the ice inside hangs along the skirt with the lowest point of the ice in the middle. At high tide the increasing water pressure below the ice causes water to penetrate through the ice onto its surface (fig.7). The water drains through the ice downward when the water level decreases again.

During our fieldwork in Svea we observed ice bustles accumulating on the piles of Kapp Amsterdam. The deformations of the quay is caused by pressure from the ice exerted on piles and cofferdams, as well as tidal effects on ice.

During low tide, the bustles remained stable even when the surface level changed. The amplitude of tidal motion was estimated to approximately 1.5m.
