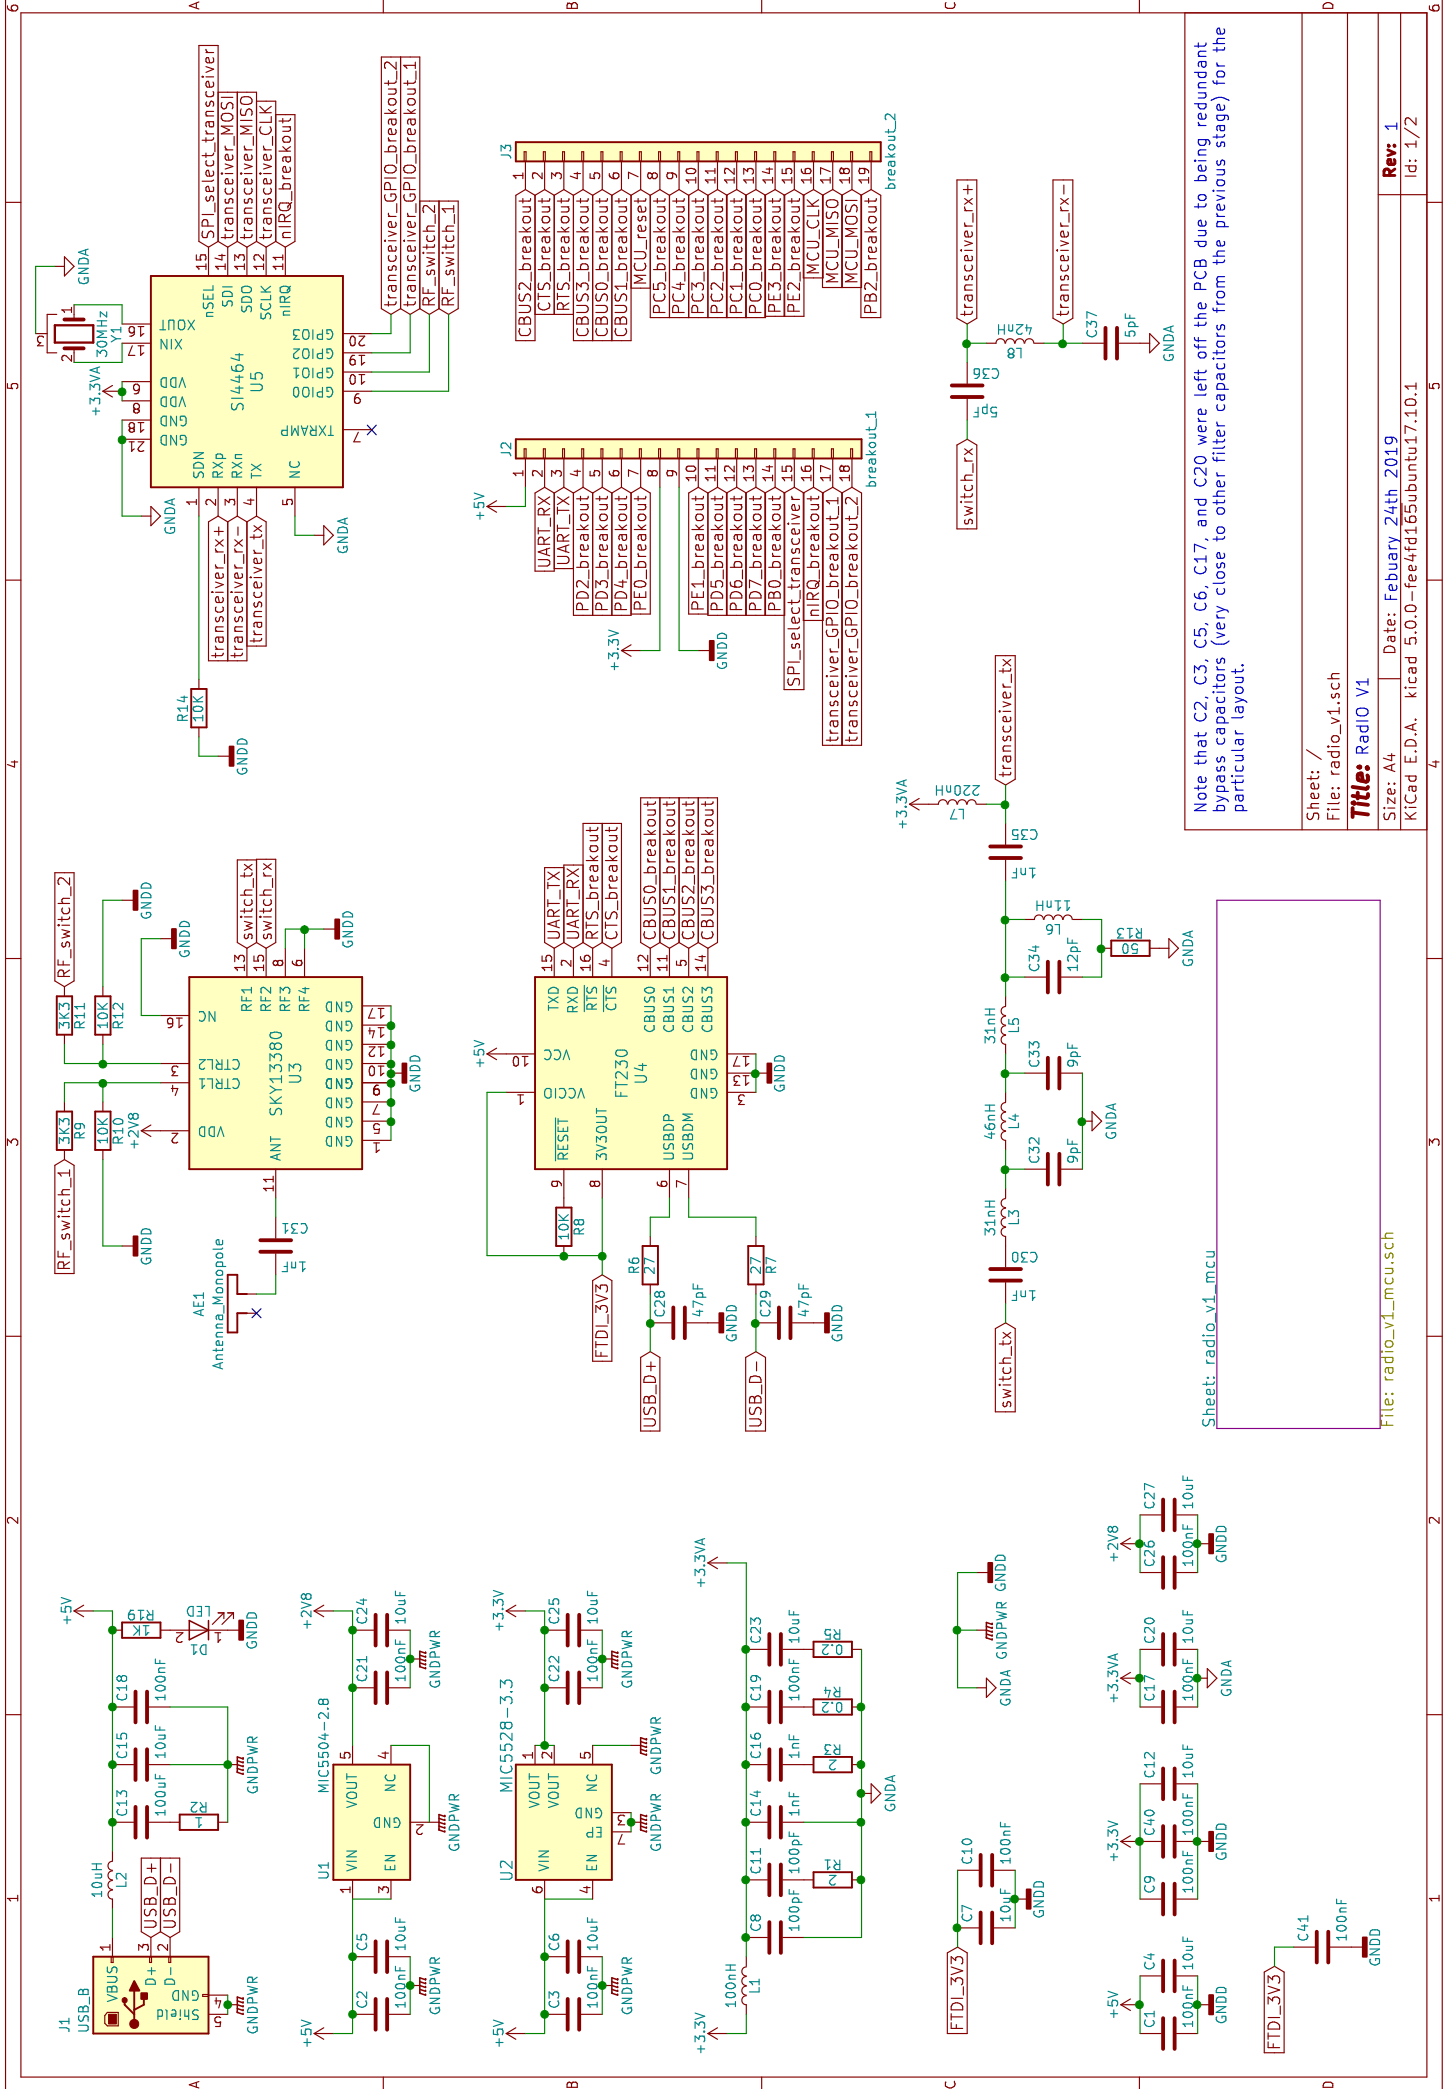
Note that C2, C3, C5, C6, C17, and C20 were left off the PCB due to being redundant bypass capacitors (very close to other filter capacitors from the previous stage) for the particular layout.
