Traffic Accident Report

Make:	Toyota	Body Type:	Sedan	Fuel:	Petrol
Model:	Corolla	Cylinders:	4	Transaxle:	2WD
Reg. year:	2016	Seating Cap.:	5	Steering Pos.:	Left hand
Model #:	Cor16	Odometer:	113406km	Transmission:	Automatic
Engine Number:	Cor16-2342GH	Rating CC:	1987cc	Colour:	RED
Reg. No.:	TBA	Import Type:	United States of America	Body Grade:	1.6l

Brief Report of the Accident

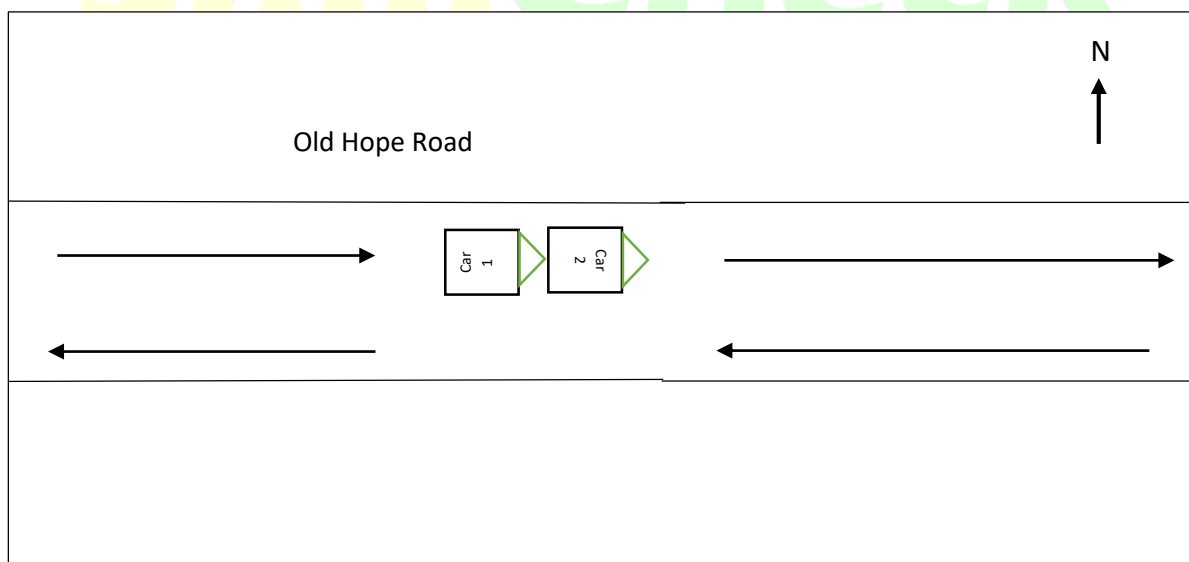
Road Diagram

On Thursday, April 2, 2021 the Toyota (Car1) motor car was traveling along Old Hope Road in an easterly direction heading towards Liguanea behind Car 2 which was heading in the same direction.

Whilst both cars were being driven, the driver of Car 1 sped up and suddenly lost control of the vehicle which caused it to collide in the rear of Car 2 causing damages.

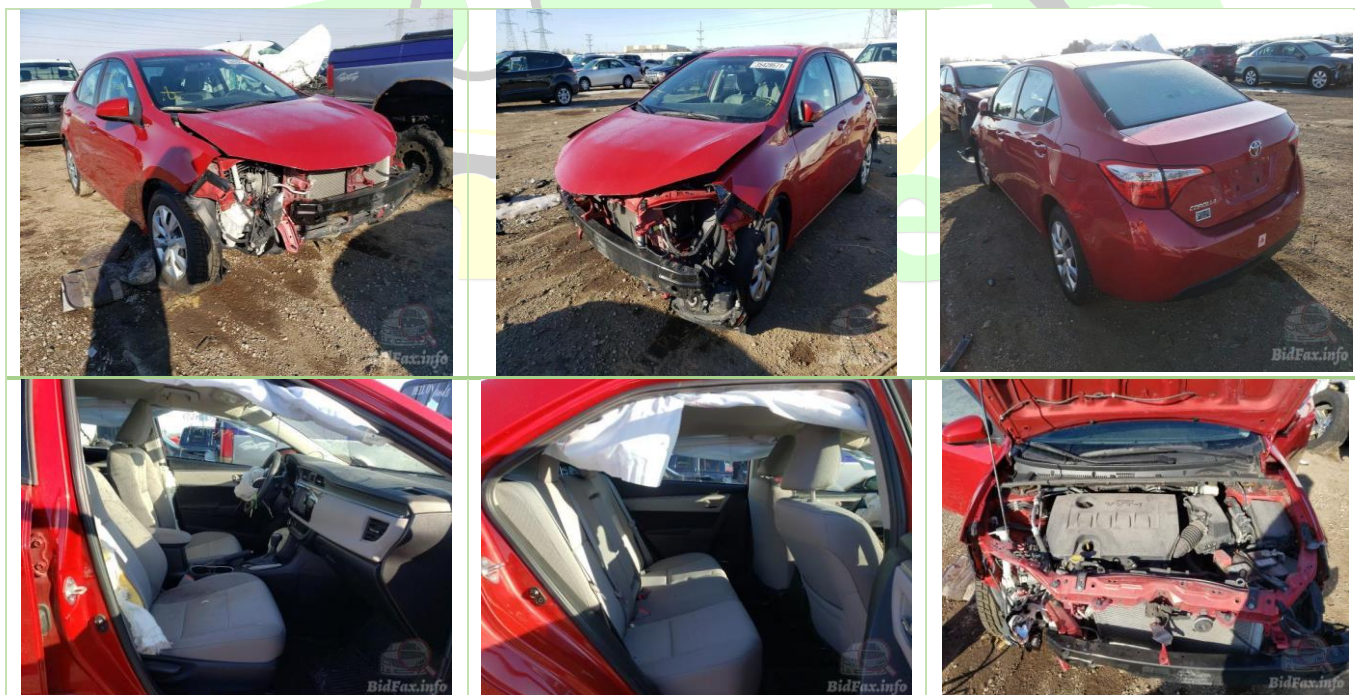
Pictures of Damages

Bonnet:	Minor damages (repairable)	Left Headlight:	Major Damages (Needs replacement)
Right Fender:	Major Damages (Needs replacement)	Radiator:	Minor Damages
Left Fender:	Minor damages (repairable)	Engine Bay:	Minor damages (repairable)
Front Bumper:	Major Damages (Needs replacement)	Fog lights:	Major Damages (Needs replacement)
Crash Bar:	Major Damages (Needs replacement)	Air bags:	Left and Right Curtain, Driver -Deployed
Grill:	Major Damages (Needs replacement)	Left and Right Rear door:	No Damage
Right Headlight:	Major Damages (Needs replacement)	Left and Right Front Door:	No Damage
