SECTION 7B

FOUNDATION REPAIR PROCEDURES

ROBERT WADE BROWN

7.22 FOUNDATION FAILURE AND REPAIR: RESIDENTIAL AND LIGHT COMMERCIAL BUILDINGS

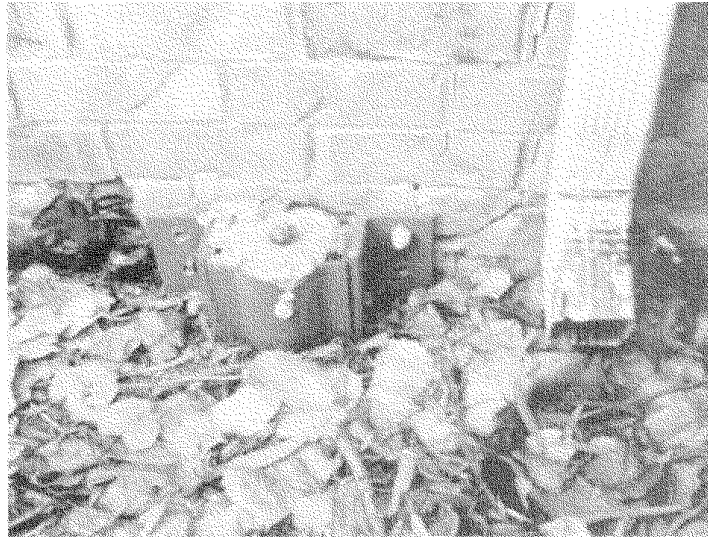
FIGURE 7B.4.10. This photograph illustrates one of the problems that can occur as a result of using the perimeter beam as the resistance to drive a steel minipile. Not only have the bolts sheared (losing all support for the structure), but the foundation beam has also been seriously sheared.

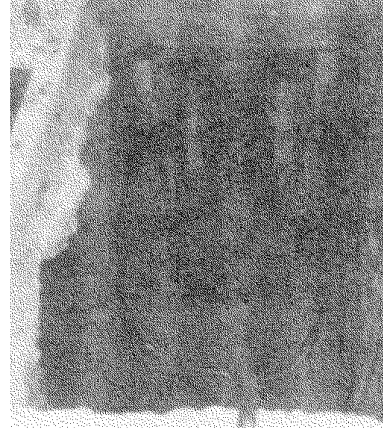
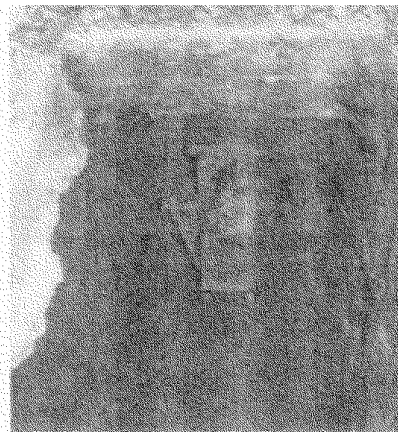
FIGURE 7B.4.11. Concentric pile technique. (a) Drawing of equipment in place; (b) photo of equipment in place; (c) photo of beam being raised; (d) beam and pier locked in place.
