“2014 ISSST”, 2014 International Symposium on Safety Science and Technology

A preliminary analysis of two Bus Rapid Transit accidents in Mexico City

Jaime SANTOS-REYES*, Vladimir ÁVALOS-BRAVO

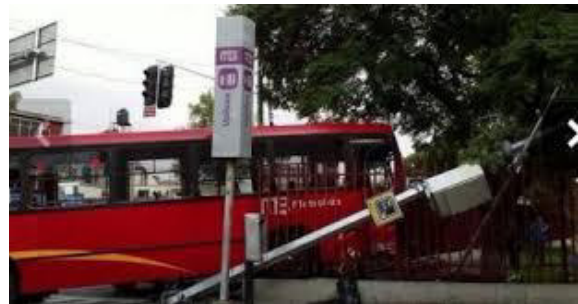
Fig. 4. Pictures of the consequences of the BRT accident-Case-2. [25]

The consequences of the accident were the following: about seventeen passengers of the BRT unit were injured; the three people including the V-driver were severely injured; and a student was injured as a result of the accident (Fig. 4). A few minutes later the emergency response teams arrived at the scene and gave medical assistance to the injured. Those who sustained severe injuries were taken to the nearest hospital. [25].

On Saturday, June 29, 2013 an accident occurred at approximately 07:30 a.m; a Metrobus-BRT unit and a Ford Explorer Van (hereafter it will be referred to as "V") collided in a junction between 'X' and 'Y' Avenues (Fig. 3) [25]. It is believed that the BRT unit left 'B' station at about 07:05 am and was travelling towards 'F' station which is the last station of the Line 2, when the accident occurred. The 'V' - vehicle, on the other hand, came from the State of Mexico to the Capital City to do some shopping and it was travelling along the 'X' Avenue and it is thought the 'V'-driver was in a hurry [25]. According to the evidence, the BRT unit was travelling at about 50 km/h just before the junction between "X" and "Y" Avenues when the traffic light was showing "Green"; the BRT unit continued its journey. At this stage the BRT unit was about 20 metres away from the 'D' station (this station was next to a university campus; see Fig. 3). Meanwhile, the 'V'-driver was travelling at about 40 km/h and in a hurry. It is thought the V-driver ignored the 'Red' light and collided with the BRT unit (Figs. 3&4). It is believed the BRT driver tried to avoid further damage by driving towards the gates of the university campus (Fig. 4(b)). [25].
