Aircraft Tire Condition Information

Purpose

This document provides additional information beneficial to the pilot in determining the wear condition of an aircraft tire.

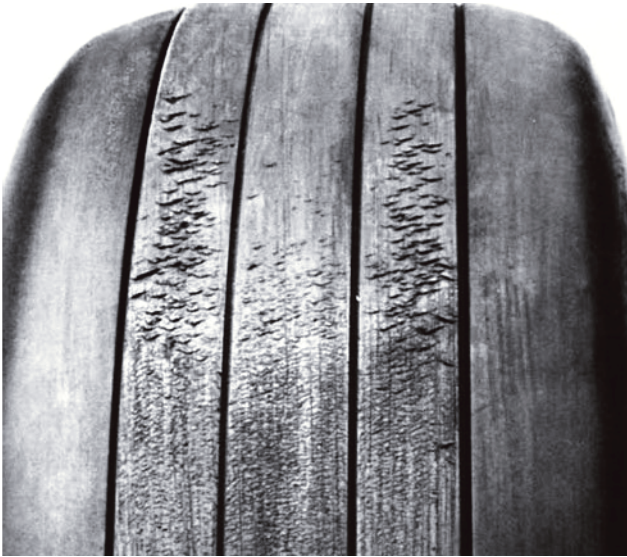
**Wear pattern referred to as
Chevron Cutting**

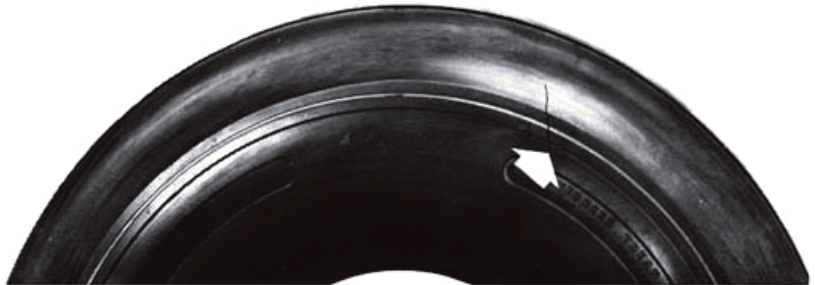
Cuts in tire sidewall

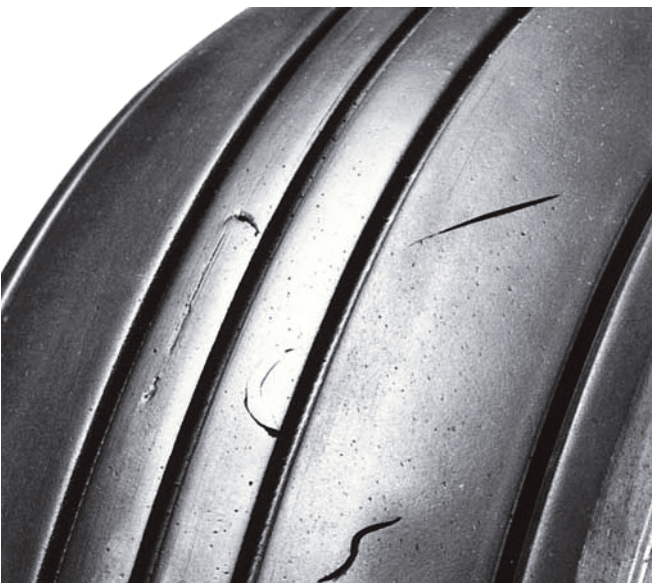
Cuts in tire tread

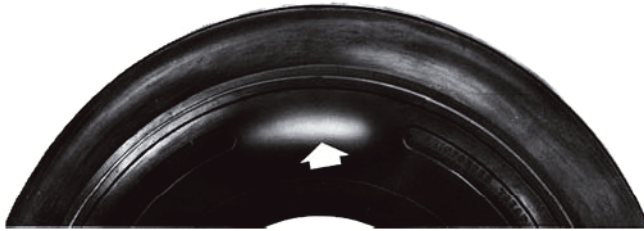
Sidewall separation

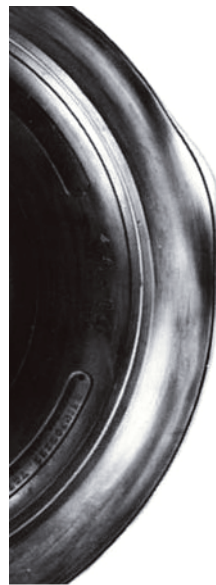
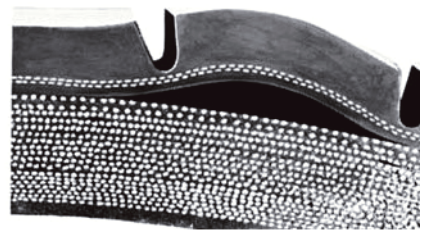
Tread separation

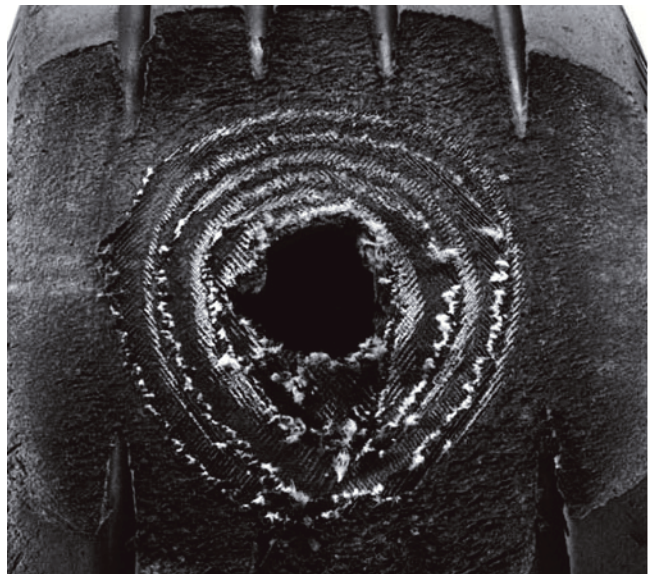
Evidence of a skid.

Note exposure of reinforcing tread plies and belt/casing plies.
