Africa New Life Ministries

Fifteenth report for Dream Center Special Project “ Water Runoff”

Photo progress report:

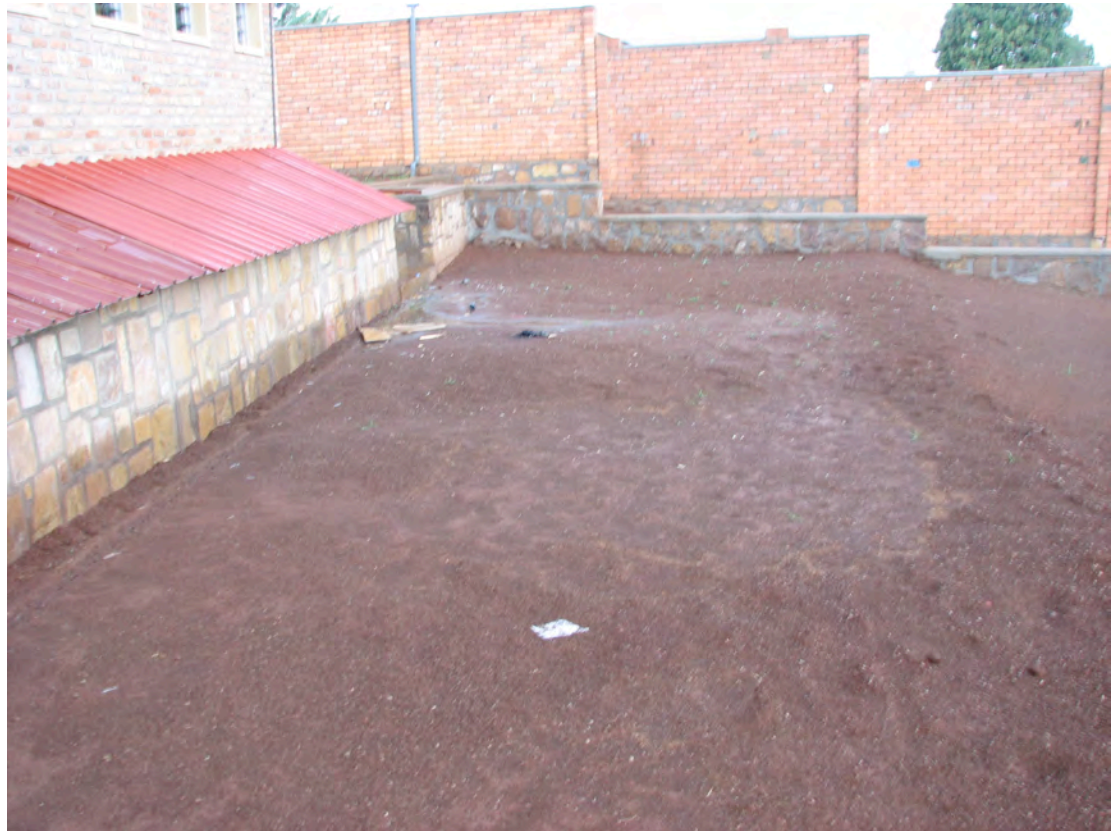
The view of the back of the bathroom block, with the roof to protect the piping and access for any repairs that might be needed in the future.

- The back of the bathroom block now has a roof to protect the piping. It also allows for access for any repairs that might be needed in the future. You can see the water path at the far end coming off the stairs. Once grass is in it will pose no problem, as it is it just gets muddy for a while till the ground absorbs the water.

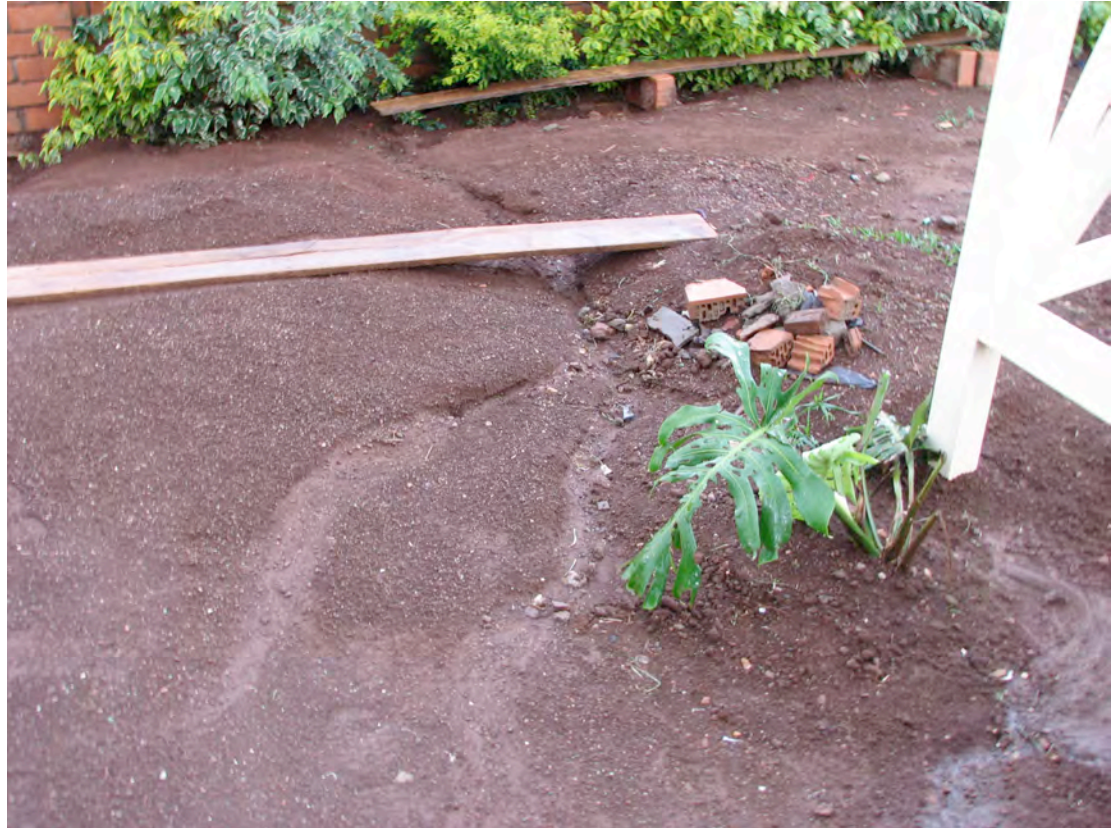
The other side there is still some work to do to fix the runoff from those stairs.

- The other side there is still some work to do to fix the runoff from those stairs and to protect the lower wall, which will start this week by putting in a small wall to redirect the water and change the slope there.

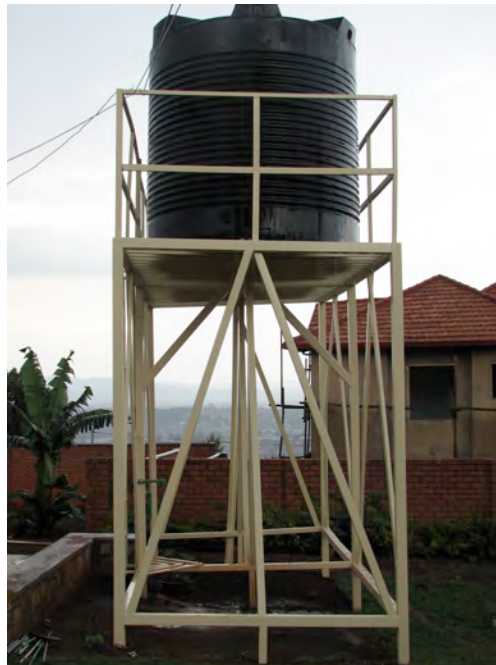
The water tower is now painted and we have water for the garden and cleaning floors as well as a tap for drinking.

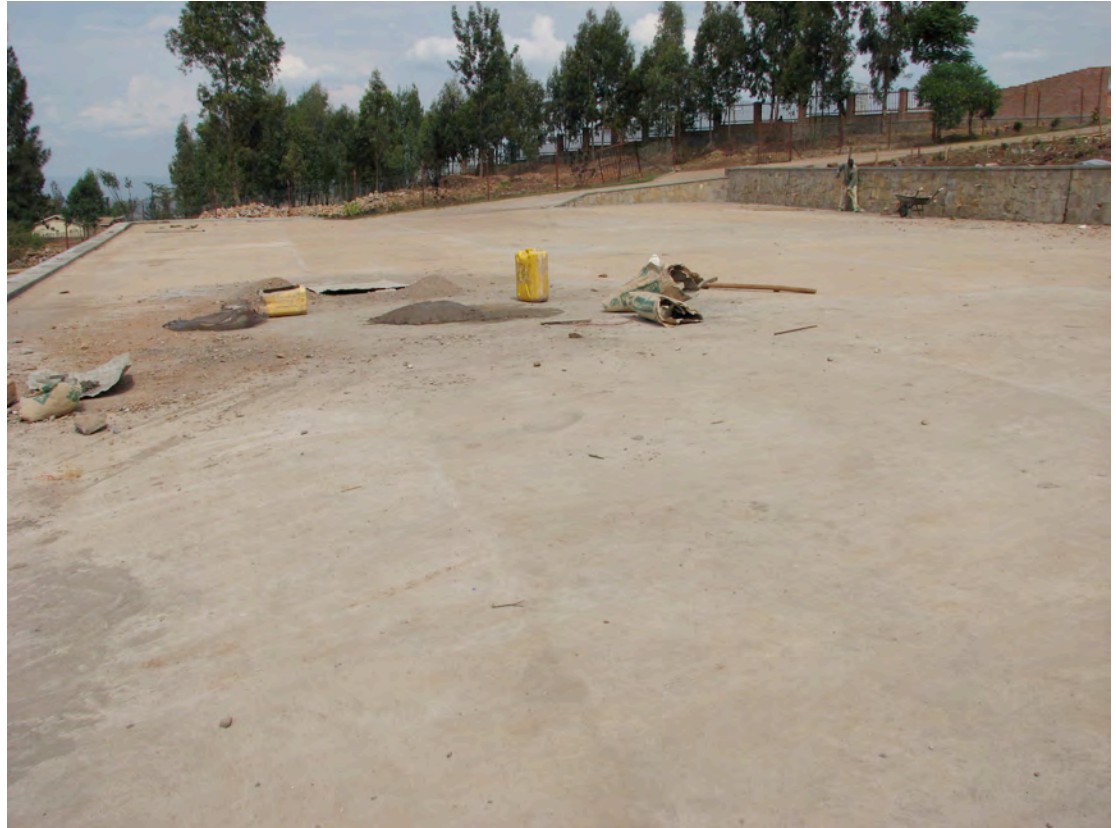
The view of the upper driveway shows that it is complete.

- The upper driveway and parking is complete. There is enough room for a full sized basketball court (hint hint). Most of the pastors parking and drive is finished it still needs to be leveled out and a drain put in at the bottom.

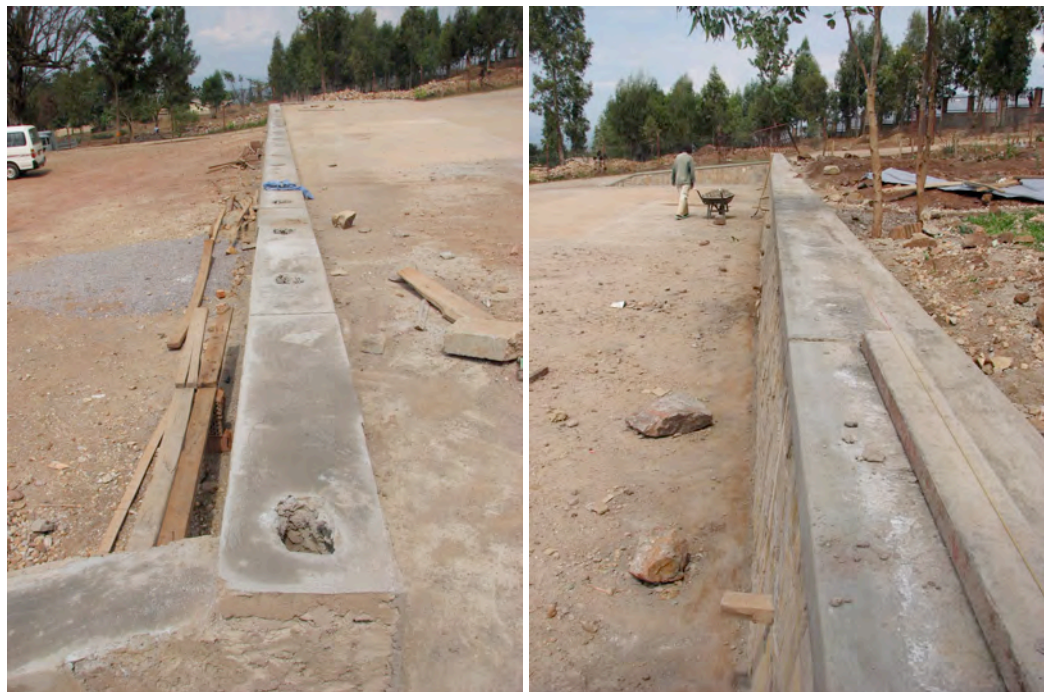
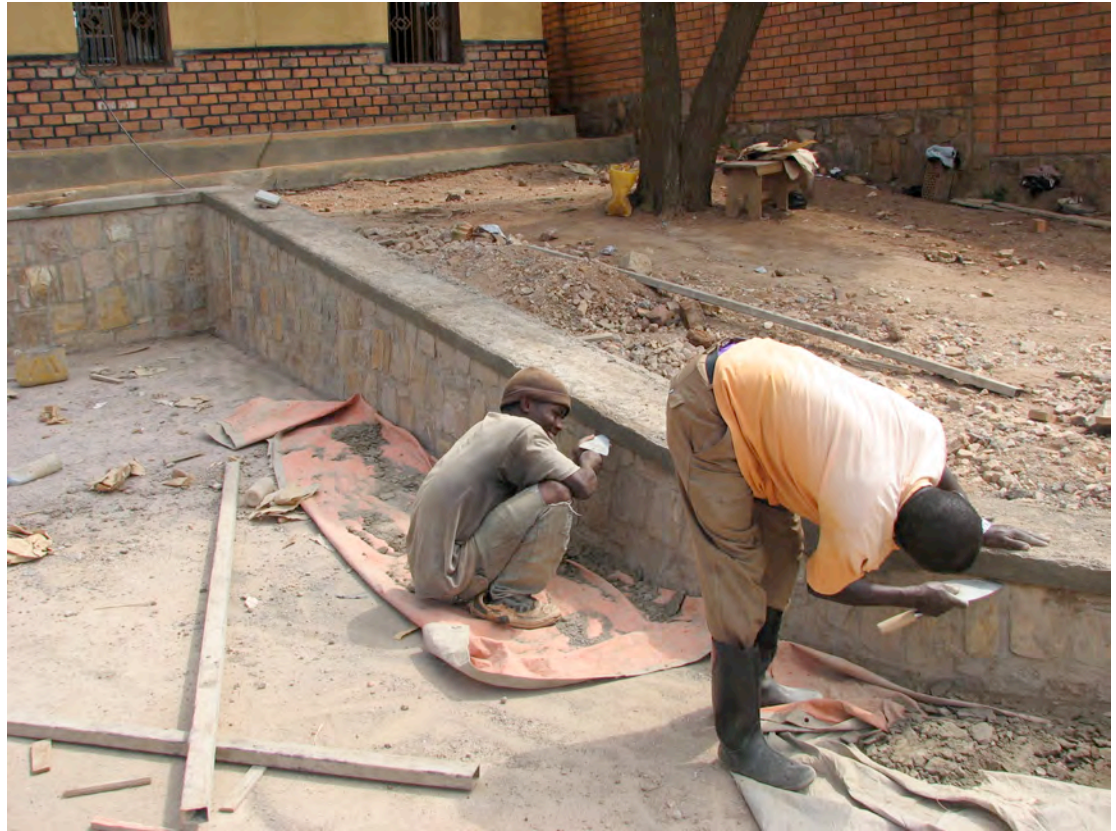
The caps for the walls of the upper parking lot have been placed.

- The cap on the parking walls are finished and we have left holes for the placement of railing just like on the lower parking lot.
- As soon as the tanks are finished we can back fill the ditches in the back and landscape the area. It would be nice if we could get seed to plant all the grass that is needed.

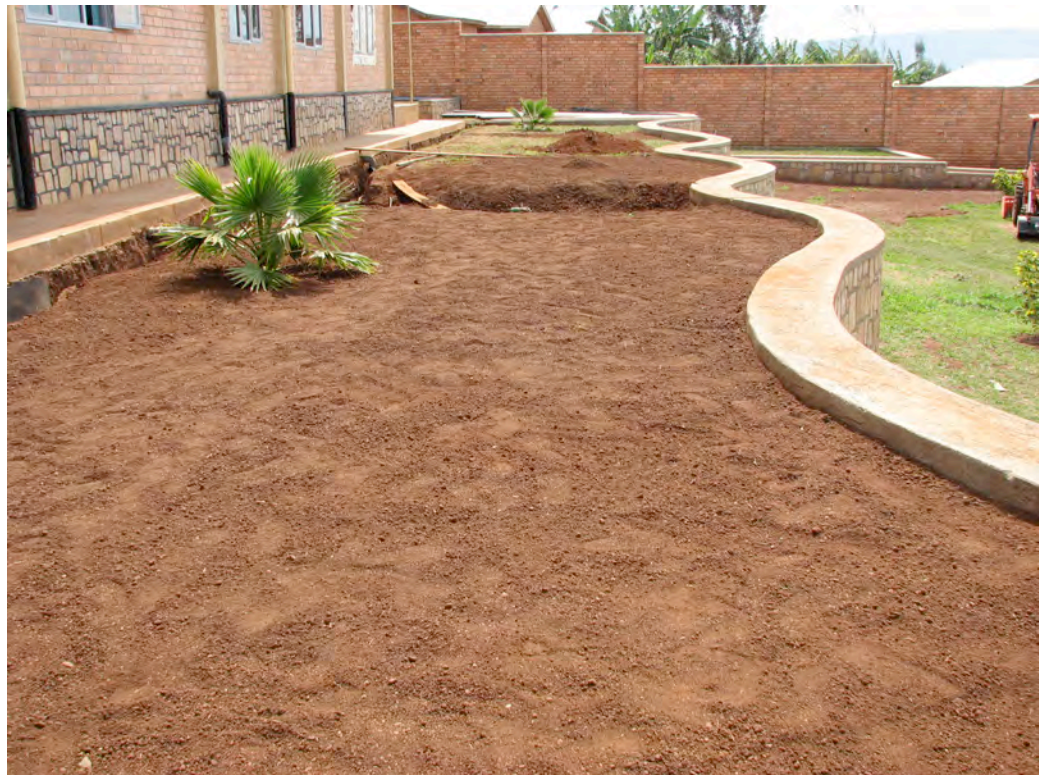
As soon as the tanks are finished we can back fill the ditches in the back and landscape the area.

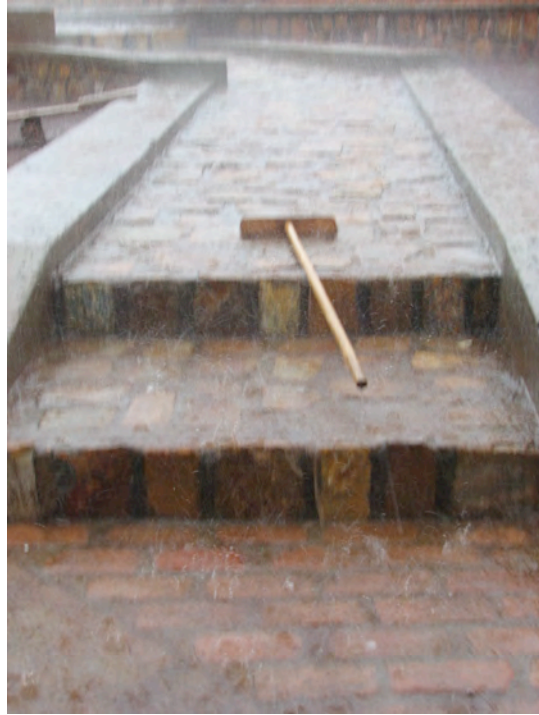
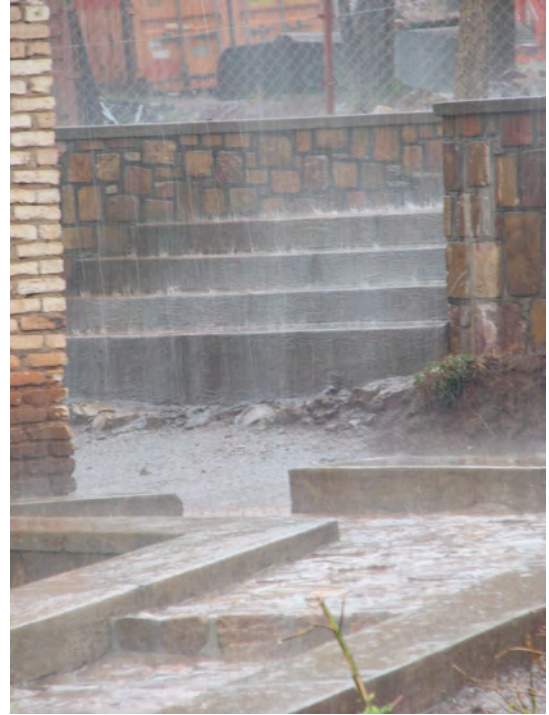
We have 4 good rains this one lasted for about 20 minutes. What you saw in the first two photos shows where some of the water goes.

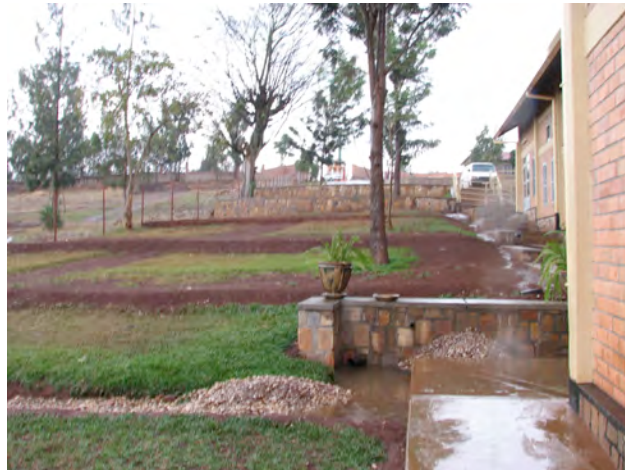
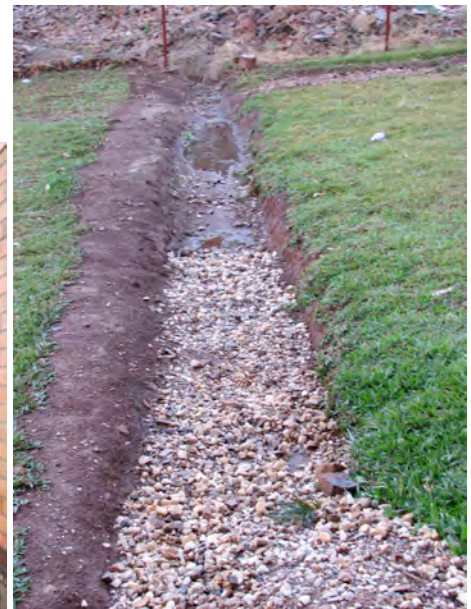
Once the drainage system is in this puddle will not exist and the landscaping along the wall will eliminate the river at the wall. The tearriousing is doing its job.

- We have had 4 good rains this one lasted for about 20 minutes. What you saw in the first two photos shows where some of the water goes. Once the drainage system is in the puddles will not exist and the landscaping along the walls will eliminate any rivers there. The tearriousing is doing the job. There is a problem at the stair way and I need to redirect the water to the other side of the wall so it will not cause any problems.

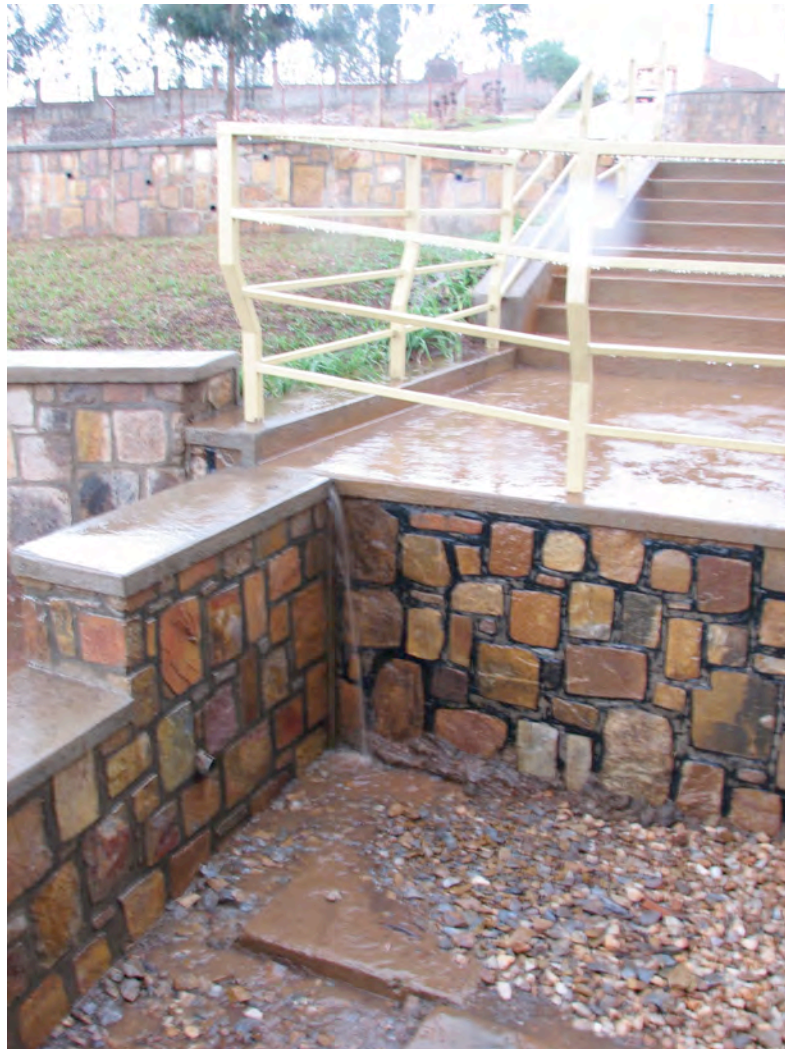
There is a problem at the stair way and I need to redirect the water to the other side of the wall.

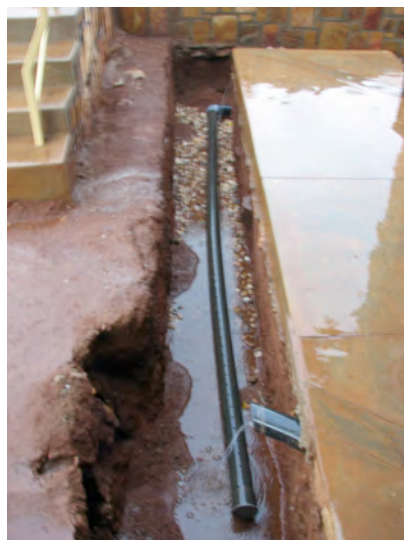
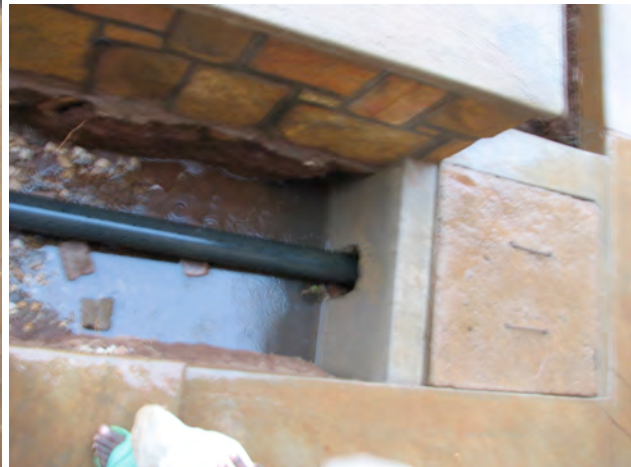
We are ready to assemble the French drain and cover it with gravel.

- We are ready to assemble a portion of the French drain and cover it with gravel. It took 3 days to drill all the holes and that was less than one quarter of the piping. So there will be about 10 more days of just drilling unless we buy another drill.

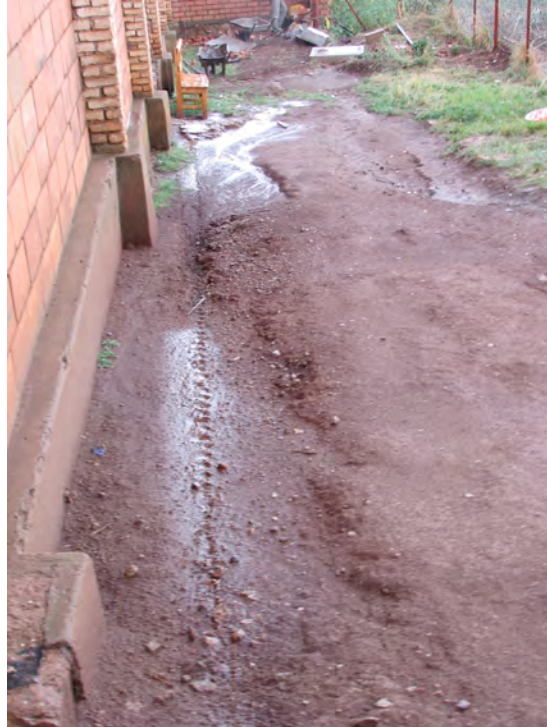
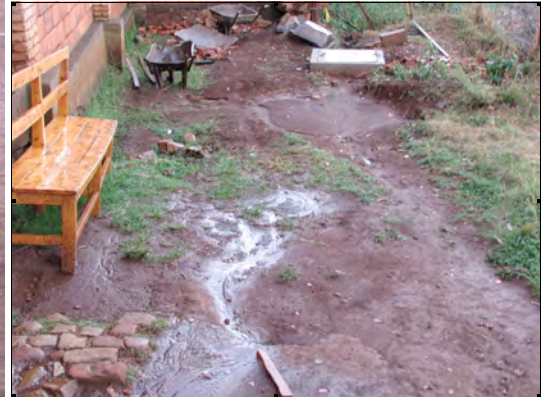
In front of the street kids building needs a little more slope work for water control.

- In front of the street kids building needs a little more slope work for water control till construction starts there. You can also see at the top of the photo the main electrical vault that was installed for power distribution to the street kids building.
