Special edition paper

Research and Development on Nondestructive Inspection Technology for Civil Engineering Structures

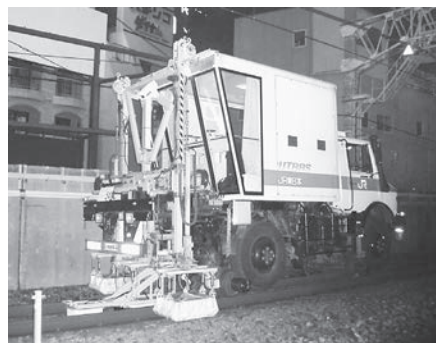
Fig. 3 UTRAS

To overcome that disadvantage, the Technical Center worked on development of an inspection machine that can inspect defects inside of structures using an electromagnetic radar. In fiscal 2000, JR East introduced an under-track survey car (UTRAS) that can inspect voids in the roadbed that could cause roadbed subsidence (Fig. 3). And in fiscal 2004, we deployed for Shinkansen tunnels the tunnel concrete lining inspection car (Shinkansen CLIC) that can inspect defects under the tunnel lining that could result in accidents where concrete falls from the tunnel lining (Fig. 4). In conjunction with upgrading of UTRAS, we carried out development for the next-generation UTRAS and also development to apply Shinkansen CLIC to tunnels on the conventional lines. This article will cover that development.
