YE SERVICE NEWS

Subject	Ring gear and air motor damage due to air vent sticking of air motor		Issue No: YEN-CP-22870-3 Issued: 2019/02/05
Engine model	6,8EY26(L)(W)	Applicable engine use	Marine propulsion/ auxiliary engine
		Applicable engine No.	-

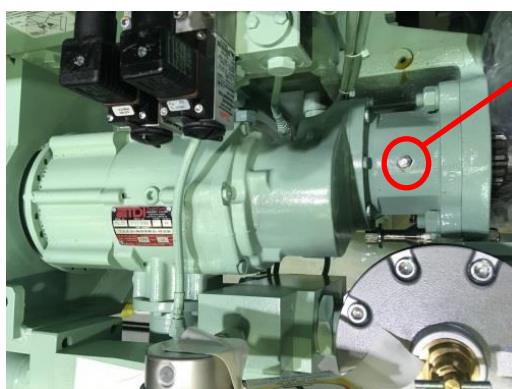
T112V air motor manufactured by TDI

When re-painting, do not apply paint to the air vent as shown circled in red in the photo below.

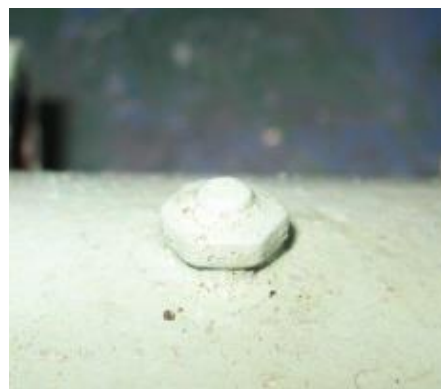
Due to sticking of the air vent in the T112V air motor manufactured by TDI, a major accident occurred resulting in damage to the ring gear and air motor.
The cause of the air vent sticking was found to be intrusion of paint onto the air vent piston's sliding surfaces during re-painting of the vessel. This paint inhibited the movement of the piston.

Painting of the air vent in which failure occurred

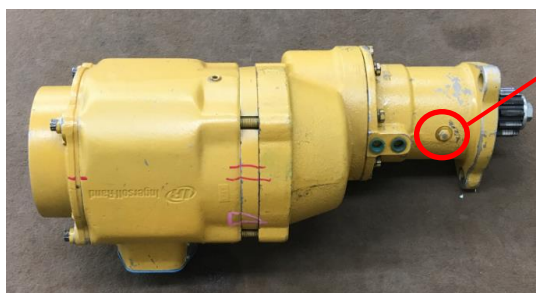
ST950 air motor manufactured by IR

An air vent is also provided on the ST950 air motor manufactured by IR. The same painting precautions must be taken with this air motor.
