TEHO Ropes & Supplies Pte Ltd

Mooring wire ropes user manual

For WREXCO® series

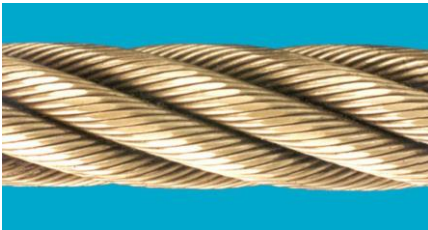
Figure 8: Severely worn rope (credit BS ISO 4309:2010)

The rope should be discarded if the outer wire diameter has reduced by 7% or more due to wear (abrasion).
