MARINE SAFETY ALERT

Safety Alert 09-18

**It's just a Slide. What could go wrong?
Get seriously injured and you'll sing a different song!**

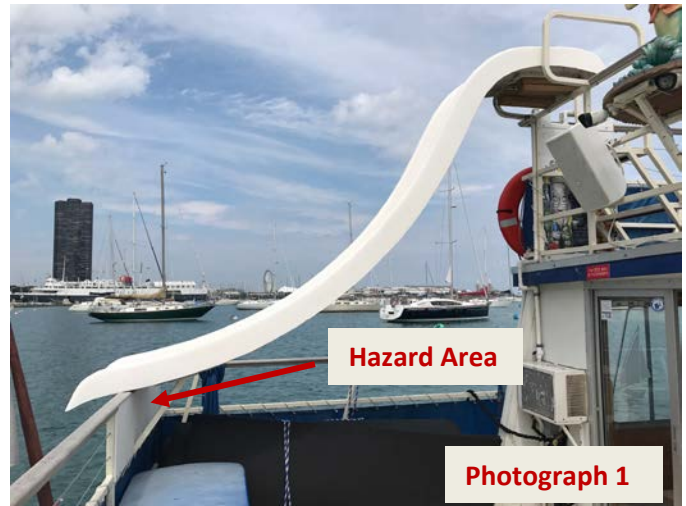
Slides much like those commonly used at pools, shown in Photograph 1, offer an element of fun during hot days on the water. Besides commercial vessels they are also found installed onboard private boats, rental house boats, and rental party barges. The Coast Guard does not regulate the installation or usage of these slides.

The slide in Photograph 1 above is of the open flume design. Closed flume slides (e.g., tubular designs) help to prevent users from contacting components external to the slide.

With the open flume slide, users should keep arms and legs away from objects they might encounter on the way down. However, that common sense approach isn't always observed. Slide users who are enjoying a party atmosphere and alcoholic beverages have strayed off the preferred path during the short descent before hitting the water. As can be seen in the Photograph 1 above, contacting the rail on which the slide sits on would not be difficult to do.

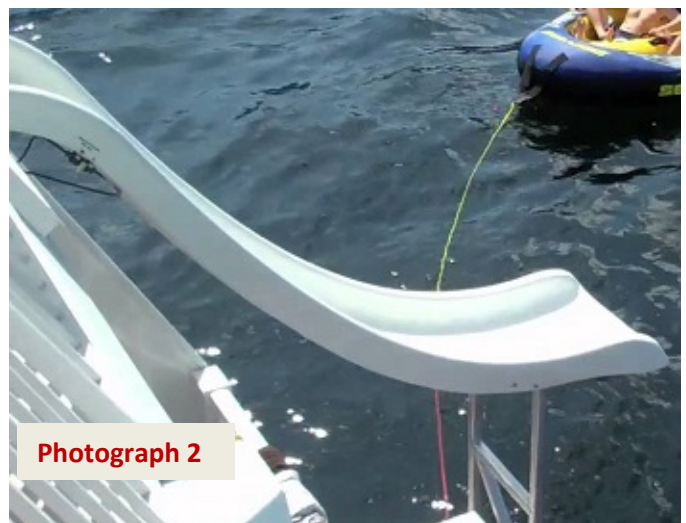
To reduce the contact hazard to slide users, supports can be installed directly under the slide as show in the Photograph 2.

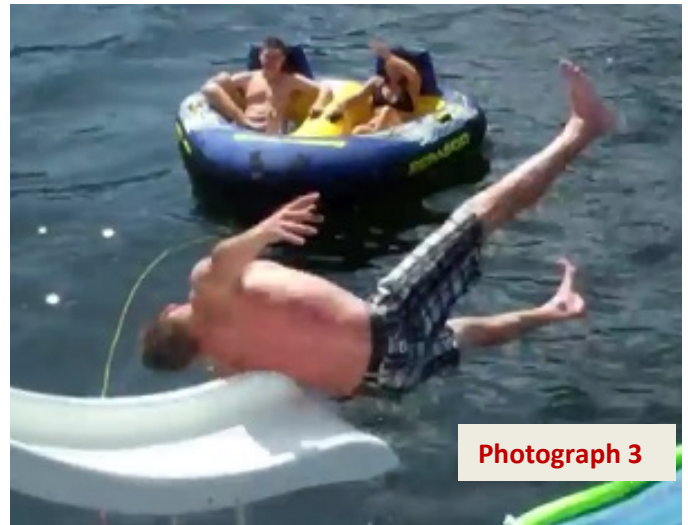
It is understood that there may be many human factors such as misjudgment, impairment, and carelessness that can lead to slide injuries. Photograph 3 shows a passenger who went down an independently supported slide that was clear of any objects at the base that could be struck and cause injury. In this instance the person's path down the slide was irregular because he attempted to go down it while standing up.

The Coast Guard **emphatically reminds** Owners, Operators and Captains of any vessel with a slide installed that they have the responsibility to ensure the overall safety of their vessels, passengers, and crewmembers. **If a slide installation appears to present unnecessary risk, actions should be taken to minimize the dangers to those persons who may use it.**
