8th International Conference Interdisciplinarity in Engineering, INTER-ENG 2014, 9-10 October  
2014, Tirgu-Mures, Romania

## Crack Analysis of Reinforced High Strength Concrete Elements in Simulated Aggressive Environments

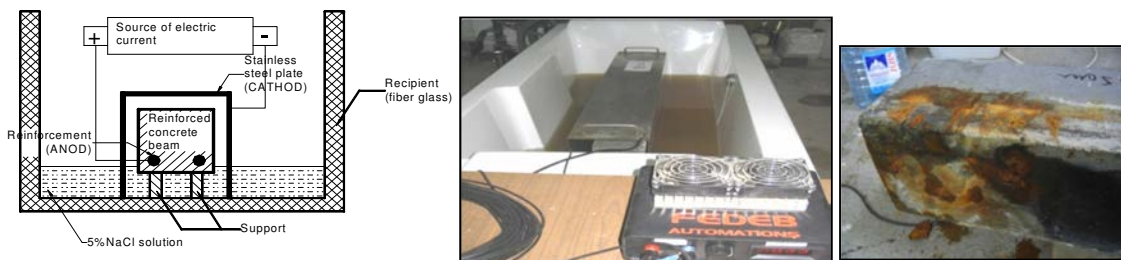
The corrosion of the embedded reinforcement usually takes place along several years especially if the concrete is strong and durable. Therefore, for the purpose of investigating the residual strength of reinforced concrete elements in service life, an aggressive, short-term, accelerated current was applied to the reinforcement, which would lead to loss of steel cross-section by corrosion. The set-up for the accelerated corrosion is similar to other research [14]. A schematic view of the set-up and a picture of the corrosion equipment are presented in Fig. 2.a and 2.b. The circuit of the electric current generated by an external source consisted in anode (the embedded reinforcement), the cathode (a stainless steel plate covering 3 faces of the element) and the electrolyte, a 5% NaCl solution. The intensity of the current was set to 3 mA/cm<sup>2</sup> and the elements were exposed for 7 days.

Fig. 2. (a) Schematic view of the corrosion process; (b) Corrosion equipment; (c) Visual aspects of a corroded specimen.

Type b elements exposed to accelerated corrosion already displayed bending cracks along their length, which in fact are the path through which the electrolyte reaches the reinforcement. After only 1 day of exposure, the intensity of the electric current dropped under  $0.5 \text{ mA/cm}^2$ , indication that the salt bridge of the electrolysis could no longer close the circuit and reach out the steel. In fact, after the exposure, the previous cracks were found to be filled with a light colored material. Although not tested microscopically, the authors believe that a process of self healing took place due to un-hydrated cement particles in low water/binder compositions, as confirmed by other research [2]. Nevertheless, corrosion took, as witnessed by the specific red spots on the surface of the beams (Fig. 2c).
