## Eight Discipline Report (8D Report)

To: 8D report No.: [CPCQ20230831](#)  
From: [Chicony Power Technology](#) RMA claim No.: [N/A](#)  
CC : [N/A](#) Chicony P/N: [A065RP72P-HW01-0A](#)

Submit date: [2023/08/31](#) Product description: [65W adapter](#)  
Receive date: [2023/08/30](#) Defect D/C or Lot No.: [2023/01](#)

Subject : [Adapter 因 DC cable 的 ID 線斷無法充電](#)

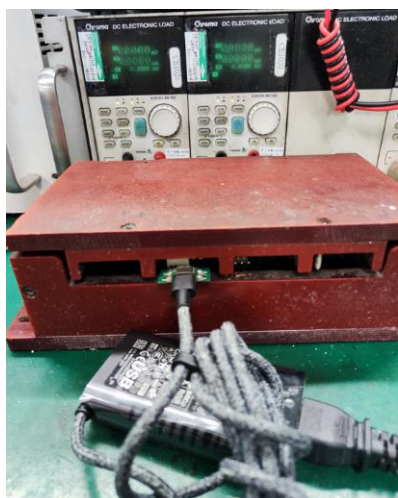
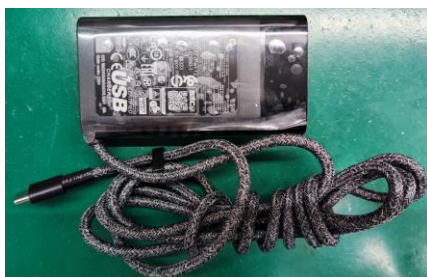
2.1.檢查 adapter 外觀無異常;通電測試無輸出.

The appearance of adapter is normal. Power on test confirms that adapter is no output.

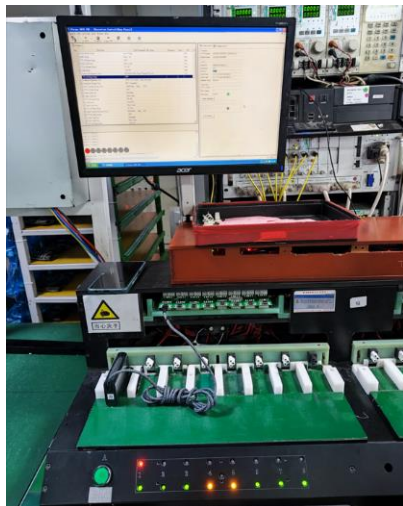
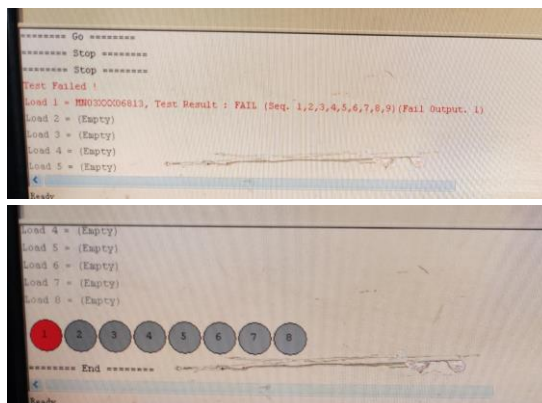
2.2.將 adapter 拿到生產線組裝段進行 Pre-ATE 測試,測試結果 fail.

Take the adapter to the Pre-ATE station of the production line, and the test result is fail(Load 1).

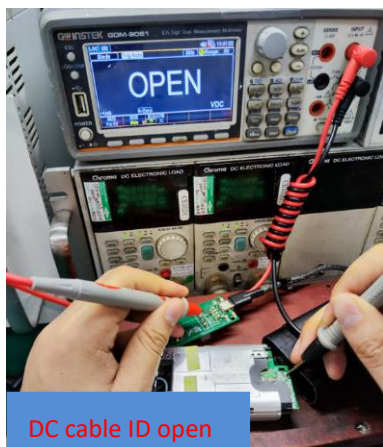
3.1.將 adapter 開殼,量測發現 DC cable ID 開路.

Open the case and found that DC cable ID open.

DC cable ID open

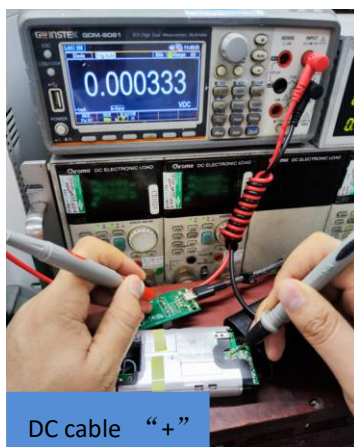
DC cable “+”

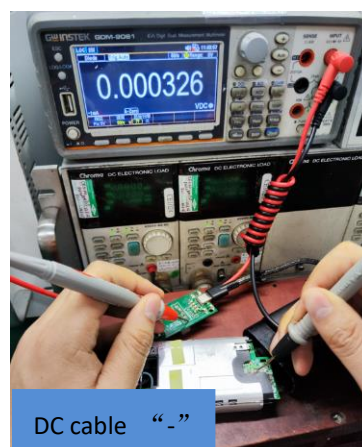
DC cable “-”

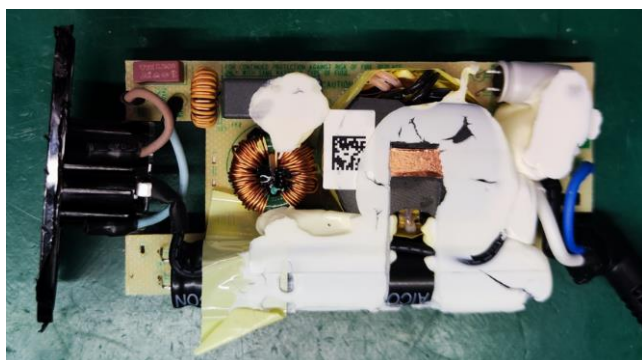
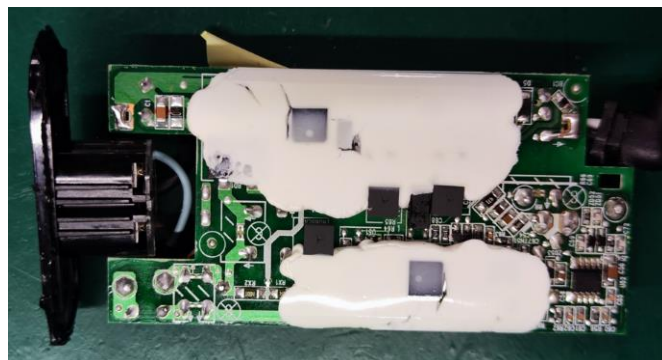
3.2.檢查零件面及錫面無異常.

Open the case to check the parts surface and tin surface. No abnormality was found.

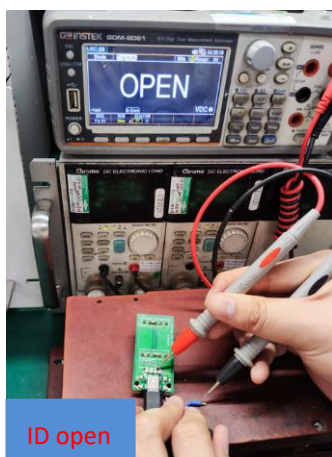
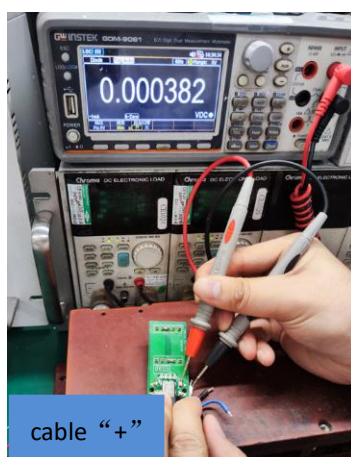
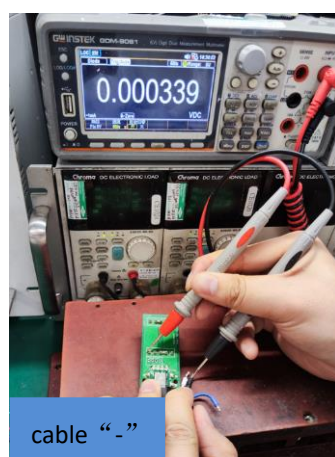
3.2.將不良 DC cable 從 adapter 取下,量測確認 ID 開路.

Remove the DC cable from the adapter. The failed sample confirmed ID open.

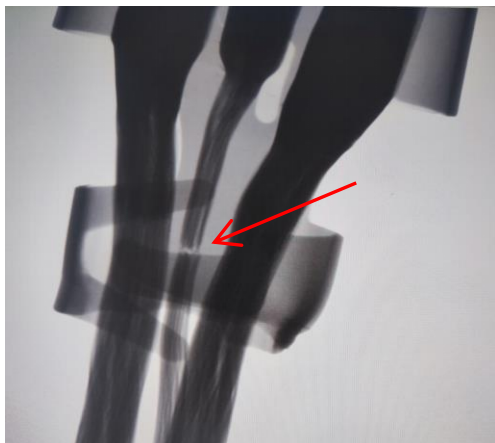
3.4.對不良 DC cable 進行 X-ray,發現 ID 芯線斷裂.

Confirm that the ID wire are disconnected by X-ray.

綜上所述:DC cable ID 開路造成產品無輸出.

The DC cable ID open leads to adapter no output.

將不良送廠商分析,預計 2023/9/11 日前取得 FA.

Send the DC cable to the vendor for analysis, and FA is expected to be get before 2023/9/8.
