M A S S I N T E R C H A N G E

Volume 17, Number 3

Summer 2003

SHARP SHOULDER DROPOFFS

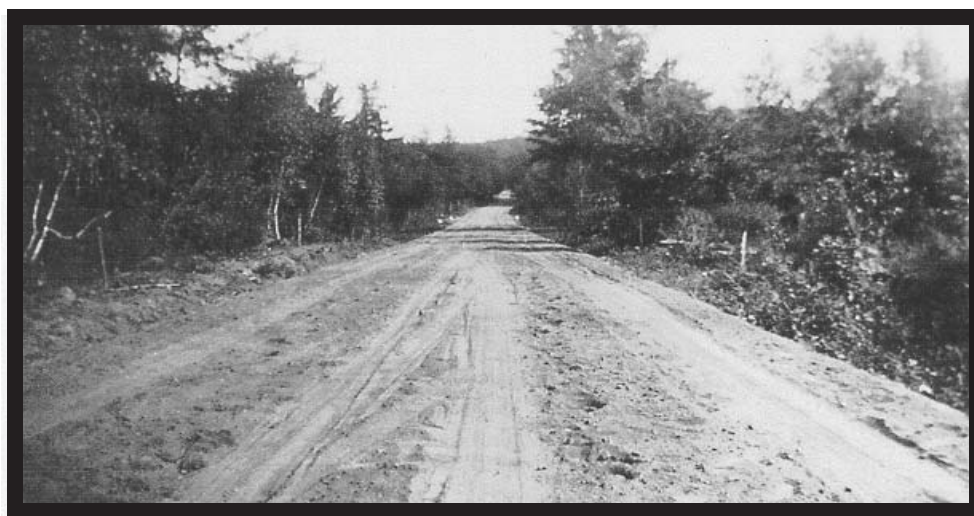
Cotton Road-1935 photo of Route 31...But where's the cotton?

The Cotton Road was an experimental, one-mile long project, which took place in the summer of 1935 or 1936 when there was a surplus of cotton in the country. Someone came up with the rather eccentric idea that the cotton could be used to keep the road smooth and prevent frost heaves from appearing in the late winter and early spring. Fred Otterson, who still lives in Washington, NH, and was a worker on this section of Rt. 31, related the information on which this article is based.

Piles of sand from the Windsor sand pit were put along the side of the road in preparation. Then oil or tar was spread on the road and some of the sand from the piles was "fanned out" onto the tar. Next came the messy job. Citizens of Washington, Fred and Earl Cilley, were about the same height so they formed a team to carry the cotton, which was put down in three layers. They ran a pole through a big roll of cotton mesh, probably 12 feet wide and about all two young men wanted to lift. They walked on the slippery tar and sand, unrolling the mesh onto the surface. When they reached the end of the roll, they got another roll of a coarse and not too fluffy cotton, so thick that their arms would not quite reach around it.

They put the rod through the second roll and unrolled it onto the first layer. This process was repeated with a third layer of fine cotton. All of this was then sealed with more tar and sand.
